1990 Corvette: Service Bulletin: SIR Diagnostics and Procedures to Prevent Codes 16 and 26 Due to Corrosion Revised

Subject: SERVICE MAN. UPDATE SEC.9J A/B REV. SIR DIAGNOSTIC PROCEDURE

Model and Year: 1990 CORVETTE

Bulletin Number: 90-436-9J - (11/07/1991)

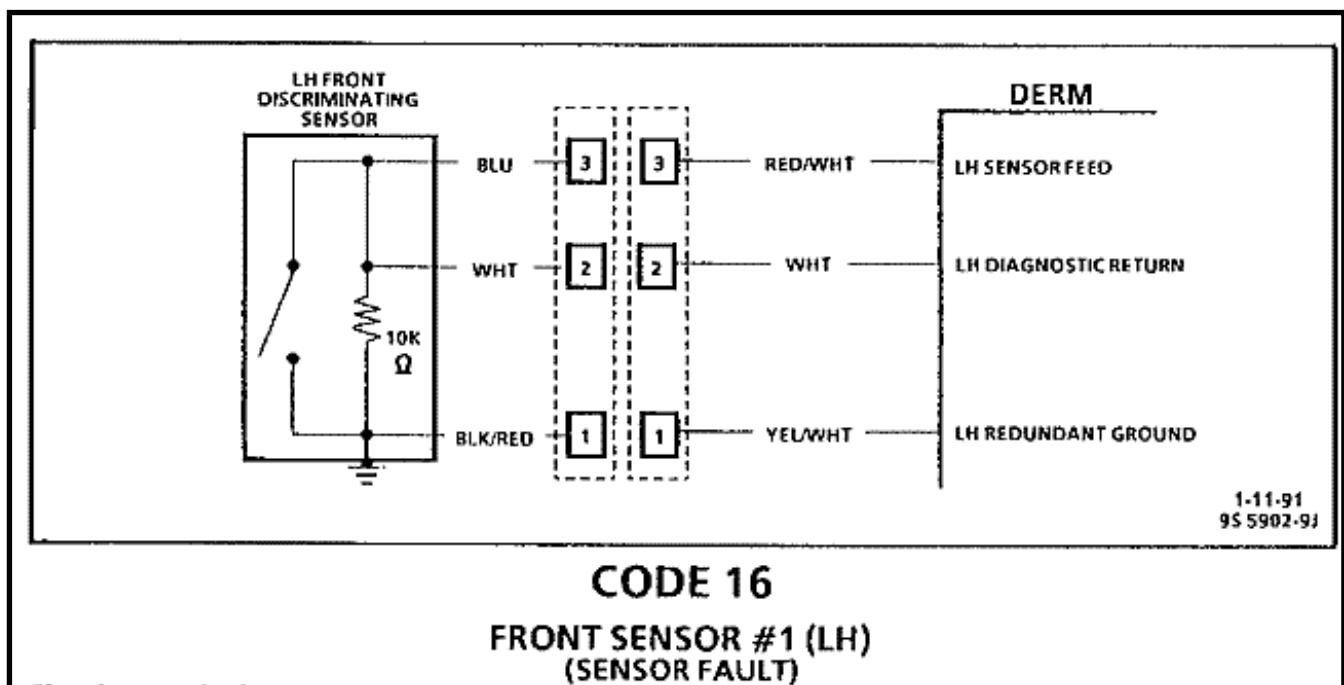
Some 1990 Corvettes have set SIR Sensor Codes 16 and 26. The DERM has detected an unacceptably high resistance between the SIR sensor and the frame rail, most likely due to a buildup of corrosion on the mounting surfaces. New service procedures have been developed to remove the corrosion and help prevent it from building up again. Diagnostic charts and removal and installation procedures, revised to address the corrosion issue, are attached. Please use these new procedures for all 1990 Corvette SIR Code 16 and Code 26 situations you encounter.

FRONT SENSOR #1 (LH) (SENSOR FAULT)

- IGNITION "OFF."
- DISCONNECT SENSOR CONNECTOR.
- USING ADAPTERS FROM J 37808-10 AND DVM J 34029-A OR DVM J 39200, MEASURE THE RESISTANCE BETWEEN TERMINALS IN THE SENSOR PIGTAIL CONNECTOR AS SHOWN BELOW. NOTE MEASUREMENTS FOR EACH CHECK.

SENSOR TERMINALS	RESISTANCE
1 AND 2	ABOUT 10,000 Ω
1 AND 3	ABOUT 10,000 Ω
2 AND 3	LESS THAN 1 Ω

- REMOVE SENSOR; REFER TO "LEFT SENSOR" ON ATTACHED PAGES.
- CLEAN ANY PAINT AND/OR CORROSION FROM SENSOR AND FRAME RAIL MOUNTING POINTS AND MOUNTING BOLTS.
- INSTALL SENSOR; REFER TO "LEFT SENSOR" ON ATTACHED PAGES TO APPLY SPECIAL GREASE AND LOCK WASHERS UPON INSTALLATION TO HELP PREVENT RECURRANCE OF CODE 16 DUE TO CORROSION.
- CLEAR CODES (TECH 1 PREFERRED).
- IGNITION "OFF," THEN "ON."
- DOES CODE 16 RESET?

- REMOVE SENSOR; REFER TO "LEFT SENSOR" ON ATTACHED PAGES.
- CLEAN ANY PAINT AND/OR CORROSION FROM FRAME RAIL MOUNTING POINTS AND MOUNTING BOLTS.
- INSTALL NEW SENSOR; REFER TO "LEFT SENSOR" ON ATTACHED PAGES TO APPLY SPECIAL GREASE AND LOCK WASHERS ON INSTALLATION TO HELP PREVENT RECURRANCE OF CODE 16 DUE TO CORROSION.
- CLEAR CODES (TECH 1 PREFERRED).
- IGNITION "OFF," THEN "ON."
- DOES CODE 16 RESET?

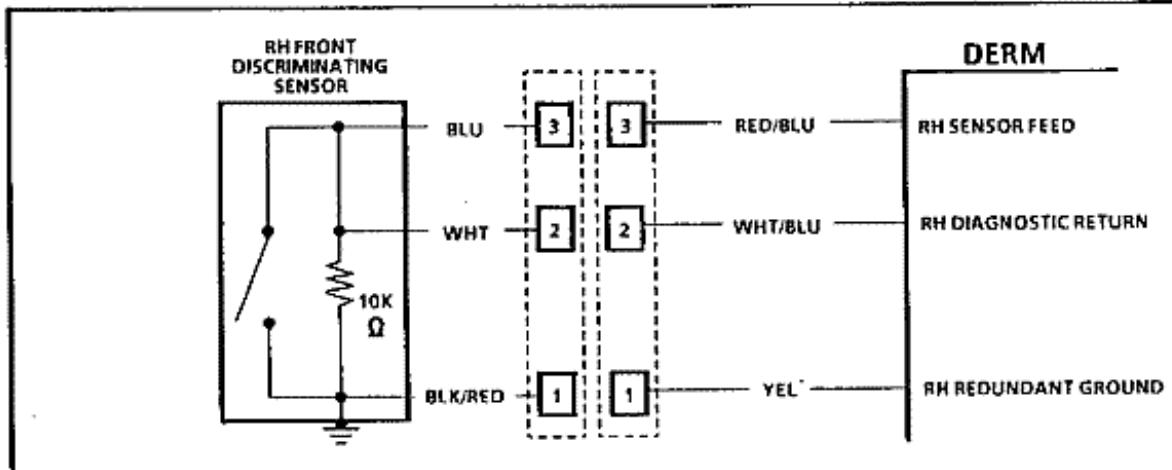
CODE 26
FRONT SENSOR #2 (RH)
(SENSOR FAULT)

- IGNITION "OFF."
- DISCONNECT SENSOR CONNECTOR.
- USING ADAPTERS FROM J 37808-10 AND DVM J 34029-A OR DVM J 39200, MEASURE THE RESISTANCE BETWEEN TERMINALS IN THE SENSOR PIGTAIL CONNECTOR AS SHOWN BELOW. NOTE MEASUREMENTS FOR EACH CHECK.

SENSOR TERMINALS	RESISTANCE
1 AND 2	ABOUT 10,000 Ω
1 AND 3	ABOUT 10,000 Ω
2 AND 3	LESS THAN 1 Ω

- REMOVE SENSOR; REFER TO "RIGHT SENSOR" ON ATTACHED PAGES.
- CLEAN ANY PAINT AND/OR CORROSION FROM SENSOR AND FRAME RAIL MOUNTING POINTS AND MOUNTING BOLTS.
- INSTALL SENSOR; REFER TO "RIGHT SENSOR" ON ATTACHED PAGES TO APPLY SPECIAL GREASE AND LOCK WASHERS UPON INSTALLATION TO HELP PREVENT RECURRENCE OF CODE 16 DUE TO CORROSION.
- CLEAR CODES (TECH 1 PREFERRED).
- IGNITION "OFF," THEN "ON."
- DOES CODE 16 RESET?

- REMOVE SENSOR; REFER TO "RIGHT SENSOR" ON ATTACHED PAGES.
- CLEAN ANY PAINT AND/OR CORROSION FROM FRAME RAIL MOUNTING POINTS AND MOUNTING BOLTS.
- INSTALL NEW SENSOR; REFER TO "RIGHT SENSOR" ON ATTACHED PAGES TO APPLY SPECIAL GREASE AND LOCK WASHERS ON INSTALLATION TO HELP PREVENT RECURRENCE OF CODE 16 DUE TO CORROSION.
- CLEAR CODES (TECH 1 PREFERRED).
- IGNITION "OFF," THEN "ON."
- DOES CODE 16 RESET?
