# 1990 Corvette: Service Bulletin: SIR Diagnostics and Procedures to Prevent Codes 16 and 26 Due to Corrosion Revised

**Subject:** SERVICE MAN. UPDATE SEC.9J A/B REV. SIR DIAGNOSTIC PROCEDURE

**Model and Year:** 1990 CORVETTE

**Bulletin Number:** 90-436-9J - (11/07/1991)

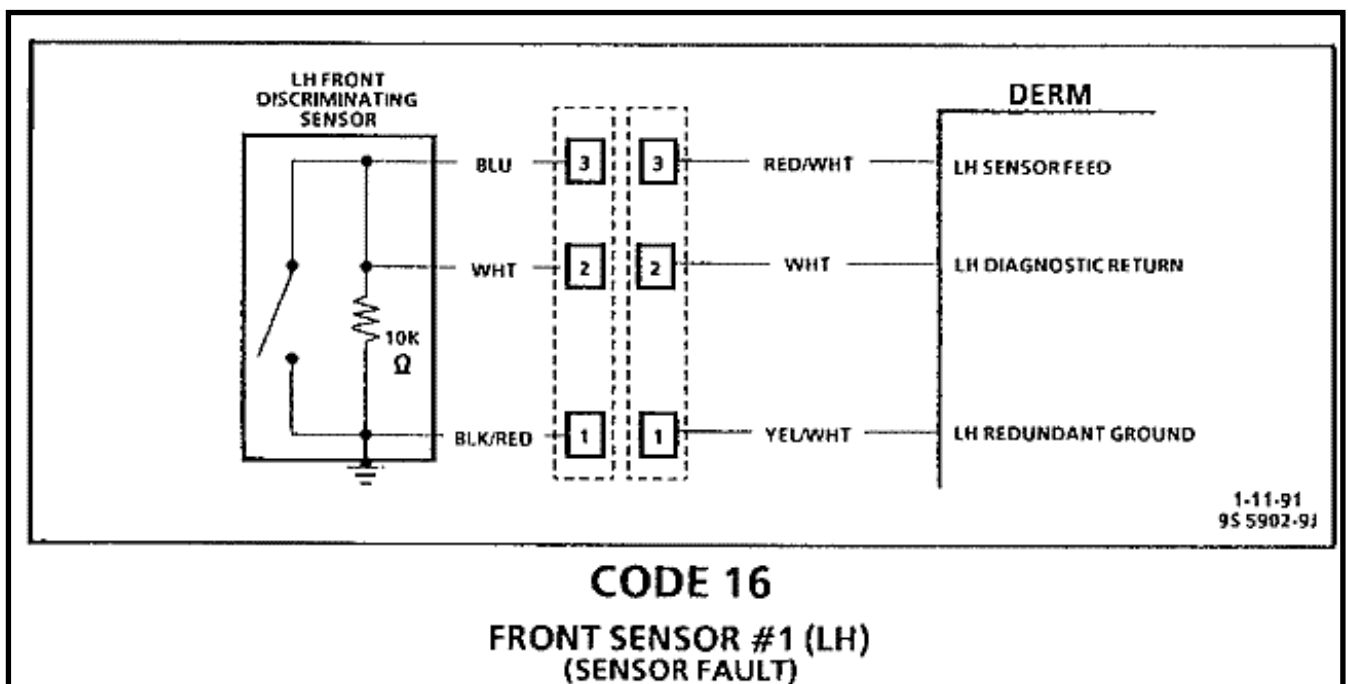
## CODE 16 FRONT SENSOR #1 (LH) (SENSOR FAULT)

Some 1990 Corvettes have set SIR Sensor Codes 16 and 26. The DERM has detected an unacceptably high resistance between the SIR sensor and the frame rail, most likely due to a buildup of corrosion on the mounting surfaces. New service procedures have been developed to remove the corrosion and help prevent it from building up again. Diagnostic charts and removal and installation procedures, revised to address the corrosion issue, are attached. Please use these new procedures for all 1990 Corvette SIR Code 16 and Code 26 situations you encounter.

Severe corrosion under the sensor mounting bracket may cause a Code 16. Refer to "Left Sensor" on attached pages to remove sensor, inspect for corrosion, and correct corrosion if found. "Left Sensor" also instructs on use of special grease and washers to help prevent recurrence of Code 16 due to corrosion.

- 1
- IGNITION "OFF."
  - DISCONNECT SENSOR CONNECTOR.
  - USING ADAPTERS FROM J 37808-10 AND DVM J 34029-A OR DVM J 39200, MEASURE THE RESISTANCE BETWEEN TERMINALS IN THE SENSOR PIGTAIL CONNECTOR AS SHOWN BELOW. NOTE MEASUREMENTS FOR EACH CHECK.

SENSOR TERMINALS	RESISTANCE
1 AND 2	ABOUT 10,000 $\Omega$
1 AND 3	ABOUT 10,000 $\Omega$
2 AND 3	LESS THAN 1 $\Omega$

- WERE ANY OF THE MEASUREMENTS OUT OF RANGE?

- 3
- REMOVE SENSOR; REFER TO "LEFT SENSOR" ON ATTACHED PAGES.
  - CLEAN ANY PAINT AND/OR CORROSION FROM SENSOR AND FRAME RAIL MOUNTING POINTS AND MOUNTING BOLTS.
  - INSTALL SENSOR; REFER TO "LEFT SENSOR" ON ATTACHED PAGES TO APPLY SPECIAL GREASE AND LOCK WASHERS UPON INSTALLATION TO HELP PREVENT RECURRENCE OF CODE 16 DUE TO CORROSION.
  - CLEAR CODES (TECH 1 PREFERRED).
  - IGNITION "OFF," THEN "ON."
  - DOES CODE 16 RESET?

- 4
- REMOVE SENSOR; REFER TO "LEFT SENSOR" ON ATTACHED PAGES.
  - CLEAN ANY PAINT AND/OR CORROSION FROM FRAME RAIL MOUNTING POINTS AND MOUNTING BOLTS.
  - INSTALL NEW SENSOR; REFER TO "LEFT SENSOR" ON ATTACHED PAGES TO APPLY SPECIAL GREASE AND LOCK WASHERS ON INSTALLATION TO HELP PREVENT RECURRENCE OF CODE 16 DUE TO CORROSION.
  - CLEAR CODES (TECH 1 PREFERRED).
  - IGNITION "OFF," THEN "ON."
  - DOES CODE 16 RESET?

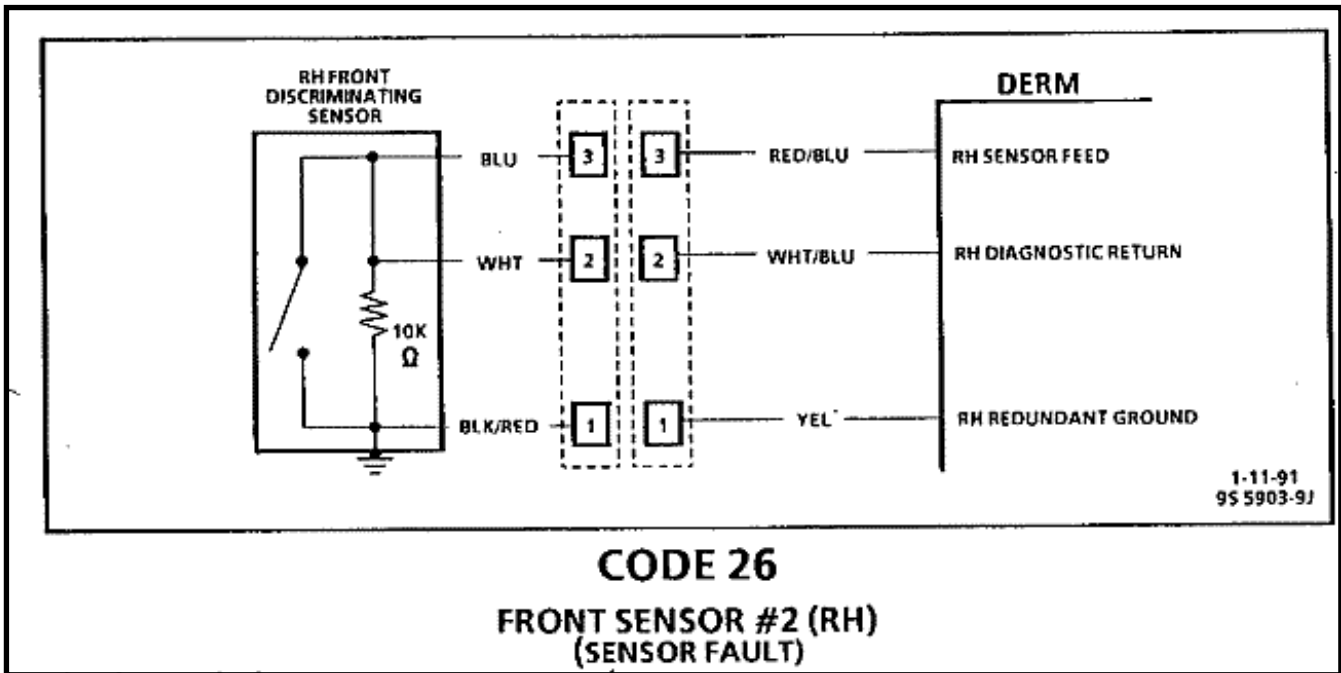
## CODE 26 FRONT SENSOR #2 (RH) (SENSOR FAULT)

Severe corrosion under the sensor mounting bracket may cause a Code 26.

- 1
- IGNITION "OFF."
  - DISCONNECT SENSOR CONNECTOR.
  - USING ADAPTERS FROM J 37808-10 AND DVM J 34029-A OR DVM J 39200, MEASURE THE RESISTANCE BETWEEN TERMINALS IN THE SENSOR PIGTAIL CONNECTOR AS SHOWN BELOW. NOTE MEASUREMENTS FOR EACH CHECK.

SENSOR TERMINALS	RESISTANCE
1 AND 2	ABOUT 10,000 $\Omega$
1 AND 3	ABOUT 10,000 $\Omega$
2 AND 3	LESS THAN 1 $\Omega$

- WERE ANY OF THE MEASUREMENTS OUT OF RANGE?

- 3
- REMOVE SENSOR; REFER TO "RIGHT SENSOR" ON ATTACHED PAGES.
  - CLEAN ANY PAINT AND/OR CORROSION FROM SENSOR AND FRAME RAIL MOUNTING POINTS AND MOUNTING BOLTS.
  - INSTALL SENSOR; REFER TO "RIGHT SENSOR" ON ATTACHED PAGES TO APPLY SPECIAL GREASE AND LOCK WASHERS UPON INSTALLATION TO HELP PREVENT RECURRENCE OF CODE 16 DUE TO CORROSION.
  - CLEAR CODES (TECH 1 PREFERRED).
  - IGNITION "OFF," THEN "ON."
  - DOES CODE 16 RESET?

- 4
- REMOVE SENSOR; REFER TO "RIGHT SENSOR" ON ATTACHED PAGES.
  - CLEAN ANY PAINT AND/OR CORROSION FROM FRAME RAIL MOUNTING POINTS AND MOUNTING BOLTS.
  - INSTALL NEW SENSOR; REFER TO "RIGHT SENSOR" ON ATTACHED PAGES TO APPLY SPECIAL GREASE AND LOCK WASHERS ON INSTALLATION TO HELP PREVENT RECURRENCE OF CODE 16 DUE TO CORROSION.
  - CLEAR CODES (TECH 1 PREFERRED).
  - IGNITION "OFF," THEN "ON."
  - DOES CODE 16 RESET?
