1990 Corvette: Service Bulletin: SIR Diagnostics and Procedures to Prevent Codes 16 and 26 Due to Corrosion Revised

Subject: SERVICE MAN. UPDATE SEC.9J A/B REV. SIR DIAGNOSTIC PROCEDURE

Model and Year: 1990 CORVETTE

Bulletin Number: 90-436-9J - (11/07/1991)

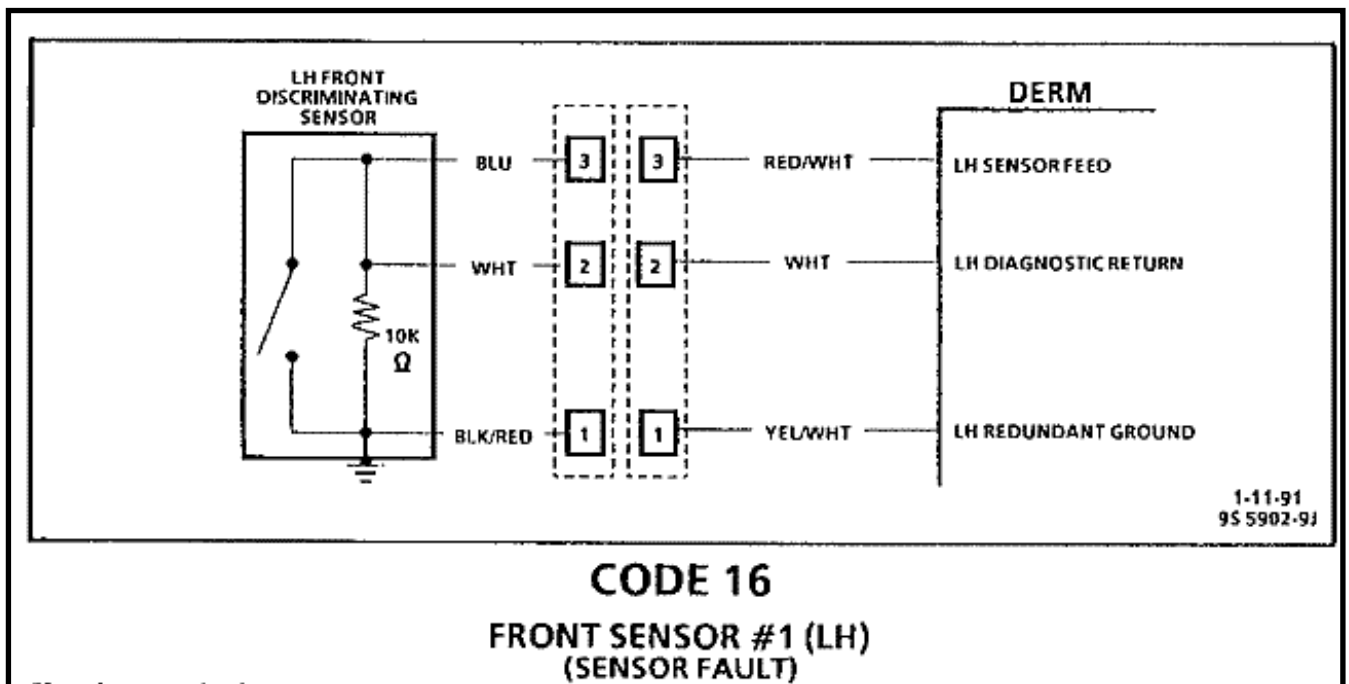
CODE 16 FRONT SENSOR #1 (LH) (SENSOR FAULT)

- 1
- IGNITION "OFF."
 - DISCONNECT SENSOR CONNECTOR.
 - USING ADAPTERS FROM J 37808-10 AND DVM J 34029-A OR DVM J 39200, MEASURE THE RESISTANCE BETWEEN TERMINALS IN THE SENSOR PIGTAIL CONNECTOR AS SHOWN BELOW. NOTE MEASUREMENTS FOR EACH CHECK.

SENSOR TERMINALS	RESISTANCE
1 AND 2	ABOUT 10,000 Ω
1 AND 3	ABOUT 10,000 Ω
2 AND 3	LESS THAN 1 Ω

- WERE ANY OF THE MEASUREMENTS OUT OF RANGE?

- 2
- REPEAT RESISTANCE MEASUREMENTS IN STEP 1 WHILE "WIGGLING" WIRING AND CONNECTORS. THIS MAY UNCOVER AN INTERMITTENT FAULT WHICH DOES NOT APPEAR DURING STEP 1.
 - WERE ANY INTERMITTENTS NOTED?

- 3
- REMOVE SENSOR; REFER TO "LEFT SENSOR" ON ATTACHED PAGES.
 - CLEAN ANY PAINT AND/OR CORROSION FROM SENSOR AND FRAME RAIL MOUNTING POINTS AND MOUNTING BOLTS.
 - INSTALL SENSOR; REFER TO "LEFT SENSOR" ON ATTACHED PAGES TO APPLY SPECIAL GREASE AND LOCK WASHERS UPON INSTALLATION TO HELP PREVENT RECURRENCE OF CODE 16 DUE TO CORROSION.
 - CLEAR CODES (TECH 1 PREFERRED).
 - IGNITION "OFF," THEN "ON."
 - DOES CODE 16 RESET?

- 4
- REMOVE SENSOR; REFER TO "LEFT SENSOR" ON ATTACHED PAGES.
 - CLEAN ANY PAINT AND/OR CORROSION FROM FRAME RAIL MOUNTING POINTS AND MOUNTING BOLTS.
 - INSTALL NEW SENSOR; REFER TO "LEFT SENSOR" ON ATTACHED PAGES TO APPLY SPECIAL GREASE AND LOCK WASHERS ON INSTALLATION TO HELP PREVENT RECURRENCE OF CODE 16 DUE TO CORROSION.
 - CLEAR CODES (TECH 1 PREFERRED).
 - IGNITION "OFF," THEN "ON."
 - DOES CODE 16 RESET?

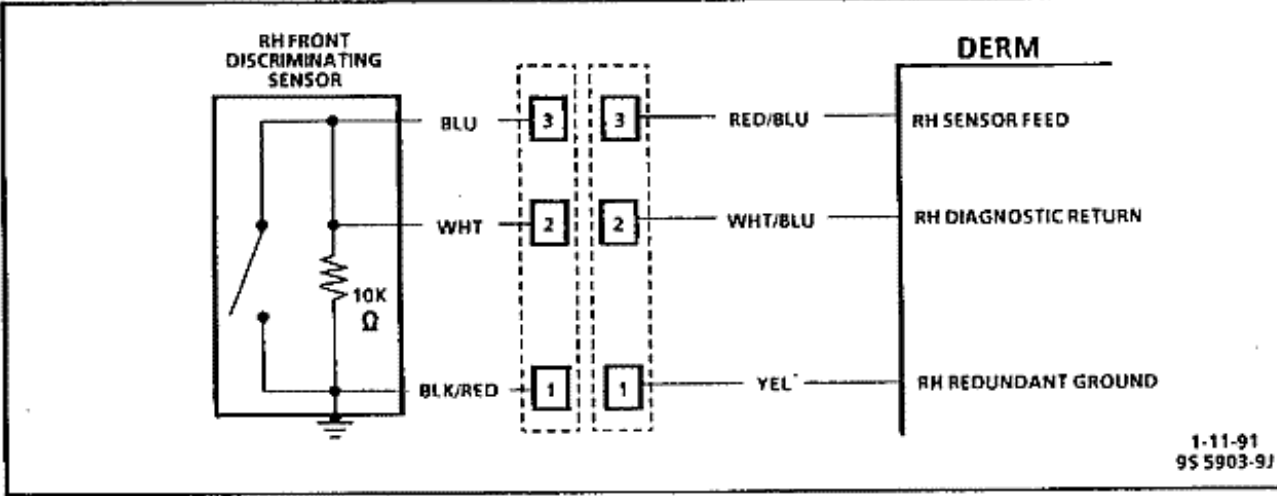
CODE 26 FRONT SENSOR #2 (RH) (SENSOR FAULT)

- 1
- IGNITION "OFF."
 - DISCONNECT SENSOR CONNECTOR.
 - USING ADAPTERS FROM J 37808-10 AND DVM J 34029-A OR DVM J 39200, MEASURE THE RESISTANCE BETWEEN TERMINALS IN THE SENSOR PIGTAIL CONNECTOR AS SHOWN BELOW. NOTE MEASUREMENTS FOR EACH CHECK.

SENSOR TERMINALS	RESISTANCE
1 AND 2	ABOUT 10,000 Ω
1 AND 3	ABOUT 10,000 Ω
2 AND 3	LESS THAN 1 Ω

- WERE ANY OF THE MEASUREMENTS OUT OF RANGE?

- 2
- REPEAT RESISTANCE MEASUREMENTS IN STEP 1 WHILE "WIGGLING" WIRING AND CONNECTORS. THIS MAY UNCOVER AN INTERMITTENT FAULT WHICH DOES NOT APPEAR DURING STEP 1.
 - WERE ANY INTERMITTENTS NOTED?

- 3
- REMOVE SENSOR; REFER TO "RIGHT SENSOR" ON ATTACHED PAGES.
 - CLEAN ANY PAINT AND/OR CORROSION FROM SENSOR AND FRAME RAIL MOUNTING POINTS AND MOUNTING BOLTS.
 - INSTALL SENSOR; REFER TO "RIGHT SENSOR" ON ATTACHED PAGES TO APPLY SPECIAL GREASE AND LOCK WASHERS UPON INSTALLATION TO HELP PREVENT RECURRENCE OF CODE 16 DUE TO CORROSION.
 - CLEAR CODES (TECH 1 PREFERRED).
 - IGNITION "OFF," THEN "ON."
 - DOES CODE 16 RESET?

- 4
- REMOVE SENSOR; REFER TO "RIGHT SENSOR" ON ATTACHED PAGES.
 - CLEAN ANY PAINT AND/OR CORROSION FROM FRAME RAIL MOUNTING POINTS AND MOUNTING BOLTS.
 - INSTALL NEW SENSOR; REFER TO "RIGHT SENSOR" ON ATTACHED PAGES TO APPLY SPECIAL GREASE AND LOCK WASHERS ON INSTALLATION TO HELP PREVENT RECURRENCE OF CODE 16 DUE TO CORROSION.
 - CLEAR CODES (TECH 1 PREFERRED).
 - IGNITION "OFF," THEN "ON."
 - DOES CODE 16 RESET?
