1990 Corvette: Service Bulletin: SIR Diagnostics and Procedures to Prevent Codes 16 and 26 Due to Corrosion Revised

Subject: SERVICE MAN. UPDATE SEC.9J A/B REV. SIR DIAGNOSTIC PROCEDURE

Model and Year: 1990 CORVETTE

Bulletin Number: 90-436-9J - (11/07/1991)

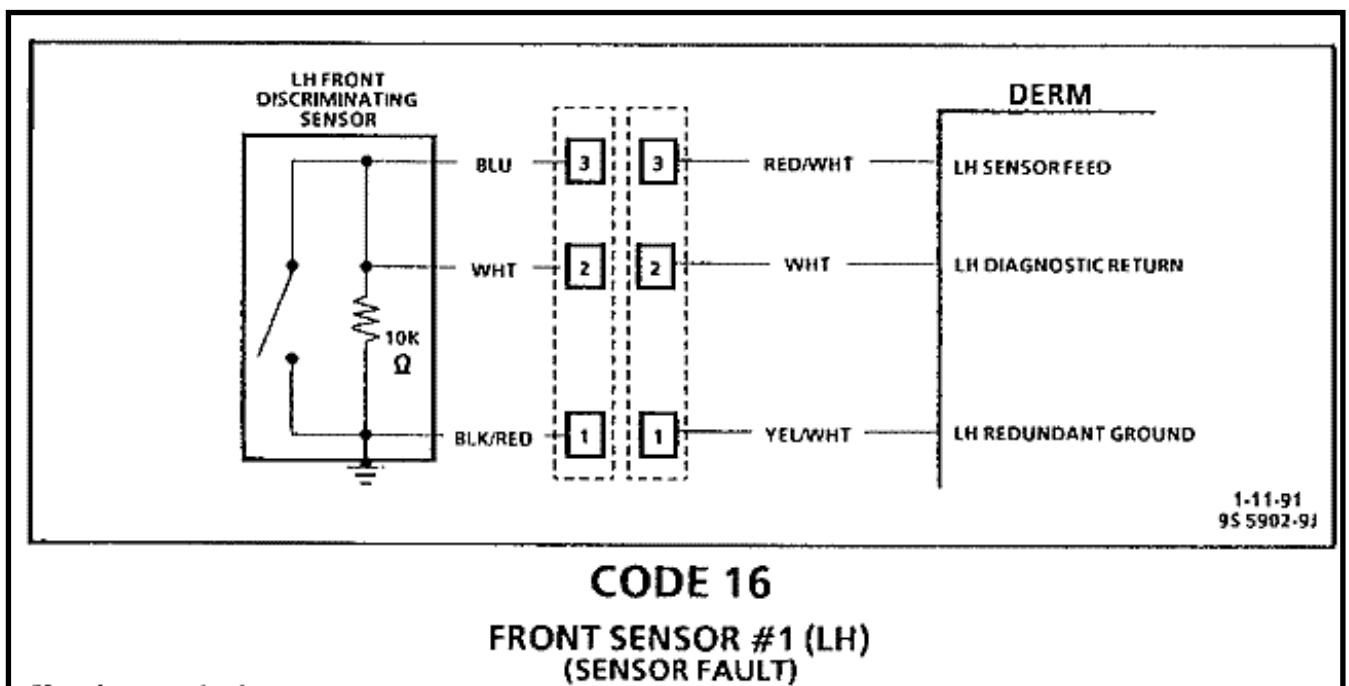
CODE 16 FRONT SENSOR #1 (LH) (SENSOR FAULT)

- 1
- IGNITION "OFF."
 - DISCONNECT SENSOR CONNECTOR.
 - USING ADAPTERS FROM J 37808-10 AND DVM J 34029-A OR DVM J 39200, MEASURE THE RESISTANCE BETWEEN TERMINALS IN THE SENSOR PIGTAIL CONNECTOR AS SHOWN BELOW. NOTE MEASUREMENTS FOR EACH CHECK.

SENSOR TERMINALS	RESISTANCE
1 AND 2	ABOUT 10,000 Ω
1 AND 3	ABOUT 10,000 Ω
2 AND 3	LESS THAN 1 Ω

- WERE ANY OF THE MEASUREMENTS OUT OF RANGE?

- 2
- REPEAT RESISTANCE MEASUREMENTS IN STEP 1 WHILE "WIGGLING" WIRING AND CONNECTORS. THIS MAY UNCOVER AN INTERMITTENT FAULT WHICH DOES NOT APPEAR DURING STEP 1.
 - WERE ANY INTERMITTENTS NOTED?

- 3
- REMOVE SENSOR; REFER TO "LEFT SENSOR" ON ATTACHED PAGES.
 - CLEAN ANY PAINT AND/OR CORROSION FROM SENSOR AND FRAME RAIL MOUNTING POINTS AND MOUNTING BOLTS.
 - INSTALL SENSOR; REFER TO "LEFT SENSOR" ON ATTACHED PAGES TO APPLY SPECIAL GREASE AND LOCK WASHERS UPON INSTALLATION TO HELP PREVENT RECURRENCE OF CODE 16 DUE TO CORROSION.
 - CLEAR CODES (TECH 1 PREFERRED).
 - IGNITION "OFF," THEN "ON."
 - DOES CODE 16 RESET?

- 4
- REMOVE SENSOR; REFER TO "LEFT SENSOR" ON ATTACHED PAGES.
 - CLEAN ANY PAINT AND/OR CORROSION FROM FRAME RAIL MOUNTING POINTS AND MOUNTING BOLTS.
 - INSTALL NEW SENSOR; REFER TO "LEFT SENSOR" ON ATTACHED PAGES TO APPLY SPECIAL GREASE AND LOCK WASHERS ON INSTALLATION TO HELP PREVENT RECURRENCE OF CODE 16 DUE TO CORROSION.
 - CLEAR CODES (TECH 1 PREFERRED).
 - IGNITION "OFF," THEN "ON."
 - DOES CODE 16 RESET?
