1990 Corvette: Service Bulletin: SIR Diagnostics and Procedures to Prevent Codes 16 and 26 Due to Corrosion Revised

Subject: SERVICE MAN. UPDATE SEC.9J A/B REV. SIR DIAGNOSTIC PROCEDURE

Model and Year: 1990 CORVETTE

Bulletin Number: 90-436-9J - (11/07/1991)

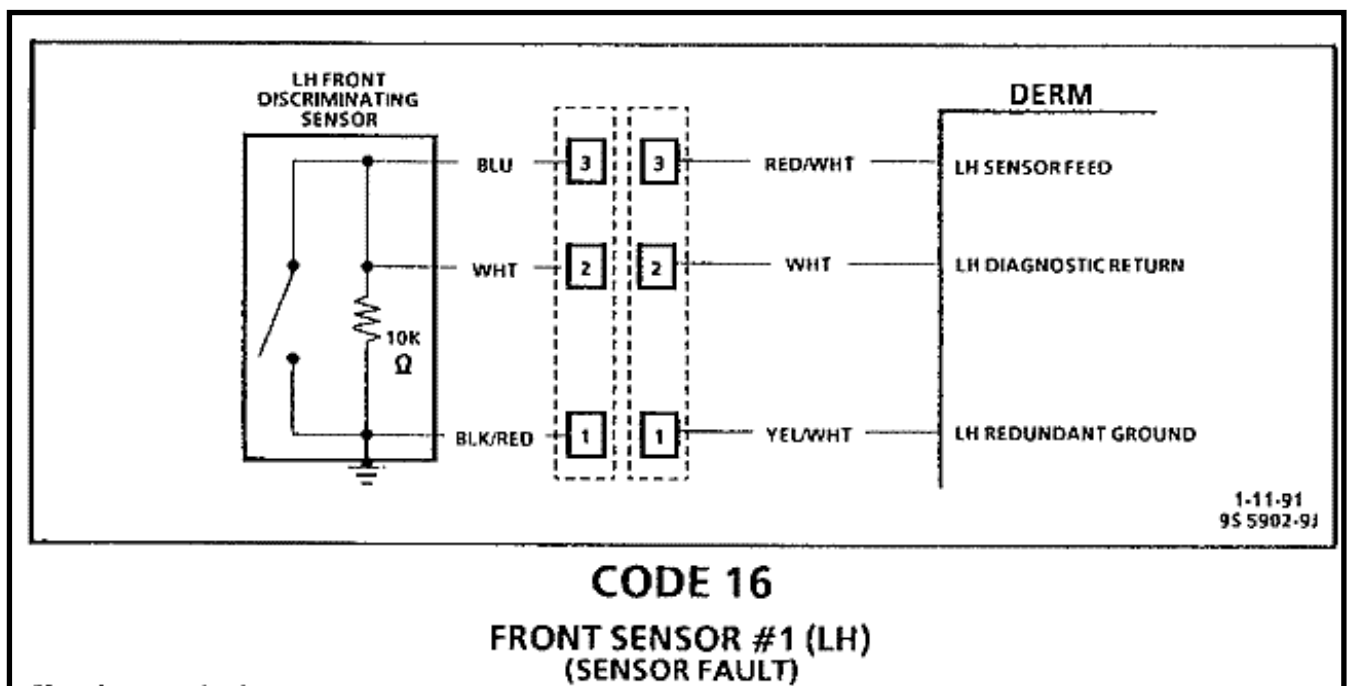
FORWARD DISCRIMINATING SENSORS Figures 1 & 2 -----

Caution should be used to assure proper location of sensors to the front frame rails. The keying of the sensors to the frame rails through the differently sized mounting bolt holes in the sensor mounting plate should never be modified in the field.

1. Apply a thin layer of special grease P/N 12345579 to the frame rail mounting surface and the mounting flange of the sensor. Do not apply the grease to the mounting bolts or holes.
2. Forward discriminating sensor, with arrow pointing toward front of vehicle.
3. External tooth lock washers, P/N 11501869 (8 mm) and 121753 (6 mm) to mounting bolts.
4. Sensor mounting bolts. Ensure that washers are between bolt head and sensor mounting flange, not between mounting flange and frame rail.

- Front (13 mm head) bolt to 25 N.m (19 lb. ft.) - Rear (10 mm head) bolt to 14 N.m (125 lb. in.)
5. Sensor electrical connection, then clip completed connection into retainer.
 6. ECM and support; refer to DRIVEABILITY AND EMISSIONS (SECTION 6E3).

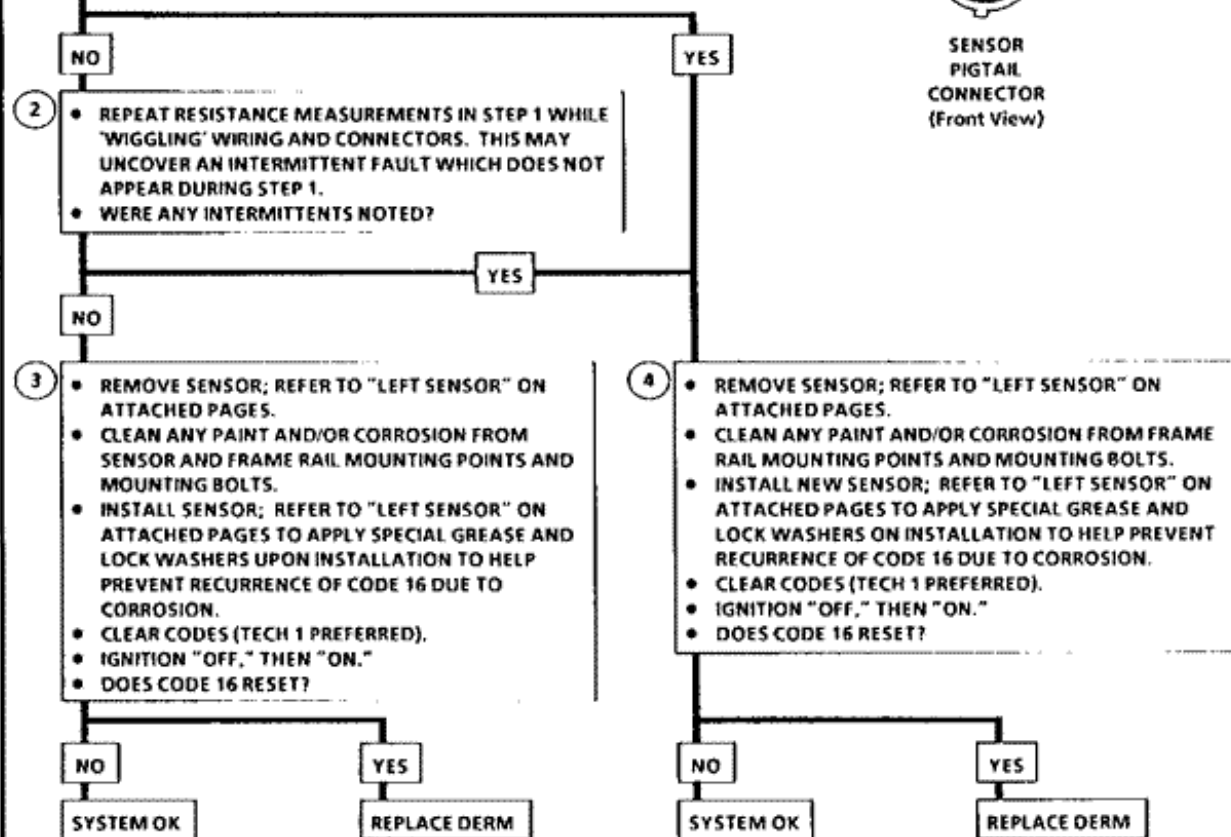
SENSOR
PIGTAIL
CONNECTOR
(Front View)

- 1
- IGNITION "OFF."
- DISCONNECT SENSOR CONNECTOR.
- USING ADAPTERS FROM J 37808-10 AND DVM J 34029-A OR DVM J 39200, MEASURE THE RESISTANCE BETWEEN TERMINALS IN THE SENSOR PIGTAIL CONNECTOR AS SHOWN BELOW. NOTE MEASUREMENTS FOR EACH CHECK.

SENSOR TERMINALS	RESISTANCE
1 AND 2	ABOUT 10,000 Ω
1 AND 3	ABOUT 10,000 Ω
2 AND 3	LESS THAN 1 Ω

- WERE ANY OF THE MEASUREMENTS OUT OF RANGE?

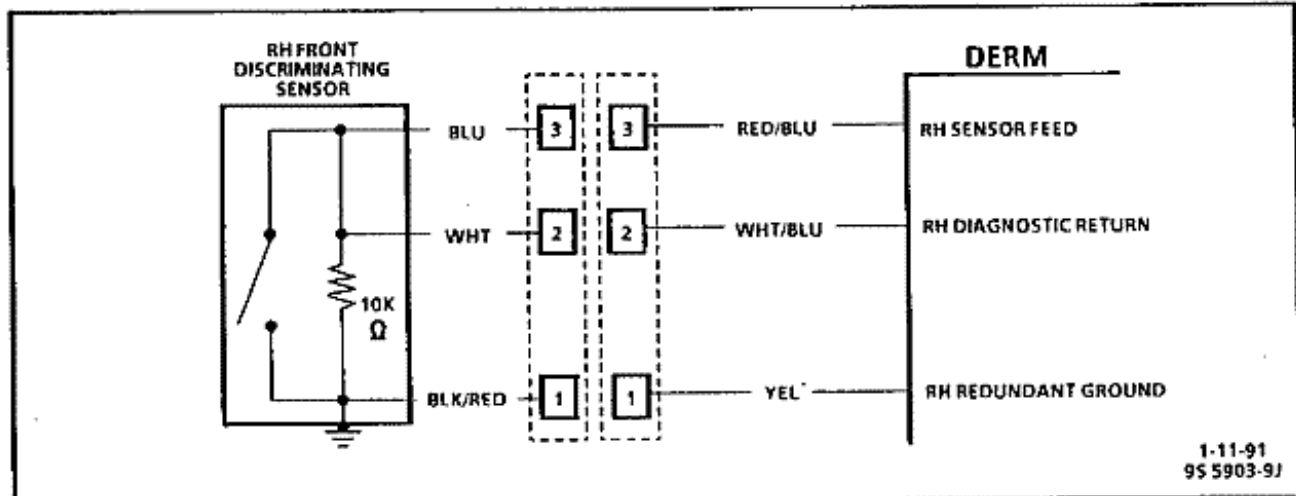
SENSOR
PIGTAIL
CONNECTOR
(Front View)

- 1
- IGNITION "OFF."
 - DISCONNECT SENSOR CONNECTOR.
 - USING ADAPTERS FROM J 37808-10 AND DVM J 34029-A OR DVM J 39200, MEASURE THE RESISTANCE BETWEEN TERMINALS IN THE SENSOR PIGTAIL CONNECTOR AS SHOWN BELOW. NOTE MEASUREMENTS FOR EACH CHECK.

SENSOR TERMINALS	RESISTANCE
1 AND 2	ABOUT 10,000 Ω
1 AND 3	ABOUT 10,000 Ω
2 AND 3	LESS THAN 1 Ω

- WERE ANY OF THE MEASUREMENTS OUT OF RANGE?

- 3
- REMOVE SENSOR; REFER TO "RIGHT SENSOR" ON ATTACHED PAGES.
 - CLEAN ANY PAINT AND/OR CORROSION FROM SENSOR AND FRAME RAIL MOUNTING POINTS AND MOUNTING BOLTS.
 - INSTALL SENSOR; REFER TO "RIGHT SENSOR" ON ATTACHED PAGES TO APPLY SPECIAL GREASE AND LOCK WASHERS UPON INSTALLATION TO HELP PREVENT RECURRENCE OF CODE 16 DUE TO CORROSION.
 - CLEAR CODES (TECH 1 PREFERRED).
 - IGNITION "OFF," THEN "ON."
 - DOES CODE 16 RESET?

- 4
- REMOVE SENSOR; REFER TO "RIGHT SENSOR" ON ATTACHED PAGES.
 - CLEAN ANY PAINT AND/OR CORROSION FROM FRAME RAIL MOUNTING POINTS AND MOUNTING BOLTS.
 - INSTALL NEW SENSOR; REFER TO "RIGHT SENSOR" ON ATTACHED PAGES TO APPLY SPECIAL GREASE AND LOCK WASHERS ON INSTALLATION TO HELP PREVENT RECURRENCE OF CODE 16 DUE TO CORROSION.
 - CLEAR CODES (TECH 1 PREFERRED).
 - IGNITION "OFF," THEN "ON."
 - DOES CODE 16 RESET?
