1989 - 1990 Corvette: Service Bulletin: Wiper Motor Starts in High Speed Only

Subject: WIPER MOTOR STARTS IN HIGH SPEED ONLY

Model and Year: 1989-90 CELEBRITY CAMARO, CORSICA, BERETTA, LUMINA AND CORVETTE

Bulletin Number: 90-420-8E

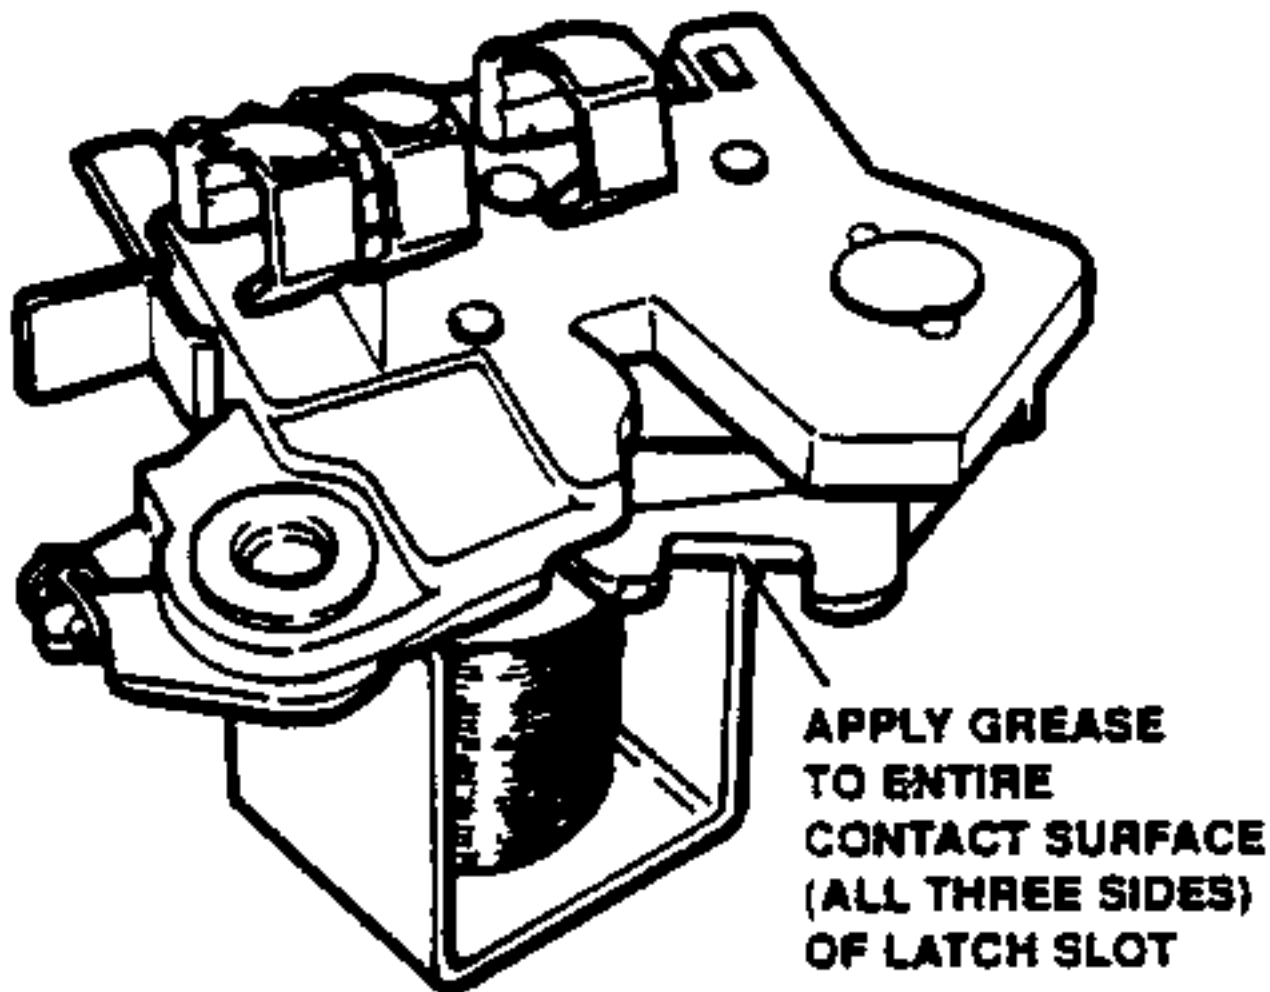
Some vehicles may exhibit a condition of the wiper motor starting in the high speed only.

Burrs on the internal motor park latch prevent the necessary movement of the latch for a normal low speed start.

Install Service Package #22063283 Park Switch Assembly in the wiper motor as per the service manual. Apply grease to the latch slot per instructions given in Figure 1.
