# 1984 - 1990 Corvette: Service Bulletin: Underhood Lamps Inoperative or Staying On

**Model Year:** 1984-1990 Y-Car

**Bulletin Number:** 90-248-8B

**Date:** 05-07-1990

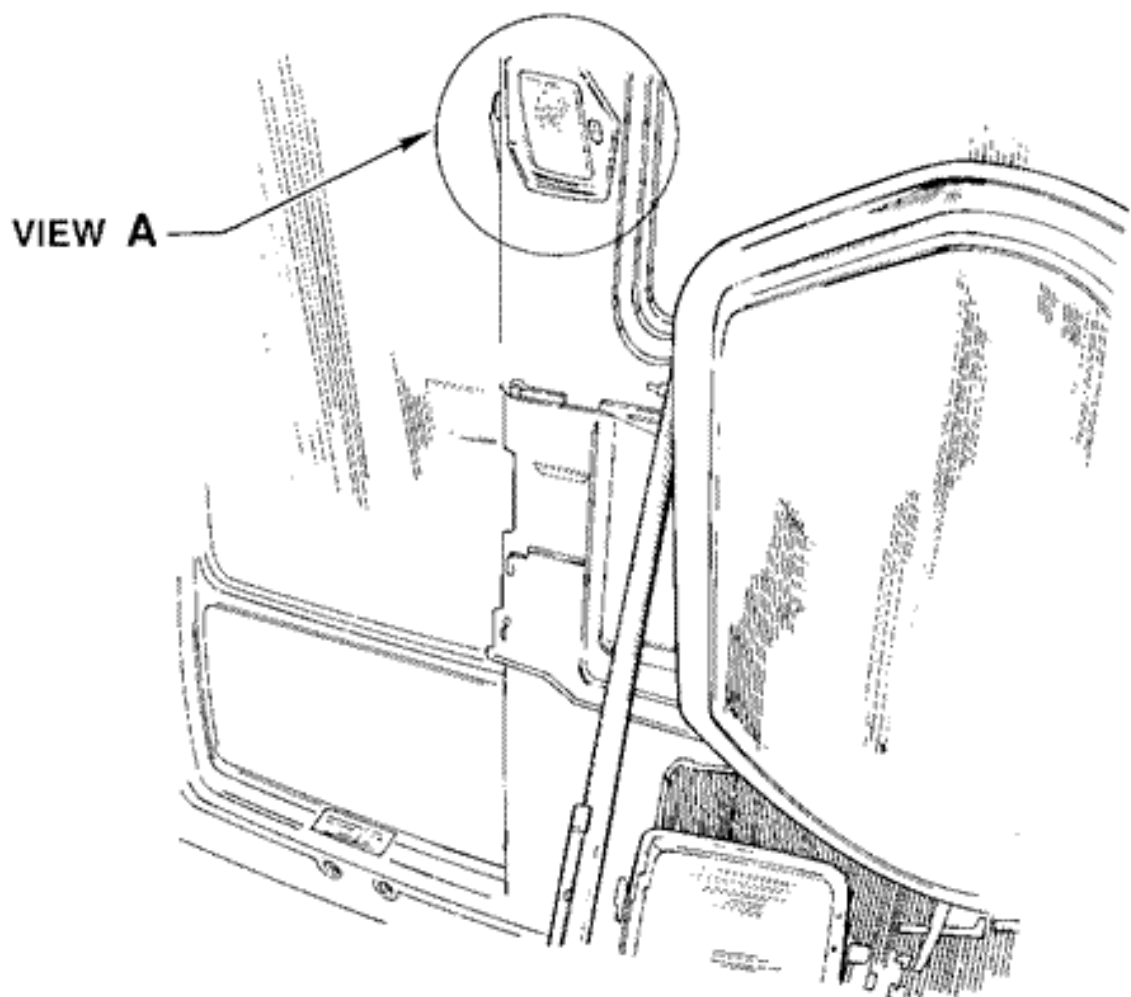
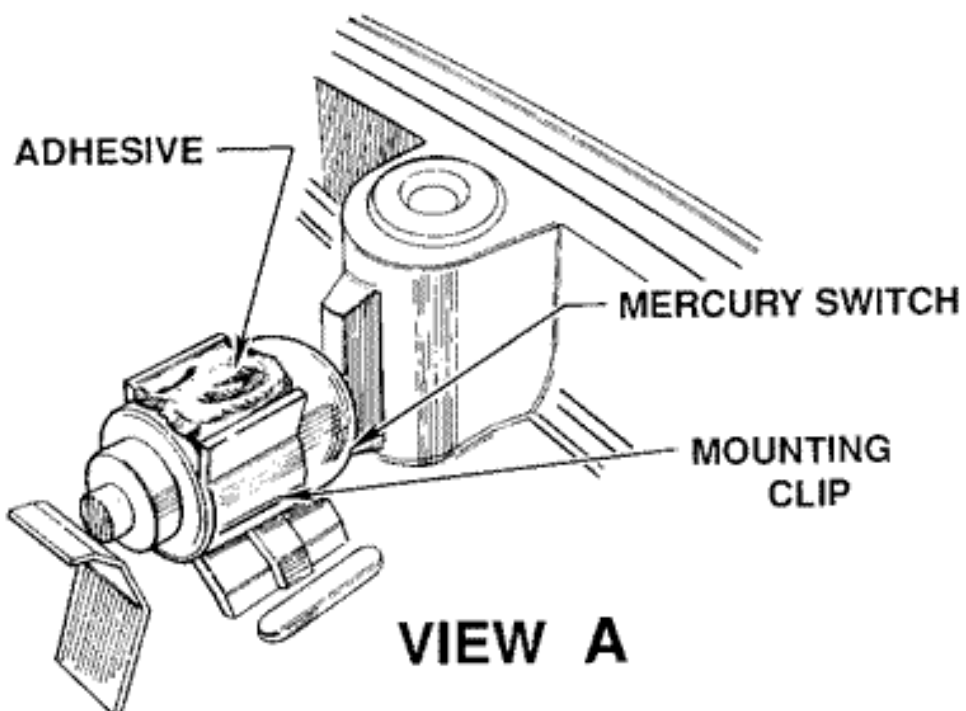
# Corvette Underhood Lamps

1. Mercury switch disengaged from retaining clip in lamp housing.
2. Mercury switch partially disengaged, and shorting across terminals.
3. Mercury switch has either short or open circuit internally.

5. Raise the hood to full open, and apply a bead of 3M #08670 T3 Silicone, Permatex #26B High Temp R.T.V. (or equivalent) across the switch and clip ends for retention as shown in the illustration.
