# 1984 - 1990 Corvette: Service Bulletin: Underhood Lamps Inoperative or Staying On

**Model Year:** 1984-1990 Y-Car

**Source:** Chevrolet Dealer Service Bulletin

**Bulletin Number:** 90-248-8B

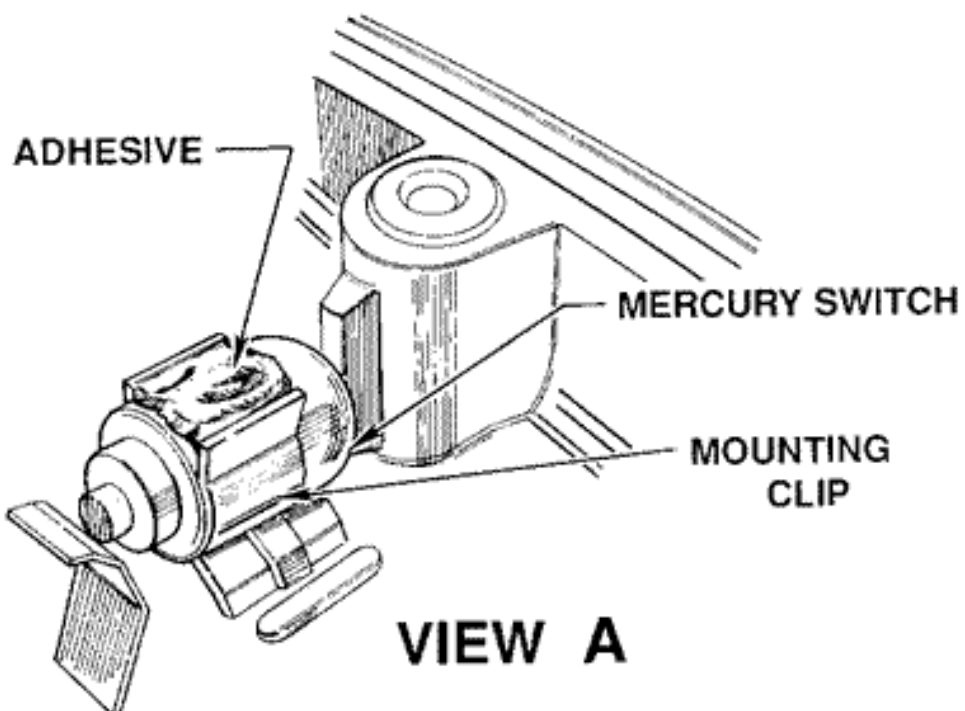
# Corvette Underhood Lamps

1. Mercury switch disengaged from retaining clip in lamp housing.
2. Mercury switch partially disengaged, and shorting across terminals.
3. Mercury switch has either short or open circuit internally.

5. Raise the hood to full open, and apply a bead of 3M #08670 T3 Silicone, Permatex #26B High Temp R.T.V. (or equivalent) across the switch and clip ends for retention as shown in the illustration.
