1984 - 1990 Corvette: Service Bulletin: Underhood Lamps Inoperative or Staying On

Model Year: 1984-1990 Y-Car

Bulletin Number: 90-248-8B

Date: 05-07-1990

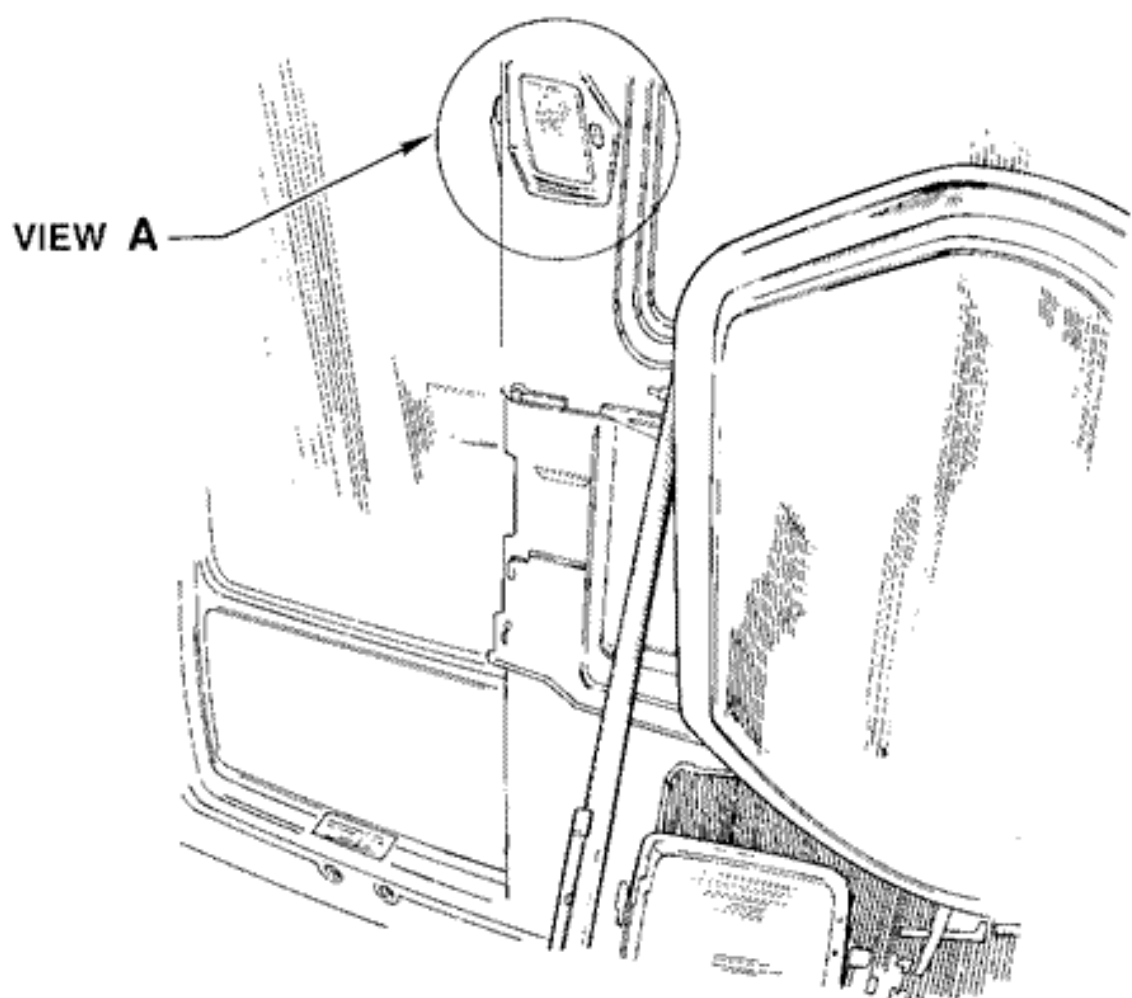
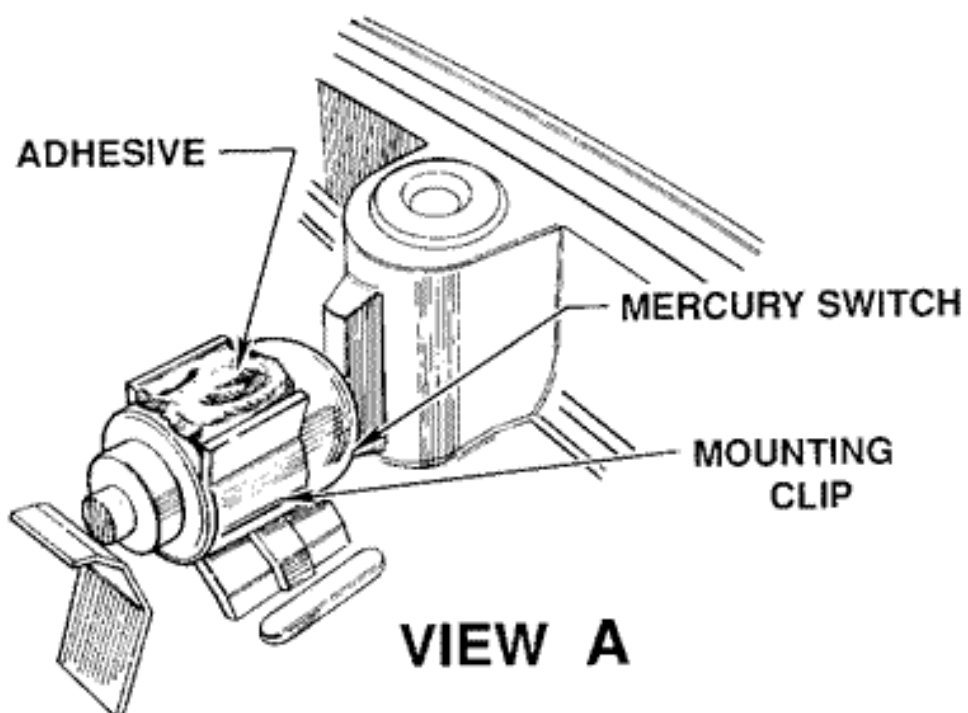
Corvette Underhood Lamps

1. Mercury switch disengaged from retaining clip in lamp housing.
2. Mercury switch partially disengaged, and shorting across terminals.
3. Mercury switch has either short or open circuit internally.

5. Raise the hood to full open, and apply a bead of 3M #08670 T3 Silicone, Permatex #26B High Temp R.T.V. (or equivalent) across the switch and clip ends for retention as shown in the illustration.
