1984 - 1990 Corvette: Service Bulletin: Underhood Lamps Inoperative or Staying On

Model Year: 1984-1990 Y-Car

Source: Chevrolet Dealer Service Bulletin

Bulletin Number: 90-248-8B

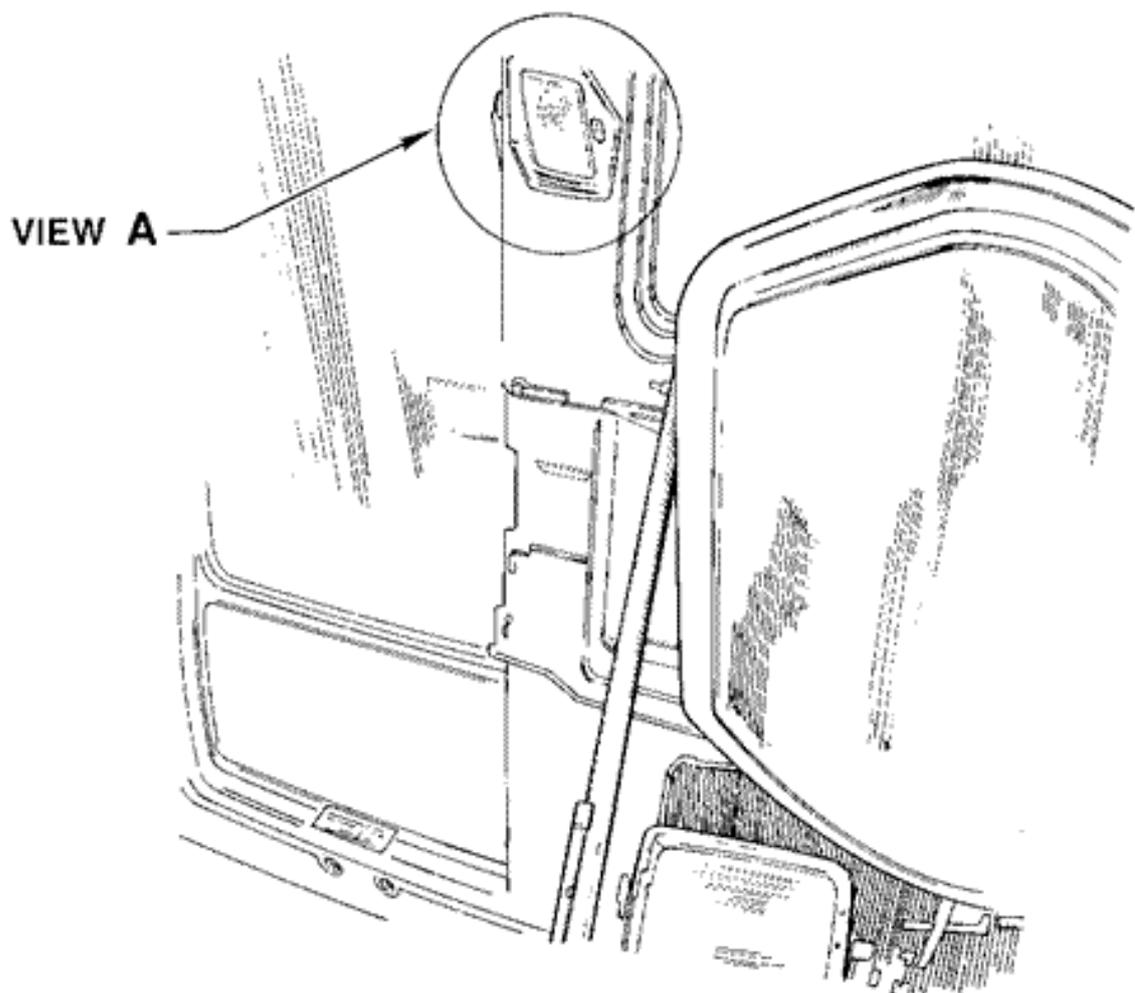
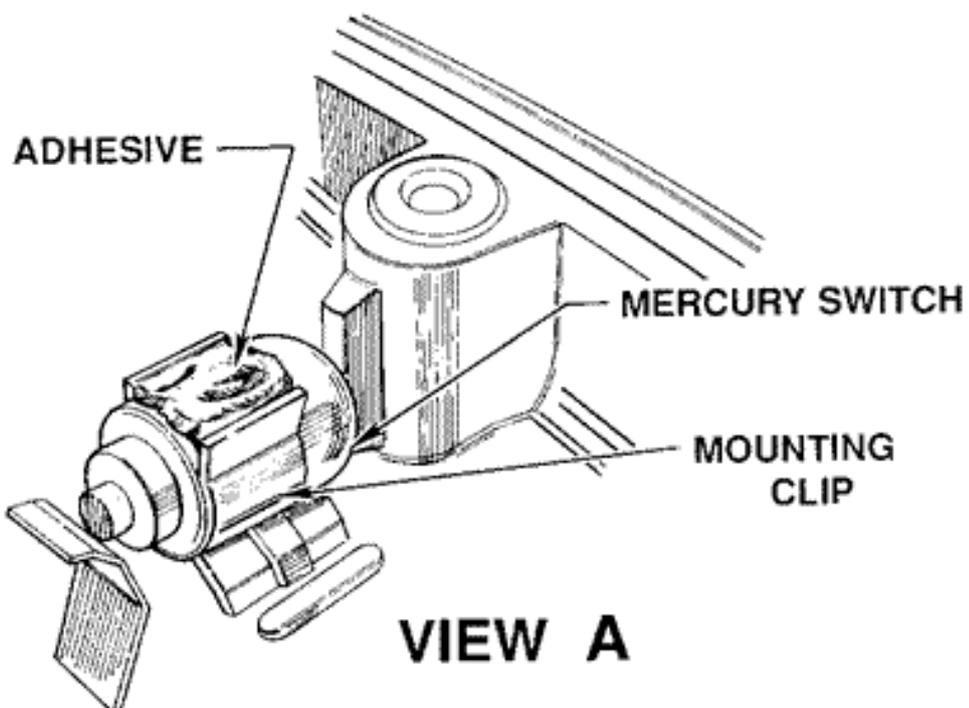
Corvette Underhood Lamps

Underhood lamps that are inoperative, or that stay on.

1. Mercury switch disengaged from retaining clip in lamp housing.
2. Mercury switch partially disengaged, and shorting across terminals.
3. Mercury switch has either short or open circuit internally.

5. Raise the hood to full open, and apply a bead of 3M #08670 T3 Silicone, Permatex #26B High Temp R.T.V. (or equivalent) across the switch and clip ends for retention as shown in the illustration.
