1995 - 1996 Corvette: Service Bulletin: Transmission Fluid Leak From Pump Body

Subject: Transmission Fluid Leak From Pump Body (Replace Bushing)

Bulletin Number: 57-71-26B

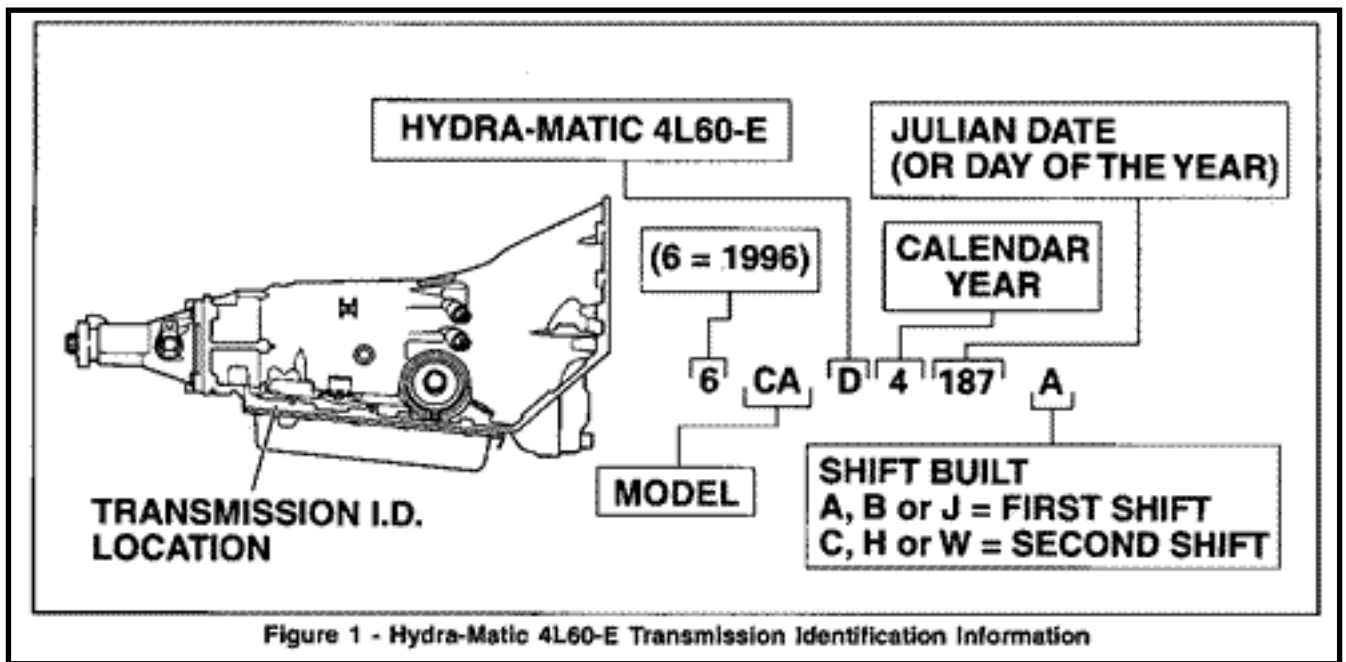
Figure 1 - Hydra-Matic 4L60-E Transmission Identification Information

(FIGURE 1) SOME OWNERS MAY EXPERIENCE A PUMP FLUID LEAK. STARTING SEPTEMBER 11, 1995 (JULIAN DATE 254) ALL UNITS ARE BUILT USING A REVISED DESIGN BODY BUSHING.

THE PUMP BUSHING IS SPINNING OR WALKING OUT OF THE BODY.

REPLACE THE PUMP BODY BUSHING USING KENT-MOORE TOOL J41778.
