1995 - 1996 Corvette: Service Bulletin: Transmission Fluid Leak From Pump Body

Subject: Transmission Fluid Leak From Pump Body (Replace Bushing)

Bulletin Number: 57-71-26B

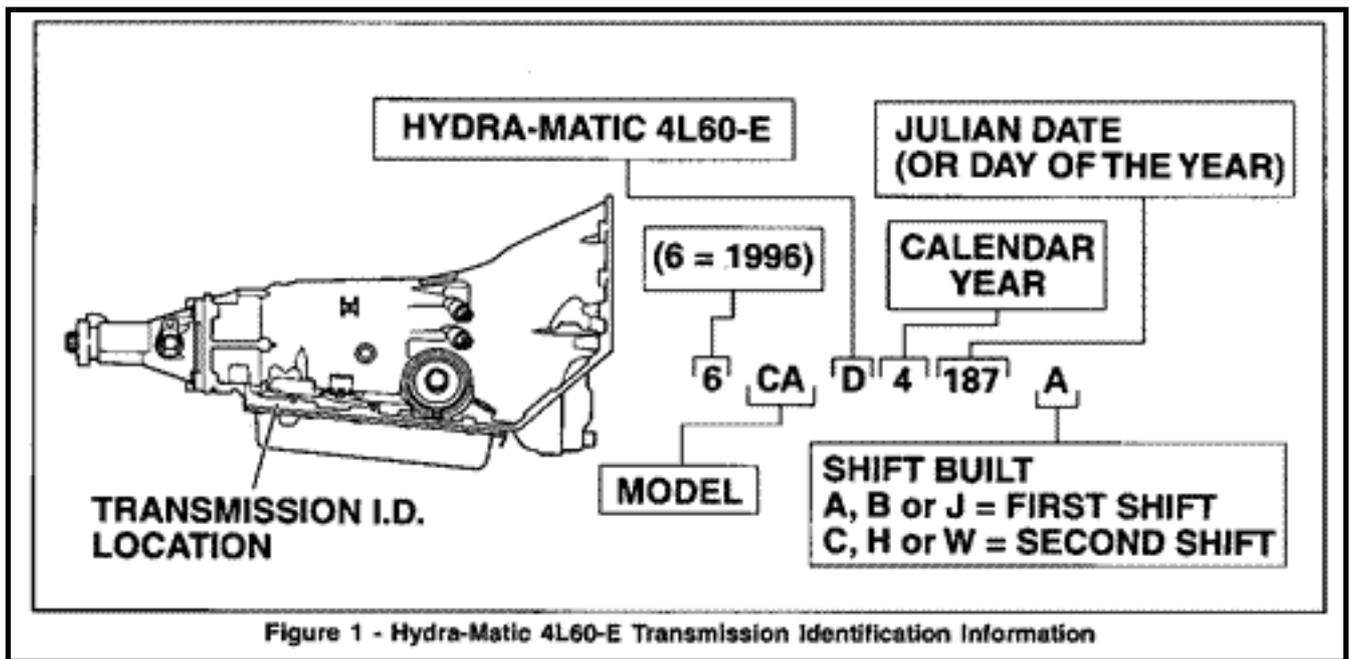
(FIGURE 1) SOME OWNERS MAY EXPERIENCE A PUMP FLUID LEAK. STARTING SEPTEMBER 11, 1995 (JULIAN DATE 254) ALL UNITS ARE BUILT USING A REVISED DESIGN BODY BUSHING.

THE PUMP BUSHING IS SPINNING OR WALKING OUT OF THE BODY.

REPLACE THE PUMP BODY BUSHING USING KENT-MOORE TOOL J41778.
