# 1995 - 1996 Corvette: Service Bulletin: Transmission Fluid Leak From Pump Body

**Subject:** Transmission Fluid Leak From Pump Body (Replace Bushing)

**Bulletin Number:** 57-71-26B

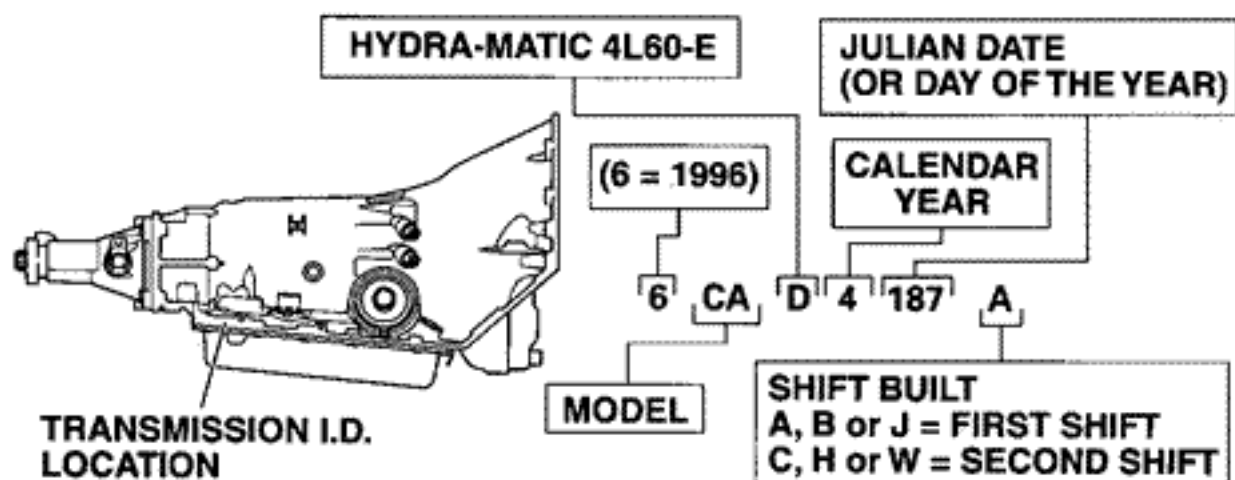
Figure 1 - Hydra-Matic 4L60-E Transmission Identification Information

(FIGURE 1) SOME OWNERS MAY EXPERIENCE A PUMP FLUID LEAK. STARTING SEPTEMBER 11, 1995 (JULIAN DATE 254) ALL UNITS ARE BUILT USING A REVISED DESIGN BODY BUSHING.

THE PUMP BUSHING IS SPINNING OR WALKING OUT OF THE BODY.

REPLACE THE PUMP BODY BUSHING USING KENT-MOORE TOOL J41778.
