1995 - 1996 Corvette: Service Bulletin: Delayed Engagement (Replace Pump Cover Assembly)

Subject: Delayed Engagement (Replace Pump Cover Assembly)

Bulletin Number: 67-71-48

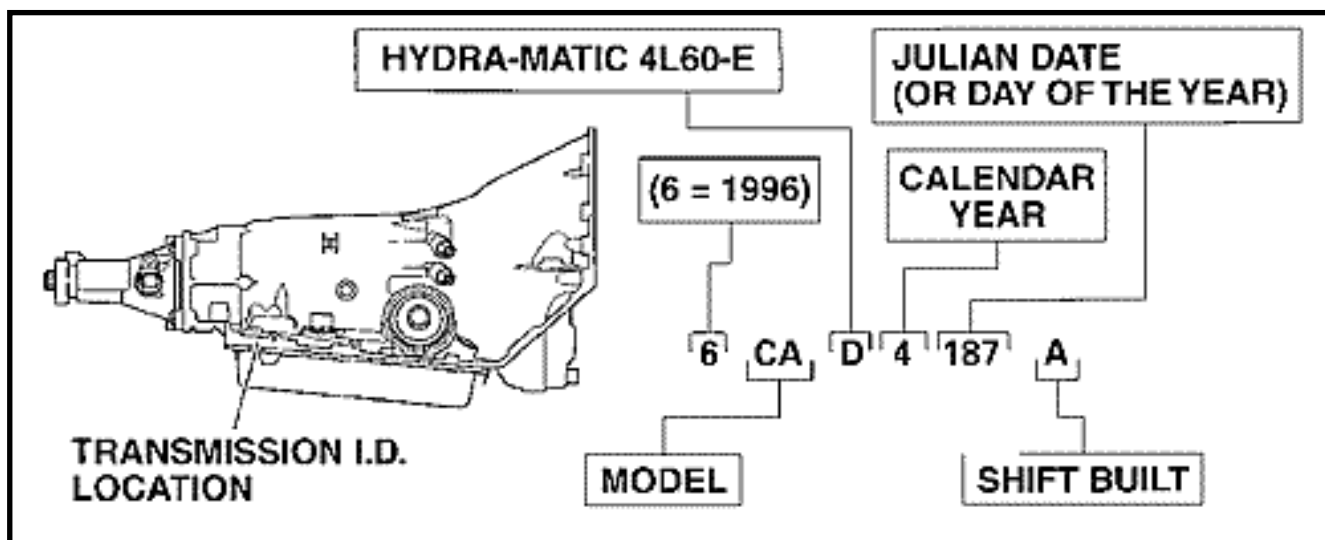
FIGURE 1. - HYDRA-MATIC 4L60-E TRANSMISSION IDENTIFICATION
INFORMATION

(FIGURES 1 AND 2) SOME OWNERS OF THE ABOVE MODELS, WITH A HYDRA-MATIC 4L60-E TRANSMISSION (BUILT BEFORE APRIL 29, 1996/JULIAN DATE 6120), MAY EXPERIENCE SOME DELAYED ENGAGEMENT WHEN VEHICLE IS NOT USED FOR MORE THAN 48 HOURS.

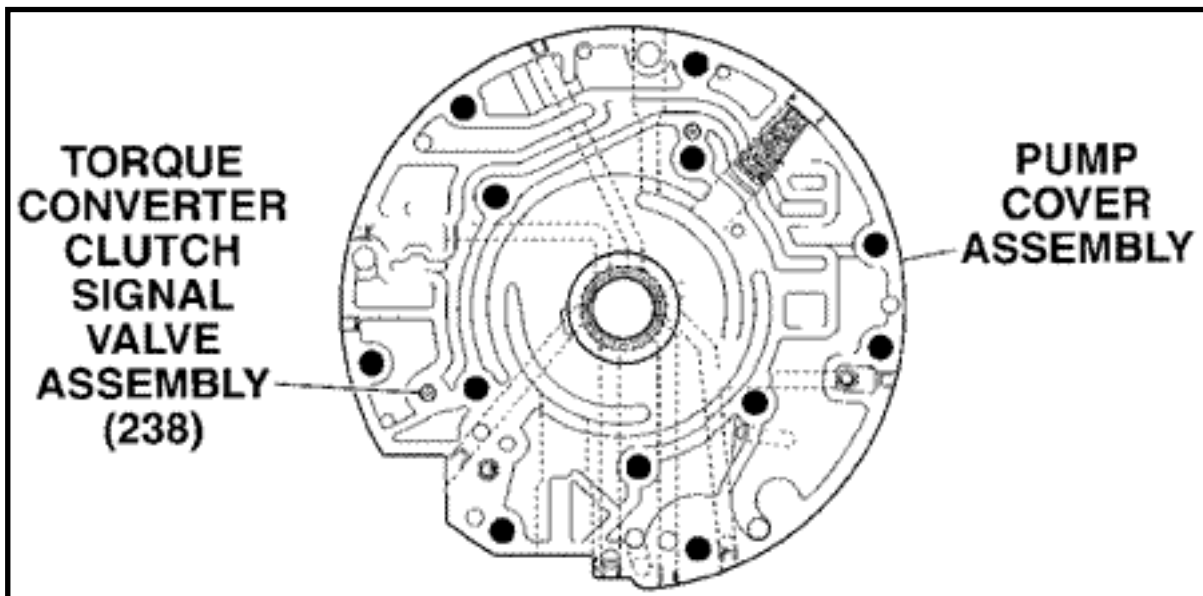
FIGURE 3. - TORQUE CONVERTER CLUTCH SIGNAL VALVE ASSEMBLY
LOCATION

TORQUE CONVERTER FLUID LEVEL LOW DUE TO FLUID DRAIN DOWN.

(FIGURE 3) REPLACE PUMP COVER ASSEMBLY WITH THE NEW TCC SIGNAL VALVE ASSEMBLY.
