1995 - 1996 Corvette: Service Bulletin: Delayed Engagement (Replace Pump Cover Assembly)

Subject: Delayed Engagement (Replace Pump Cover Assembly)

Bulletin Number: 67-71-48

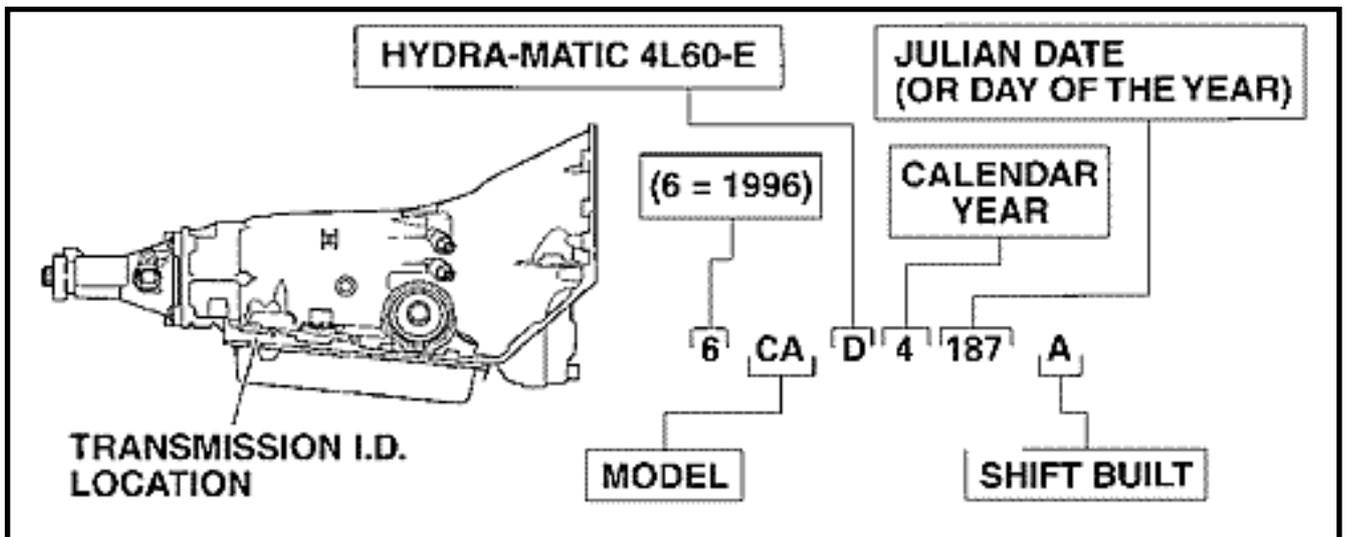
FIGURE 1. - HYDRA-MATIC 4L60-E TRANSMISSION IDENTIFICATION INFORMATION

(FIGURES 1 AND 2) SOME OWNERS OF THE ABOVE MODELS, WITH A HYDRA-MATIC 4L60-E TRANSMISSION (BUILT BEFORE APRIL 29, 1996/JULIAN DATE 6120), MAY EXPERIENCE SOME DELAYED ENGAGEMENT WHEN VEHICLE IS NOT USED FOR MORE THAN 48 HOURS.

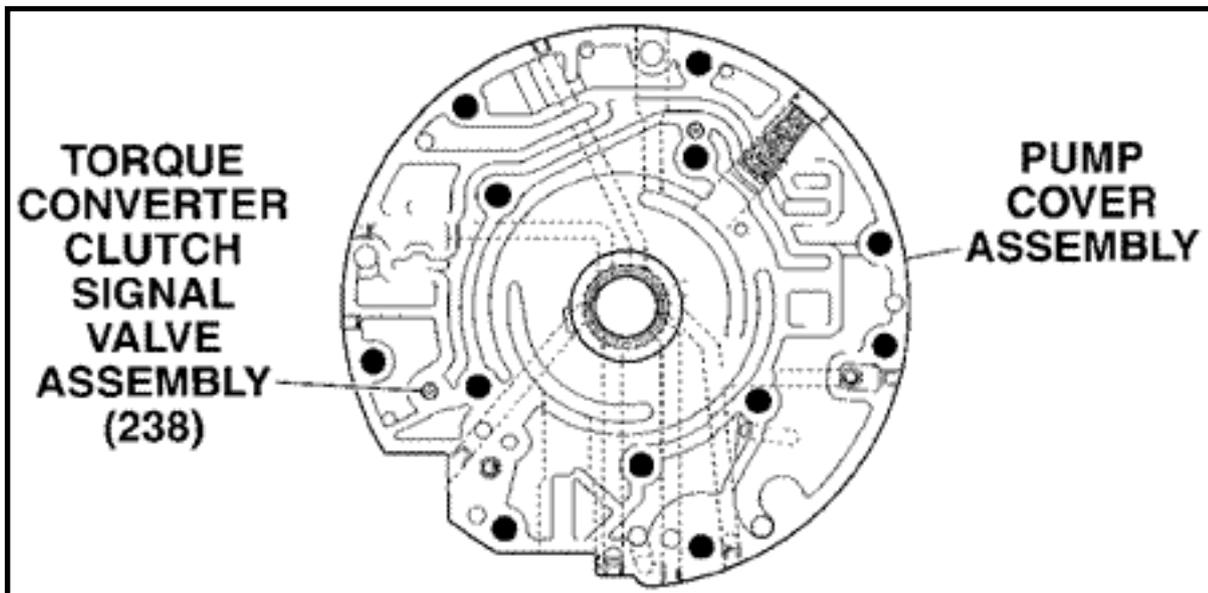
FIGURE 3. - TORQUE CONVERTER CLUTCH SIGNAL VALVE ASSEMBLY LOCATION

TORQUE CONVERTER FLUID LEVEL LOW DUE TO FLUID DRAIN DOWN.

(FIGURE 3) REPLACE PUMP COVER ASSEMBLY WITH THE NEW TCC SIGNAL VALVE ASSEMBLY.
