1995 - 1996 Corvette: Service Bulletin: Delayed Engagement (Replace Pump Cover Assembly)

Bulletin Number: 67-71-48

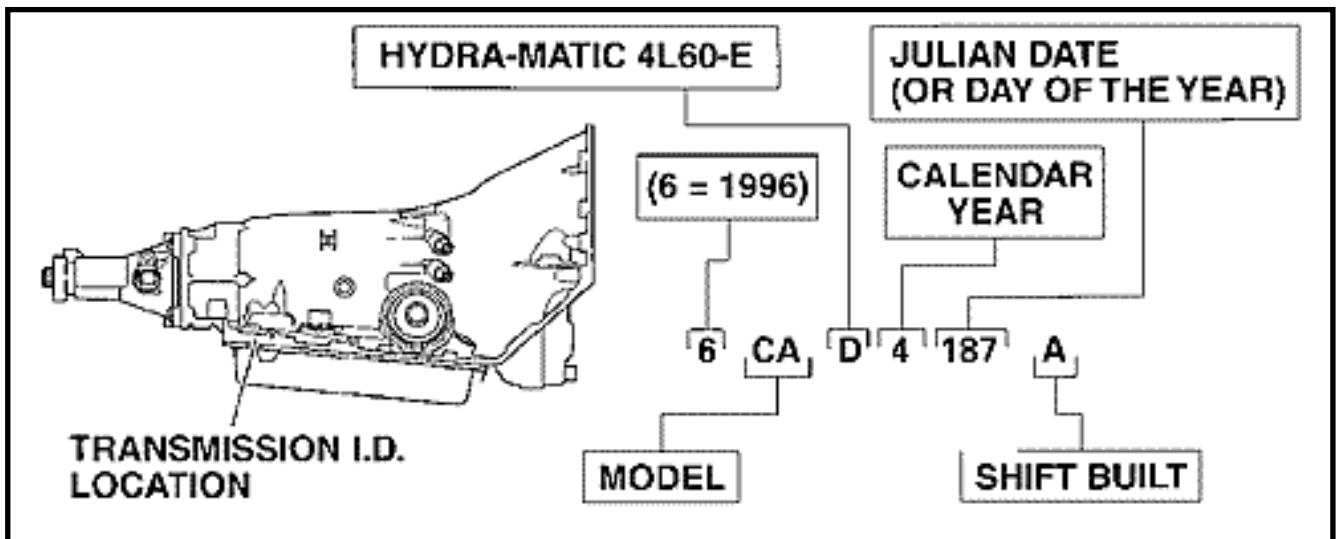
FIGURE 1. - HYDRA-MATIC 4L60-E TRANSMISSION IDENTIFICATION INFORMATION

(FIGURES 1 AND 2) SOME OWNERS OF THE ABOVE MODELS, WITH A HYDRA-MATIC 4L60-E TRANSMISSION (BUILT BEFORE APRIL 29, 1996/JULIAN DATE 6120), MAY EXPERIENCE SOME DELAYED ENGAGEMENT WHEN VEHICLE IS NOT USED FOR MORE THAN 48 HOURS.

TORQUE CONVERTER FLUID LEVEL LOW DUE TO FLUID DRAIN DOWN.
