# 1995 - 1996 Corvette: Service Bulletin: Delayed Engagement (Replace Pump Cover Assembly)

**Subject:** Delayed Engagement (Replace Pump Cover Assembly)

**Bulletin Number:** 67-71-48

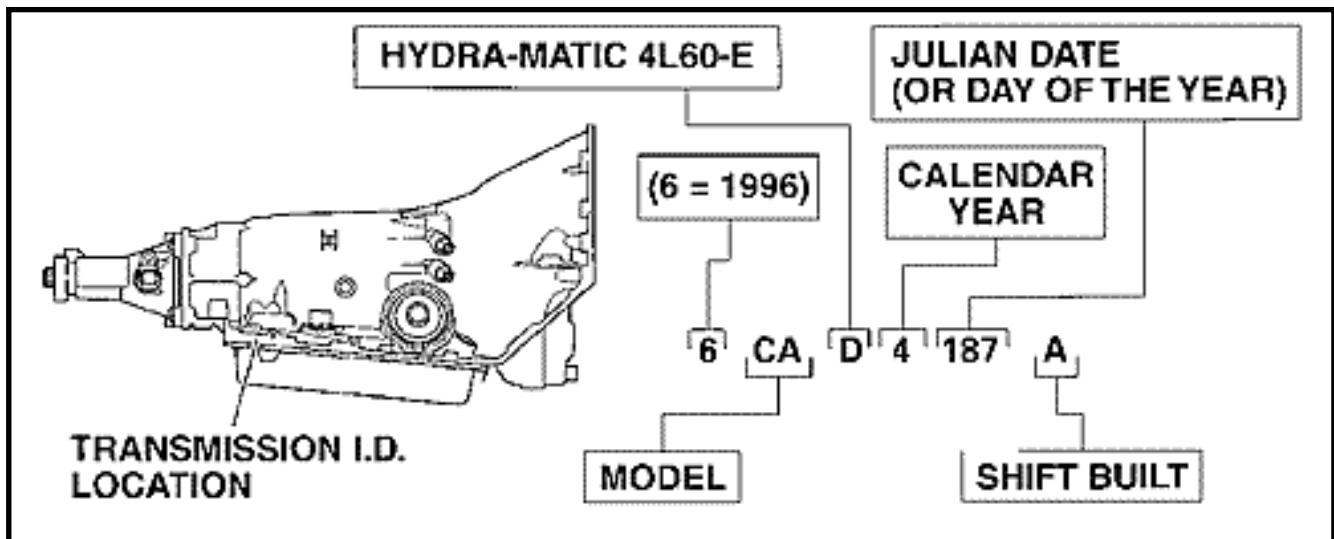
FIGURE 1. - HYDRA-MATIC 4L60-E TRANSMISSION IDENTIFICATION INFORMATION

(FIGURES 1 AND 2) SOME OWNERS OF THE ABOVE MODELS, WITH A HYDRA-MATIC 4L60-E TRANSMISSION (BUILT BEFORE APRIL 29, 1996/JULIAN DATE 6120), MAY EXPERIENCE SOME DELAYED ENGAGEMENT WHEN VEHICLE IS NOT USED FOR MORE THAN 48 HOURS.

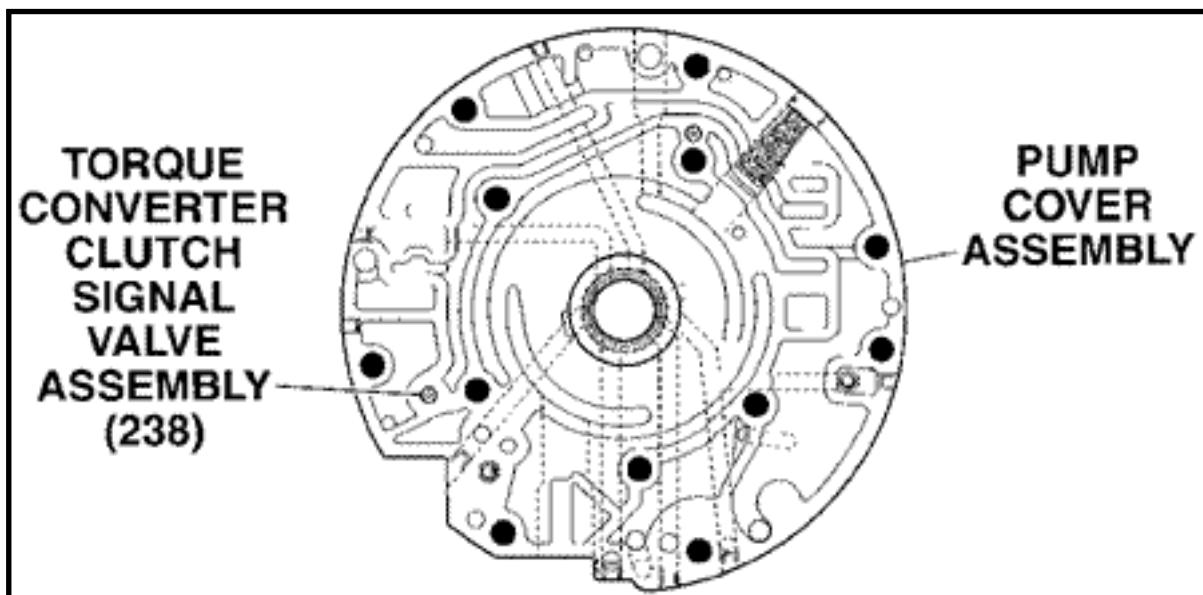
FIGURE 3. - TORQUE CONVERTER CLUTCH SIGNAL VALVE ASSEMBLY LOCATION

TORQUE CONVERTER FLUID LEVEL LOW DUE TO FLUID DRAIN DOWN.

(FIGURE 3) REPLACE PUMP COVER ASSEMBLY WITH THE NEW TCC SIGNAL VALVE ASSEMBLY.
