1995 - 1996 Corvette: Service Bulletin: Delayed Engagement (Replace Pump Cover Assembly)

Subject: Delayed Engagement (Replace Pump Cover Assembly)

Bulletin Number: 67-71-48

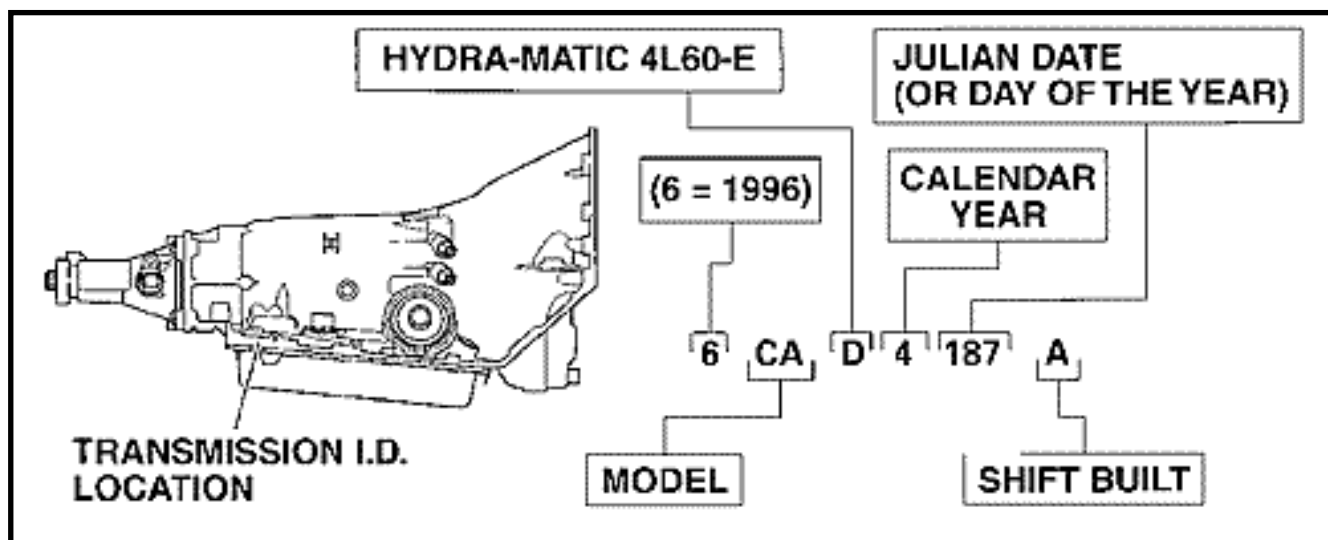
FIGURE 1. - HYDRA-MATIC 4L60-E TRANSMISSION IDENTIFICATION
INFORMATION

(FIGURES 1 AND 2) SOME OWNERS OF THE ABOVE MODELS, WITH A HYDRA-MATIC 4L60-E TRANSMISSION (BUILT BEFORE APRIL 29, 1996/JULIAN DATE 6120), MAY EXPERIENCE SOME DELAYED ENGAGEMENT WHEN VEHICLE IS NOT USED FOR MORE THAN 48 HOURS.

TORQUE CONVERTER FLUID LEVEL LOW DUE TO FLUID DRAIN DOWN.
