1994 Corvette: Service Bulletin: Garage Shift Delay Engagement (New Garage Shift Package)

Subject: Garage Shift Delay Engagement (New Garage Shift Package)

Bulletin Number: 47-71-20A

REVISION: 09/12/94

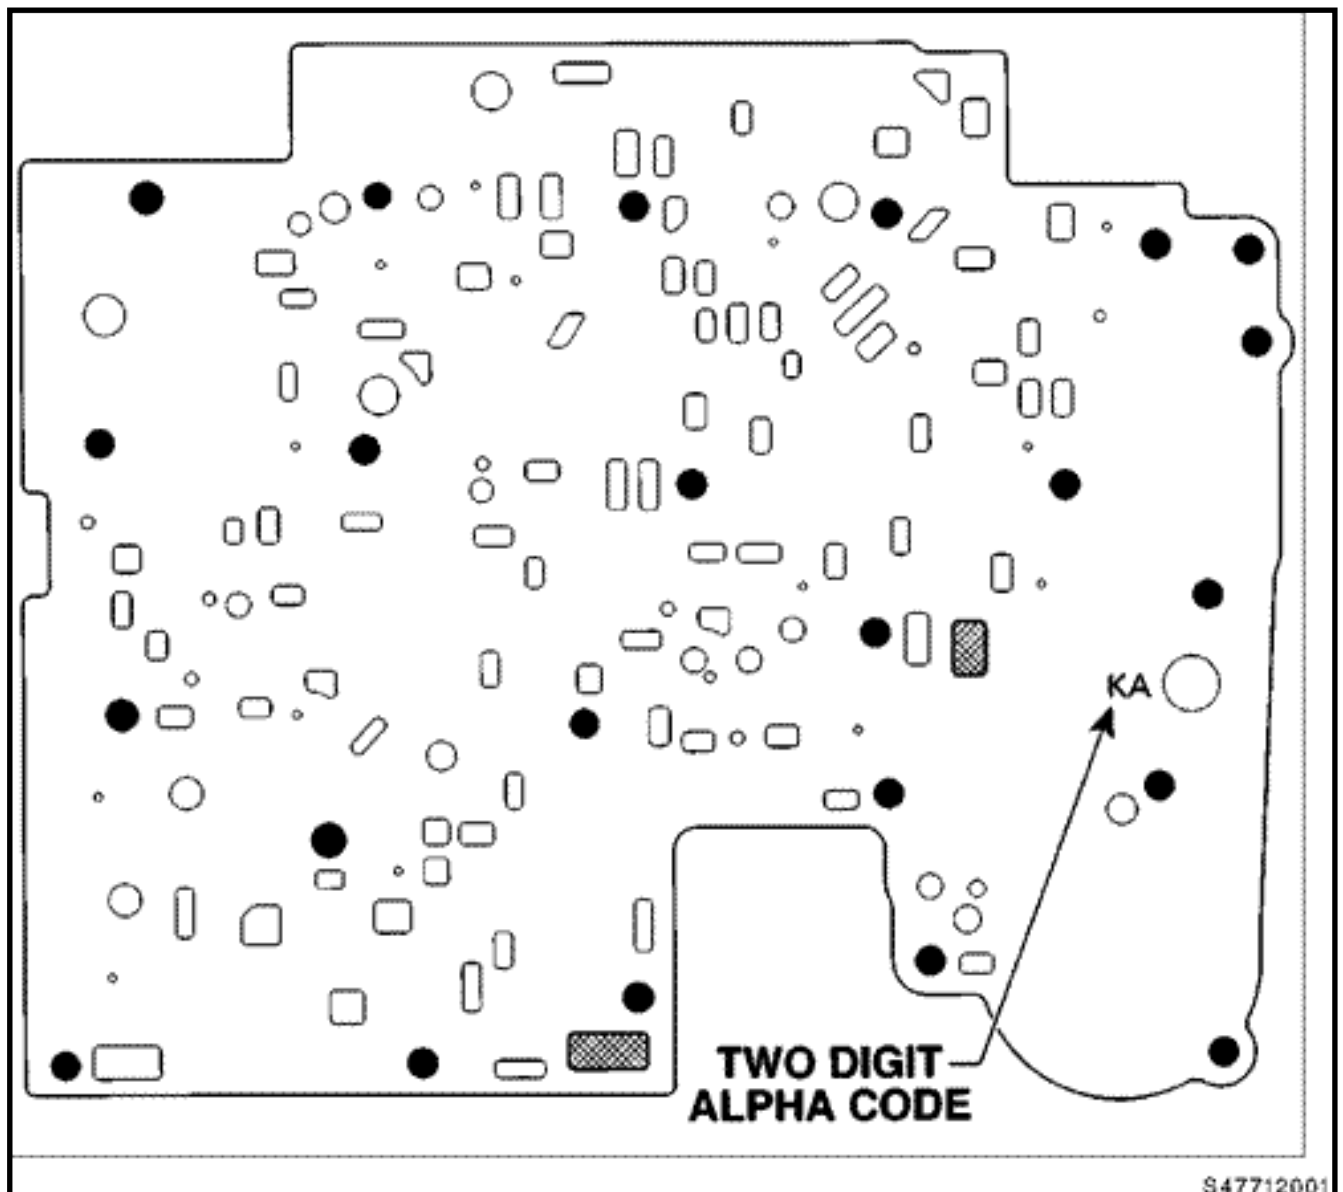
WHEN PERFORMING ANY OTHER REPAIRS ON A 1994 VEHICLE EQUIPPED WITH A HYDRA-MATIC 4L60-E TRANSMISSION BUILT BEFORE MARCH 7, 1994 (JULIAN DATE 066), THE SPACER PLATE IDENTIFICATION MUST BE

CHECKED TO SEE IF THE TRANSMISSION HAS HAD A NEW GARAGE SHIFT PACKAGE INSTALLED TO BE SURE THE TRANSMISSION IS BEING SERVICED WITH THE PROPER PARTS. SEE THE FOLLOWING CHART FOR SPACER PLATE IDENTIFICATION.

THE NEW SPACER PLATES MUST BE USED WITH THE ENHANCED GARAGE SHIFT PACKAGE AND THE ORIGINAL SPACER PLATES MUST BE USED WITH THE ORIGINAL GARAGE SHIFT PACKAGE. THE SPACER PLATES AND GARAGE SHIFT PACKAGES ARE CALIBRATION SENSITIVE; MIXING SPACER PLATES AND GARAGE SHIFT PACKAGES MAY CAUSE PREMATURE FAILURE. WHEN A GARAGE SHIFT PACKAGE IS CHANGED, THE SPACER PLATE MUST ALSO BE CHANGED.

NOTE: THE TRANSMISSION SPACER PLATE MUST ALSO BE REPLACED WITH AN ENHANCED GARAGE SHIFT PACKAGE SPACER PLATE, CONSULT YOUR PARTS CATALOG FOR THE PROPER SPACER PLATE PART NUMBER.
