1993 Corvette: Service Bulletin: Transmission "Whine" Noise, Loss of Motion in all Gears, or Missing Clutch Disc Rivets

Model and Year: 1993 CHEVROLET CORVETTE WITH SIX-SPEED MANUAL TRANSMISSION AND 5.7L (LT1) ENGINE (VIN CODE P)

Source: Chevrolet Service Bulletin

Bulletin Number: 37-71-40

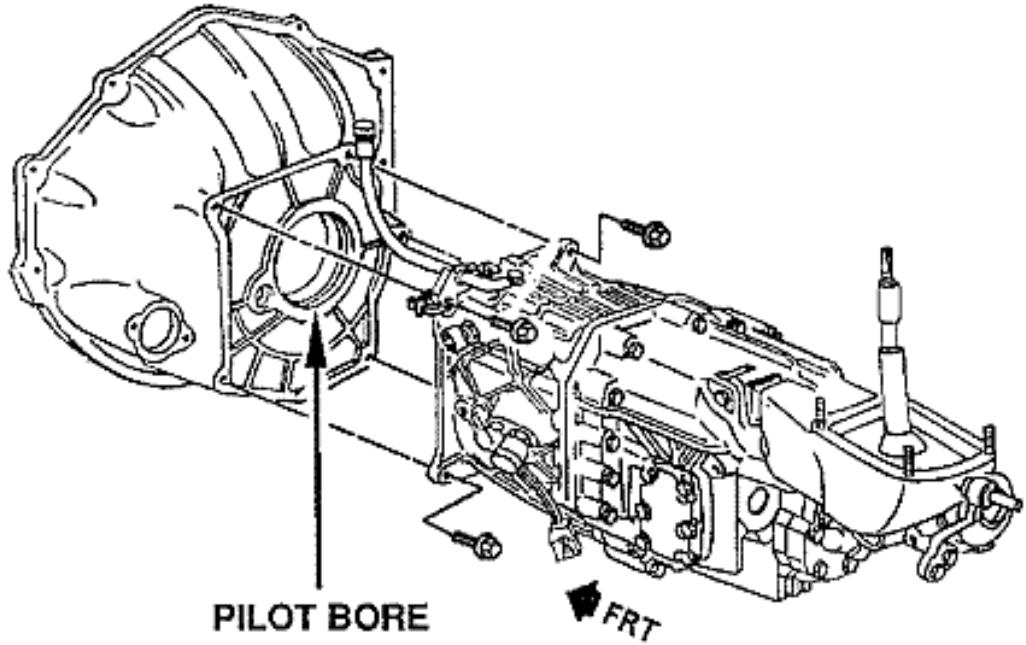
IF THE VEHICLE IS BUILT BETWEEN THE VIN BREAKPOINTS OF 110966 THROUGH 113902 AND THE CLUTCH HOUSING HAS A CASTING DATE OF EITHER "JANUARY, FEBRUARY, OR MARCH 1993", THE CLUTCH HOUSING MAY BE THE CAUSE OF THE CONCERNS. THE CLUTCH HOUSING MAY HAVE A MISLOCATED TRANSMISSION TO CLUTCH HOUSING PILOT BORE. SEE FIGURE.

THIS MISLOCATED PILOT BORE MAY SIDELOAD THE TRANSMISSION'S INPUT SHAFT, THEREBY PRODUCING THE "WHINE" NOISE.

THE ABOVE CONDITION MAY ALSO SHEAR THE RIVETS OF THE CLUTCH DRIVEN DISC CAUSING THE CLUTCH DRIVEN DISC FRICTION FACING TO BE DISENGAGED FROM THE SPLINED HUB.

AFTER ABOVE VERIFICATION, REPLACE CLUTCH HOUSING, P/N 10126448. PARTS ARE CURRENTLY AVAILABLE FROM GMSPO.

NOTE: IF THE VEHICLE REQUIRES A REPLACEMENT OF THE CLUTCH DRIVEN DISC DUE TO SHEARED RIVETS, THE CLUTCH HOUSING ** MUST ** ALSO BE REPLACED.

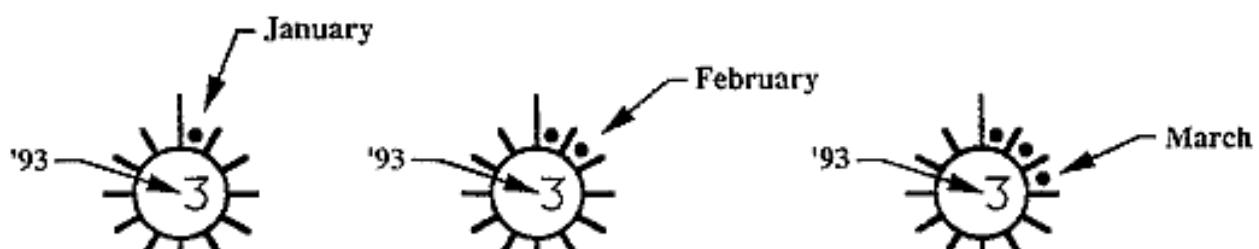
Casting Date
(located on right side of clutch housing, above part number)

VERIFY THE SUSPECT CLUTCH HOUSING HAS A CASTING DATE OF EITHER "JANUARY, FEBRUARY, OR MARCH 1993". NOTE: SUSPECT HOUSINGS WILL HAVE NO MORE THAN THREE (3) "DOTS" IN THE CAST DATE. SEE FIGURE.
