1992 Corvette: Service Bulletin: Harsh 1-2 Upshift

Subject: HARSH 1-2 UPSHIFT INSTALL SERVICE PACKAGE
Model and Year: 1992 CAPRICE, CAMARO AND CORVETTE 1992 C/K, G, L/M, S/T TRUCKS
Source: Chevrolet Service Bulletin
Bulletin Number: 92-318-7A - (09/15/1992)

TRANSMISSION APPLICATIONS: SUBJECT: 1992 HYDRA-MATIC 4L60 Harsh 1-2 Upshift ;Install Service Package

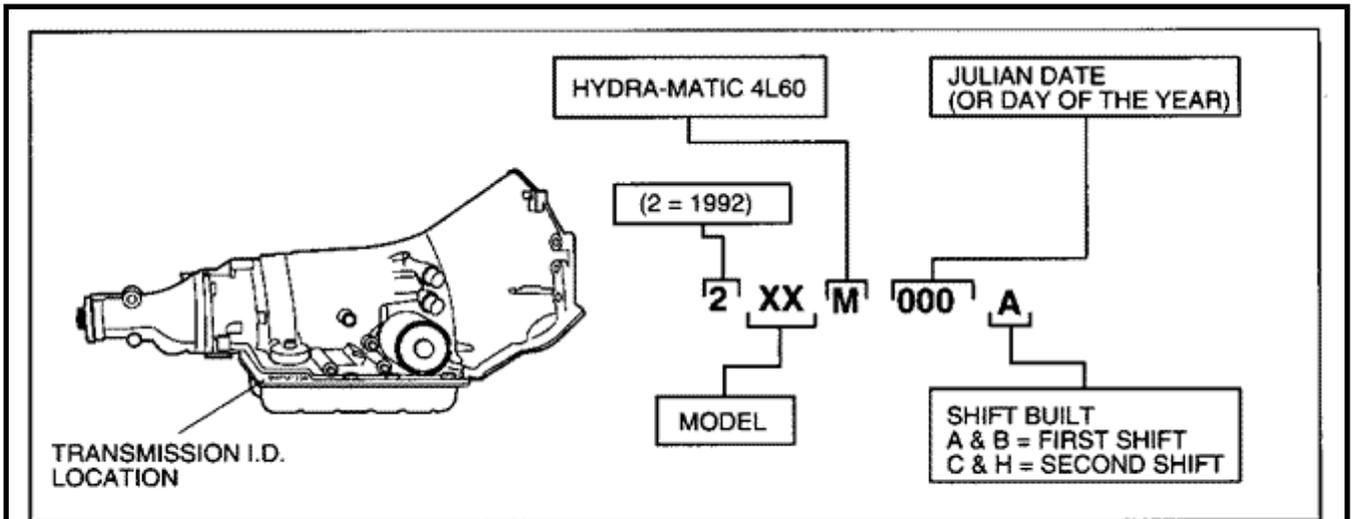
Figure 1 - HYDRA-MATIC 4L60 Transmission Identification Information

CONDITION (Figure 1):

Some vehicles equipped with a 1992 HYDRA-MATIC 4L60 transmission built between Julian Date 061 (March 1, 1992) and Julian Date 171 (June 19, 1992) may experience a harsh 1-2 upshift. NOTE: Once the transmission is brought to operating temperature, the condition may not be able to be reproduced until a "cold soak" (overnight) is performed.

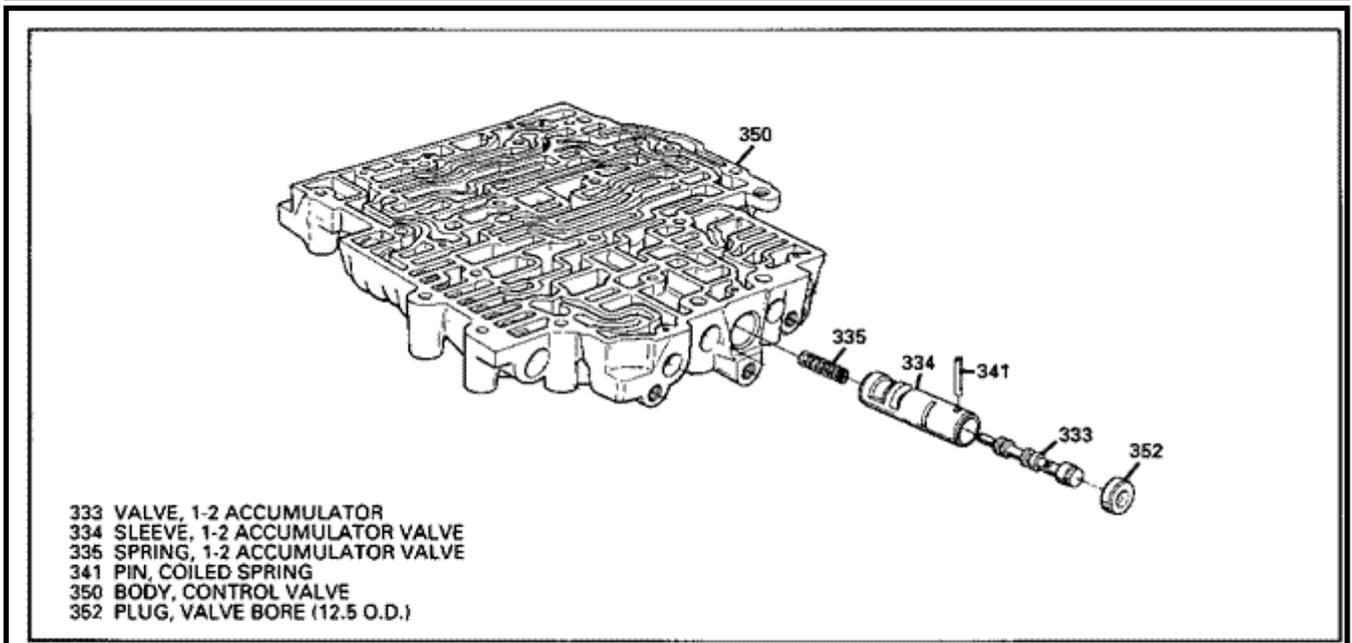
Figure 2

The above condition may be caused due to a tapered 1-2 accumulator sleeve. The tapered bore may cause the 1-2 accumulator valve to stick in the bottom of the bore.

CORRECTION (Figure 2):

To improve the 1-2 shift, install the service package listed in this bulletin. A 1-2 accumulator valve and 1-2 accumulator valve sleeve (which, normally, is not serviceable) is included in the package.
