# 1992 Corvette: Service Bulletin: Harsh 1-2 Upshift

**Subject:** HARSH 1-2 UPSHIFT INSTALL SERVICE PACKAGE

**Source:** Chevrolet Service Bulletin

**Bulletin Number:** 92-318-7A - (09/15/1992)

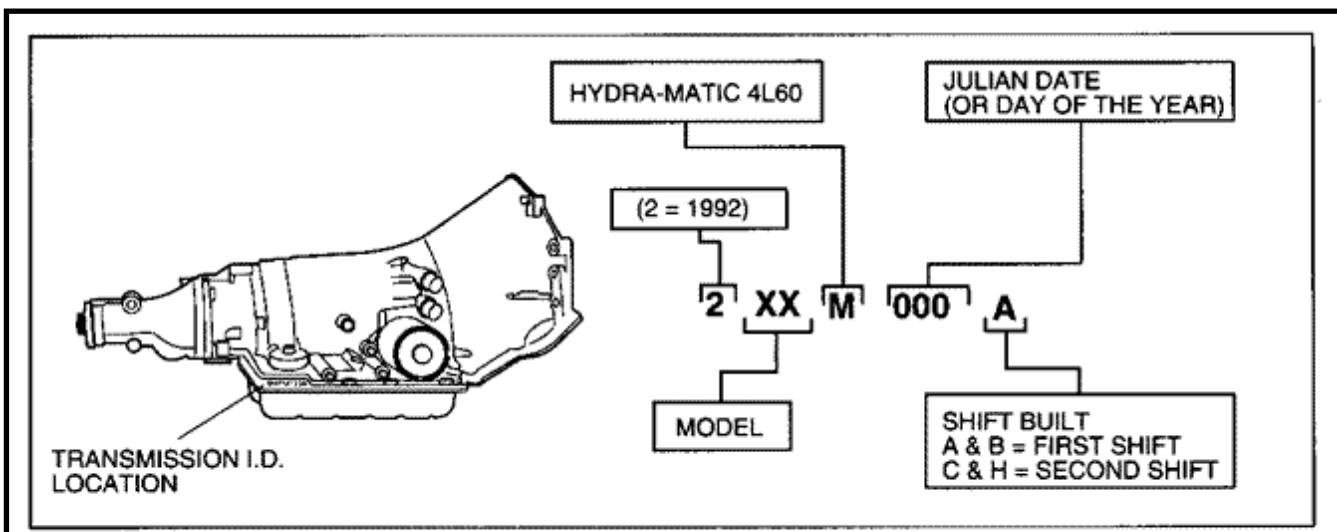
Figure 1 - HYDRA-MATIC 4L60 Transmission Identification Information

## **CONDITION (Figure 1):**

Some vehicles equipped with a 1992 HYDRA-MATIC 4L60 transmission built between Julian Date 061 (March 1, 1992) and Julian Date 171 (June 19, 1992) may experience a harsh 1-2 upshift. NOTE: Once the transmission is brought to operating temperature, the condition may not be able to be reproduced until a "cold soak" (overnight) is performed.

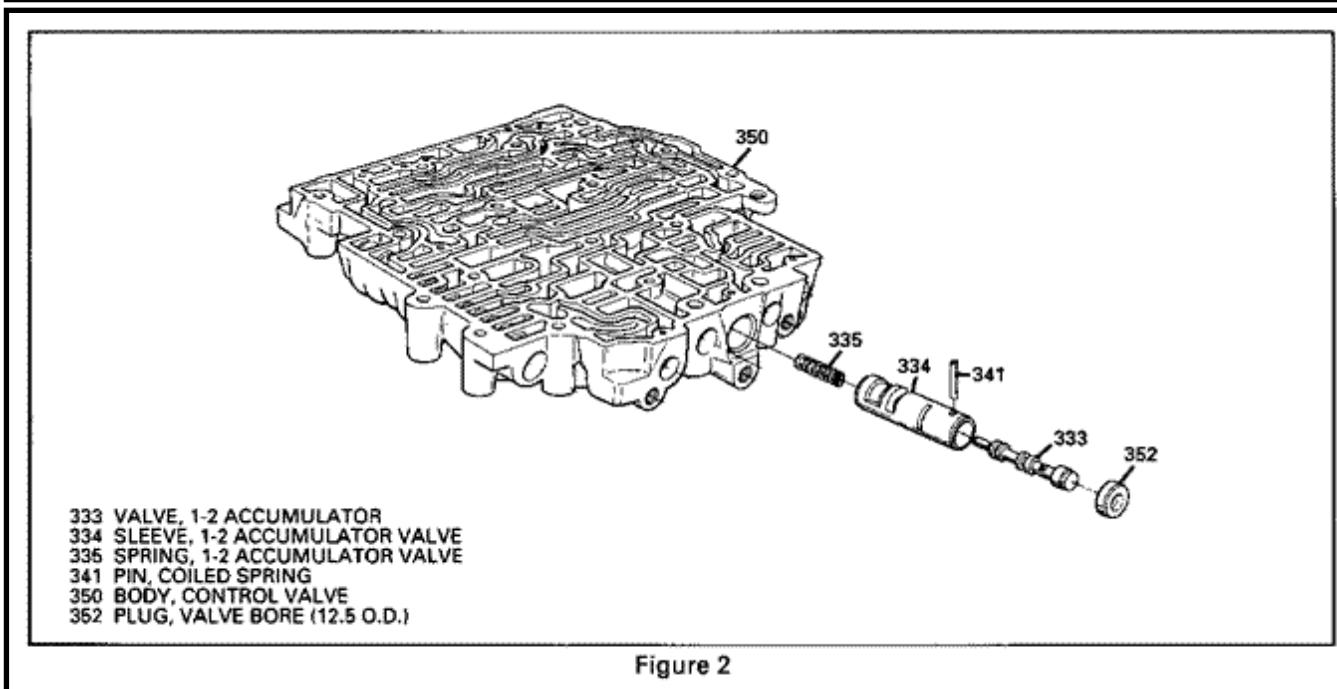
Figure 2

The above condition may be caused due to a tapered 1-2 accumulator sleeve. The tapered bore may cause the 1-2 accumulator valve to stick in the bottom of the bore.

## **CORRECTION (Figure 2):**

To improve the 1-2 shift, install the service package listed in this bulletin. A 1-2 accumulator valve and 1-2 accumulator valve sleeve (which, normally, is not serviceable) is included in the package.
