1992 Corvette: Service Bulletin: Harsh 1-2 Upshift

Subject: HARSH 1-2 UPSHIFT INSTALL SERVICE PACKAGE

Source: Chevrolet Service Bulletin

Bulletin Number: 92-318-7A - (09/15/1992)

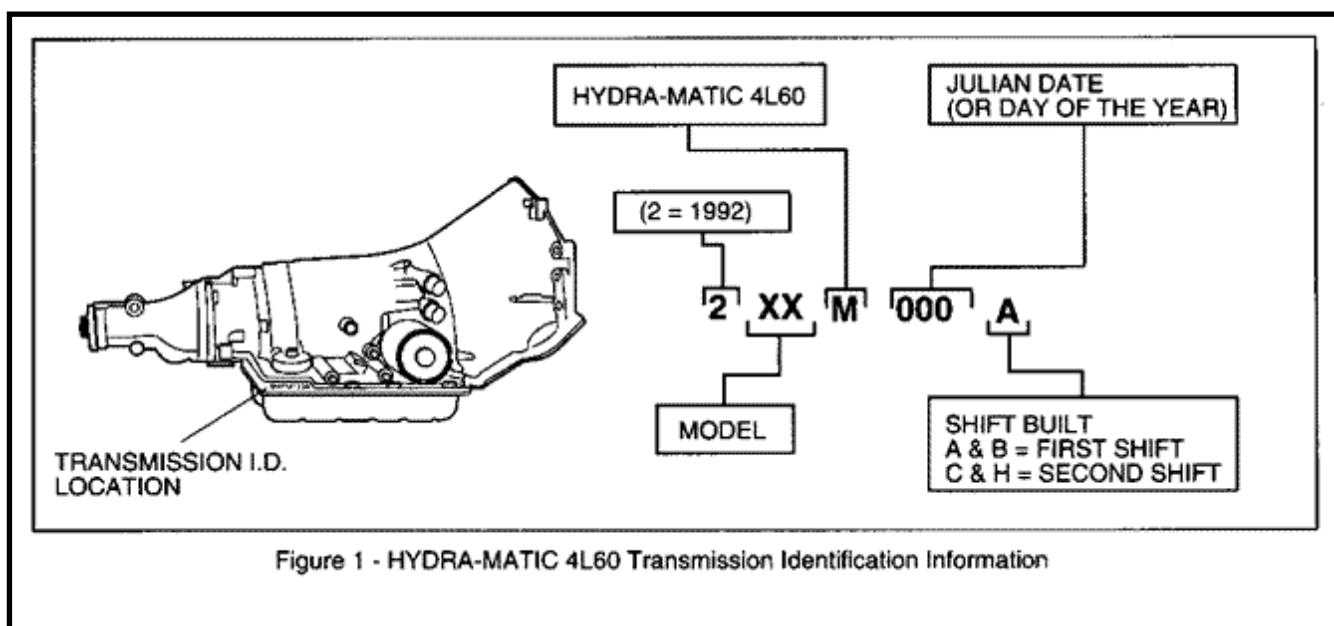
CONDITION (Figure 1):

Some vehicles equipped with a 1992 HYDRA-MATIC 4L60 transmission built between Julian Date 061 (March 1, 1992) and Julian Date 171 (June 19, 1992) may experience a harsh 1-2 upshift. NOTE: Once the transmission is brought to operating temperature, the condition may not be able to be reproduced until a "cold soak" (overnight) is performed.

The above condition may be caused due to a tapered 1-2 accumulator sleeve. The tapered bore may cause the 1-2 accumulator valve to stick in the bottom of the bore.
