# 2005 - 2013 Corvette: GM TechLink Article: DTC P0300 Setting after Engine Repairs

**Source:** GM TechLink

**Date:** January 14, 2014

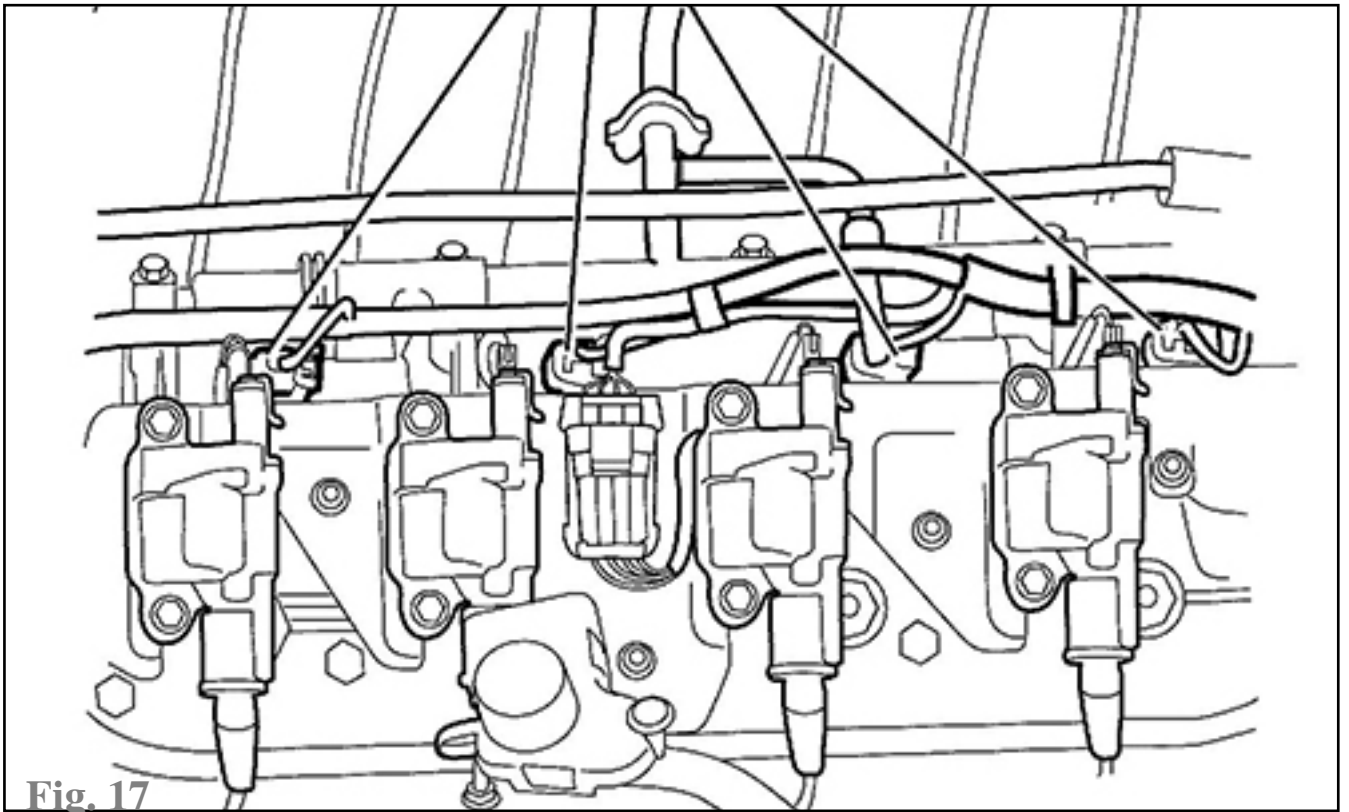
**Fig. 17**

It is possible to have the fuel injector electrical connectors crossed for cylinders 5-7 and 6-8, which may cause an engine misfire. The engine misfire may not be detected and may happen during deceleration.

If crossed injector connectors may be a possible cause, follow the appropriate Service Information to validate the injector connector routing. (Fig. 17) If necessary, correct the injector connector routing and evaluate for proper operation.
