# 1990 - 1991 Corvette: Service Bulletin: 3-2 Coast Down Clunk

**Subject:** 3-2 COAST DOWN CLUNK (INSTALL SERVO SPRING)

**Model and Year:** 1990-91 CORVETTE WITH 4L60 AUTOMATIC TRANSMISSION

**Bulletin Number:** 91-372-7A - (06/27/1991)

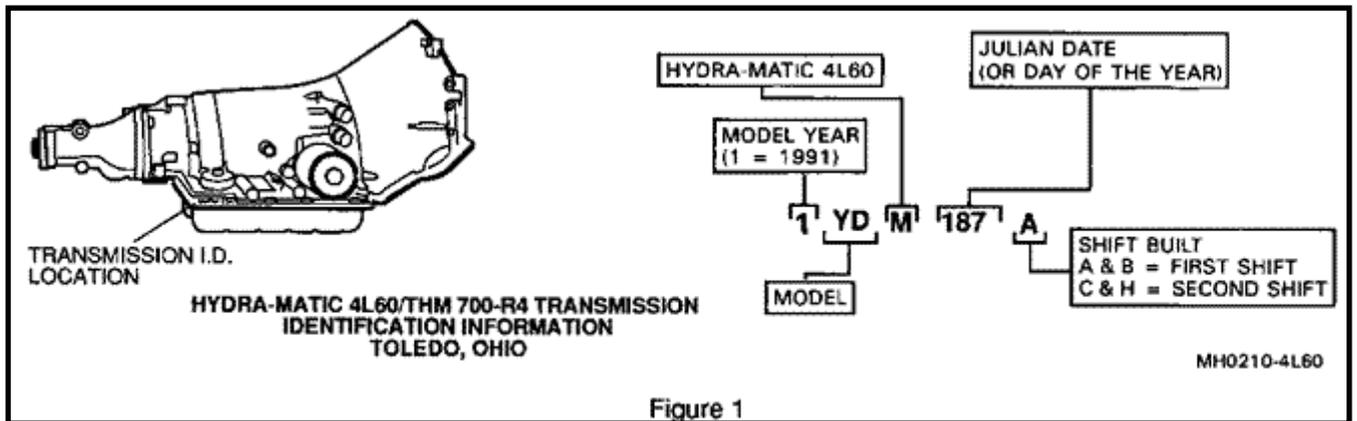
Date of Production Change: (Figure 1)

Beginning May 20, 1991 (Julian Date 140), all 1 YHM models of the HYDRAMATIC 4L60 were built using the new servo cushion assist spring and spacer plate.

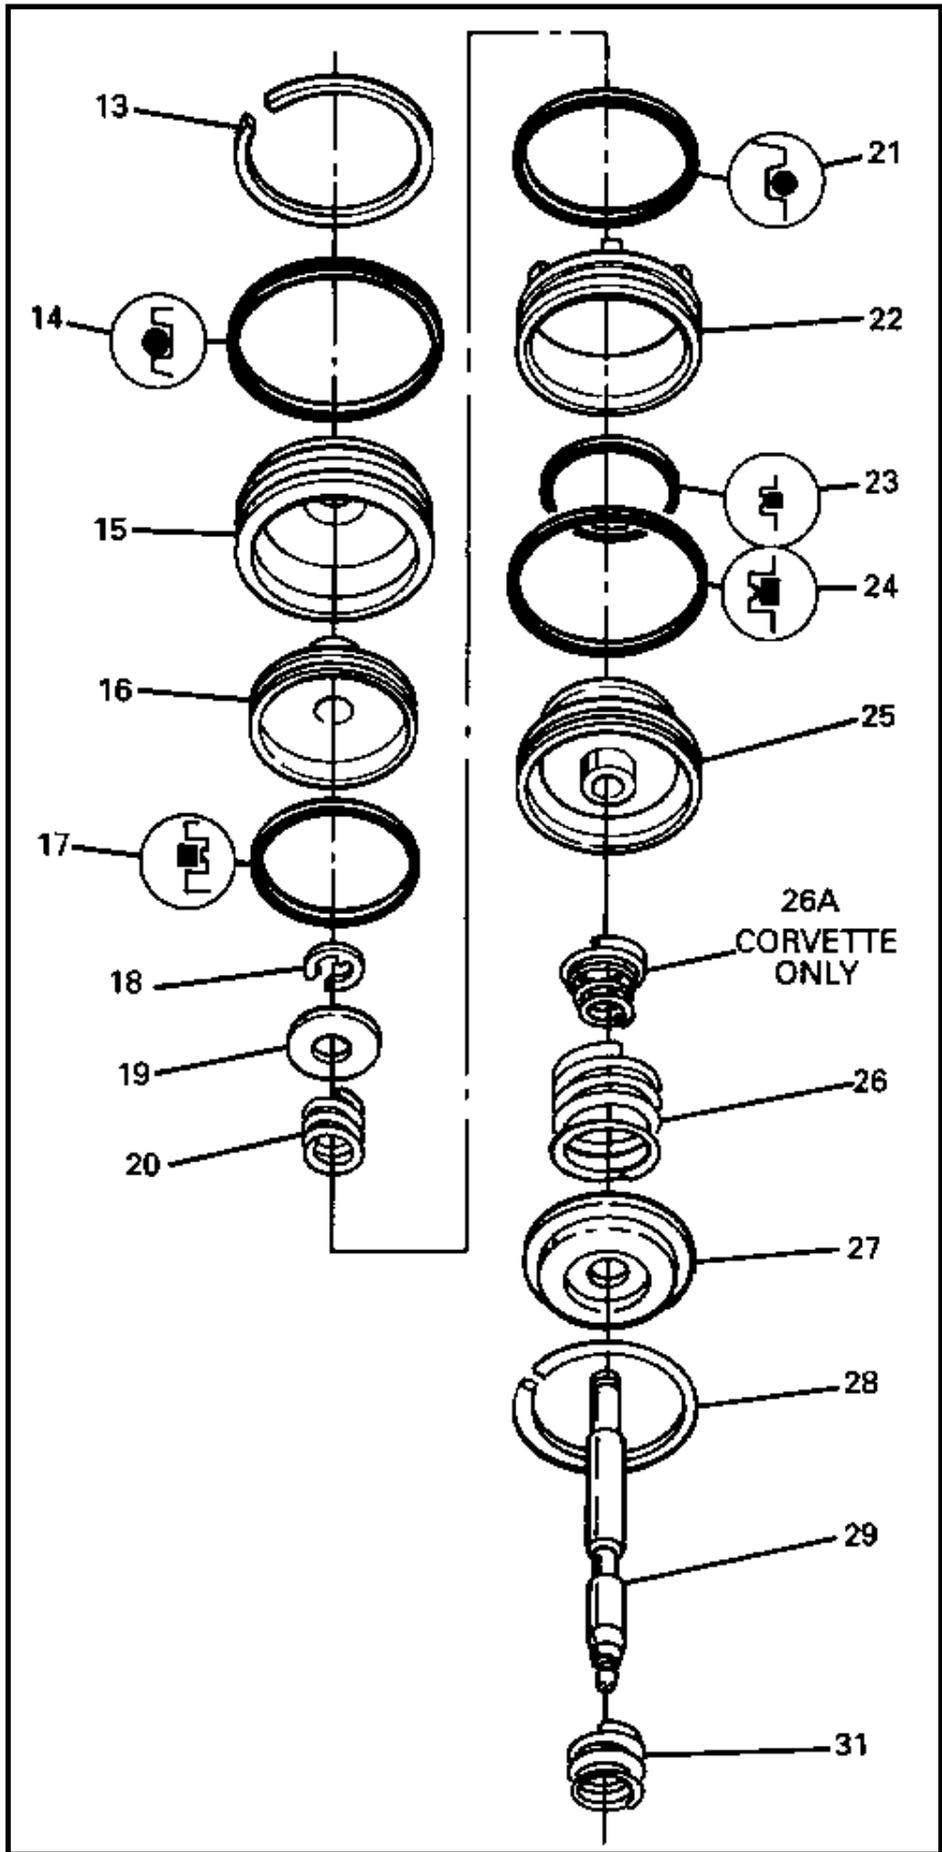
Refer to Figure 2

Some 1990 and 1991 Chevrolet Corvettes may experience a 3-2 coastdown clunk. The clunk can be felt around 10-14 miles per hour while lightly braking to a stop. It is most noticeable in D3 range, but can occur in D4 (overdrive) range.

A new 2-4 servo cushion assist spring and spacer plate have been released to alleviate this condition. The new spring is a conical spring which nests inside the current 2-4 servo cushion spring. The new spacer plate has a modified third clutch exhaust orifice.

Install the new servo cushion assist spring inside the current servo cushion spring as shown in figure 2. Figure 2 shows the ONLY way the spring should be installed. Do not install the spring upside down. The new spring should not be used by itself.

Refer to the Automatic Transmission Unit Repair Section of the appropriate service manual for spacer plate removal and installation information. The 2-4 servo cushion assist spring is not shown in a service manual. Follow instructions for installing a 2-4 servo cushion spring, and add the servo cushion assist spring as shown in figure 2 of this bulletin.
