# 1990 - 1991 Corvette: Service Bulletin: 3-2 Coast Down Clunk

**Subject:** 3-2 COAST DOWN CLUNK (INSTALL SERVO SPRING)

**Model and Year:** 1990-91 CORVETTE WITH 4L60 AUTOMATIC TRANSMISSION

**Bulletin Number:** 91-372-7A - (06/27/1991)

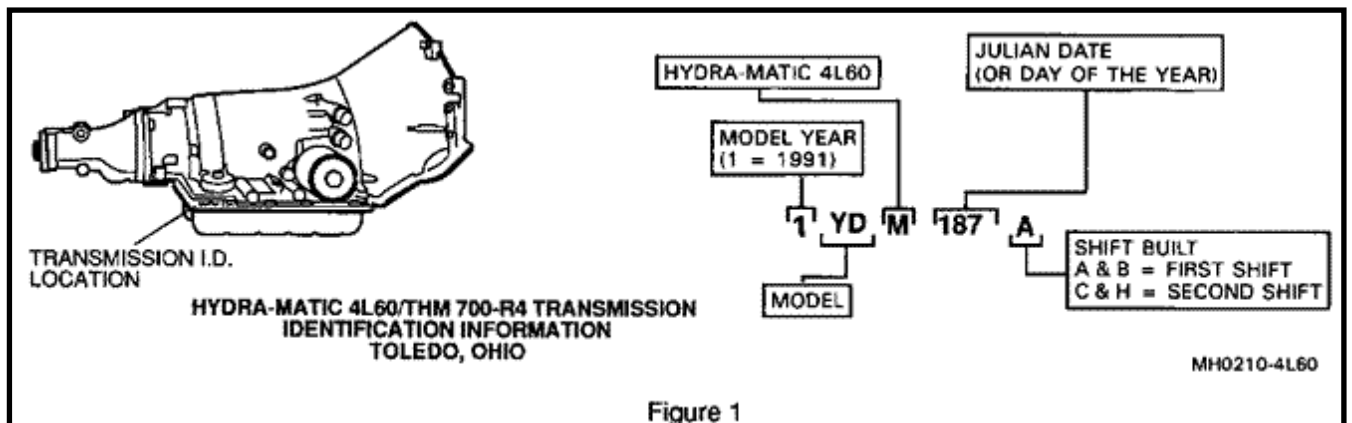
Date of Production Change: (Figure 1)

Beginning May 20, 1991 (Julian Date 140), all 1 YHM models of the HYDRAMATIC 4L60 were built using the new servo cushion assist spring and spacer plate.

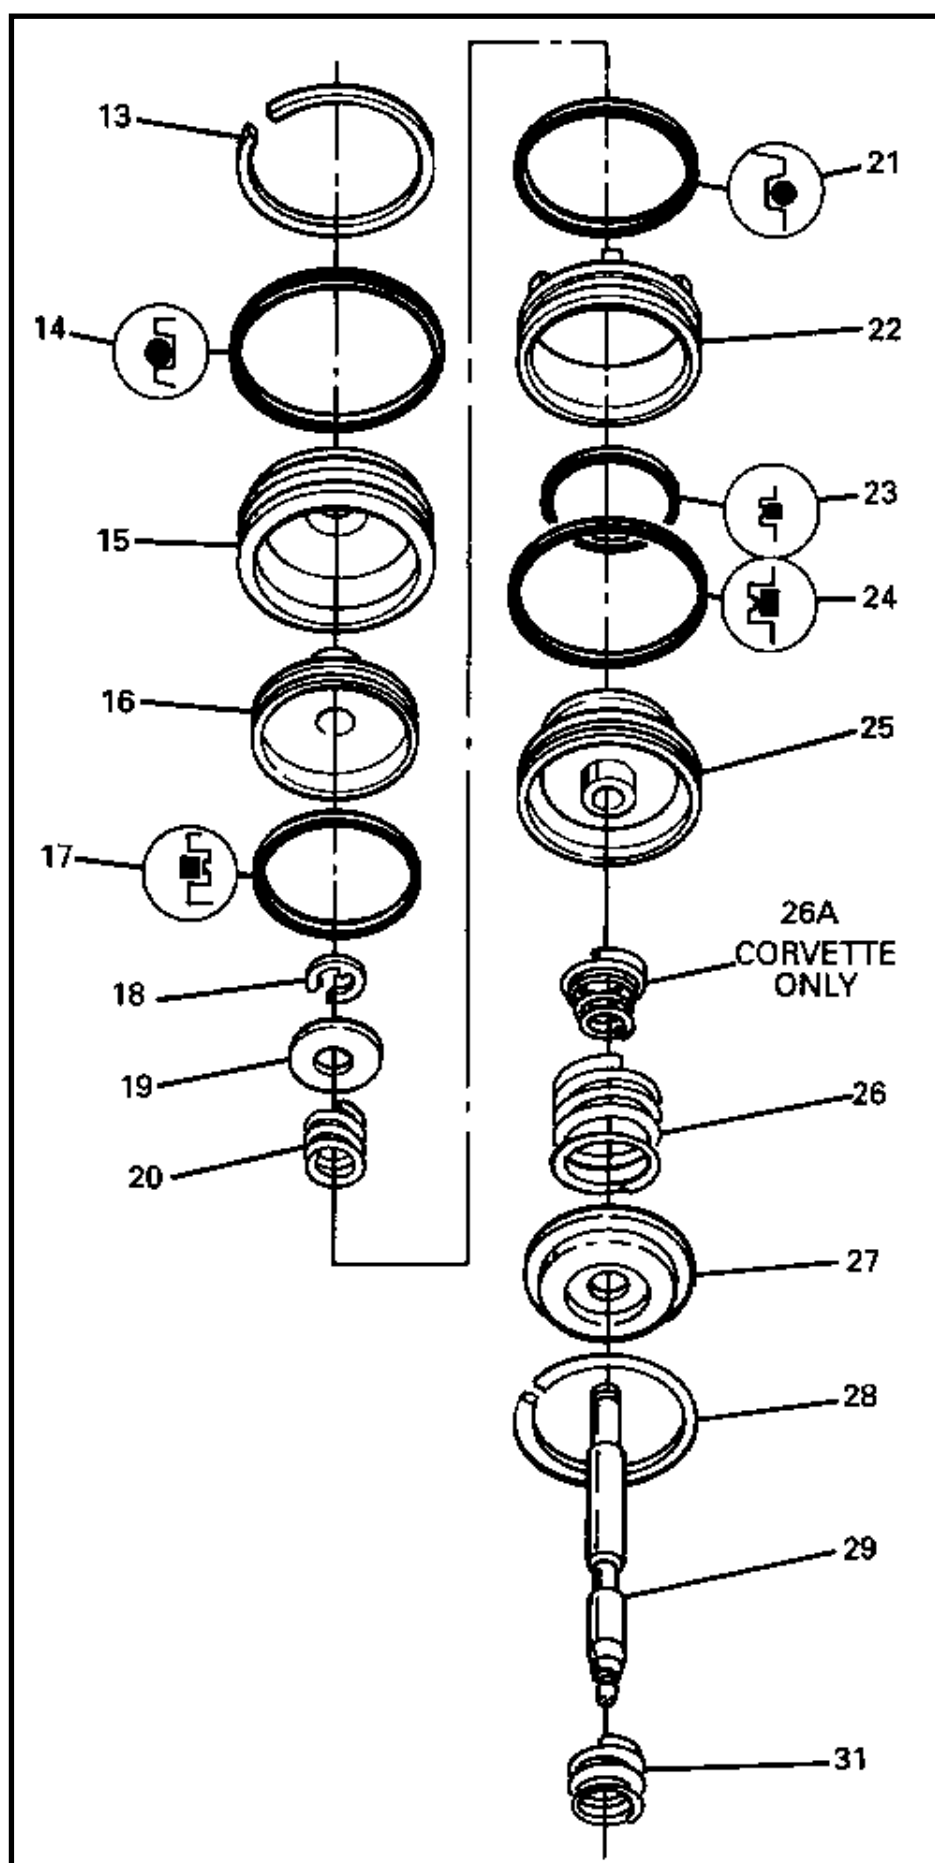
Refer to Figure 2

A new 2-4 servo cushion assist spring and spacer plate have been released to alleviate this condition. The new spring is a conical spring which nests inside the current 2-4 servo cushion spring. The new spacer plate has a modified third clutch exhaust orifice.

Install the new servo cushion assist spring inside the current servo cushion spring as shown in figure 2. Figure 2 shows the ONLY way the spring should be installed. Do not install the spring upside down. The new spring should not be used by itself.

Refer to the Automatic Transmission Unit Repair Section of the appropriate service manual for spacer plate removal and installation information. The 2-4 servo cushion assist spring is not shown in a service manual. Follow instructions for installing a 2-4 servo cushion spring, and add the servo cushion assist spring as shown in figure 2 of this bulletin.
