# 1990 - 1991 Corvette: Service Bulletin: 3-2 Coast Down Clunk

**Subject:** 3-2 COAST DOWN CLUNK (INSTALL SERVO SPRING)

**Model and Year:** 1990-91 CORVETTE WITH 4L60 AUTOMATIC TRANSMISSION

**Bulletin Number:** 91-372-7A - (06/27/1991)

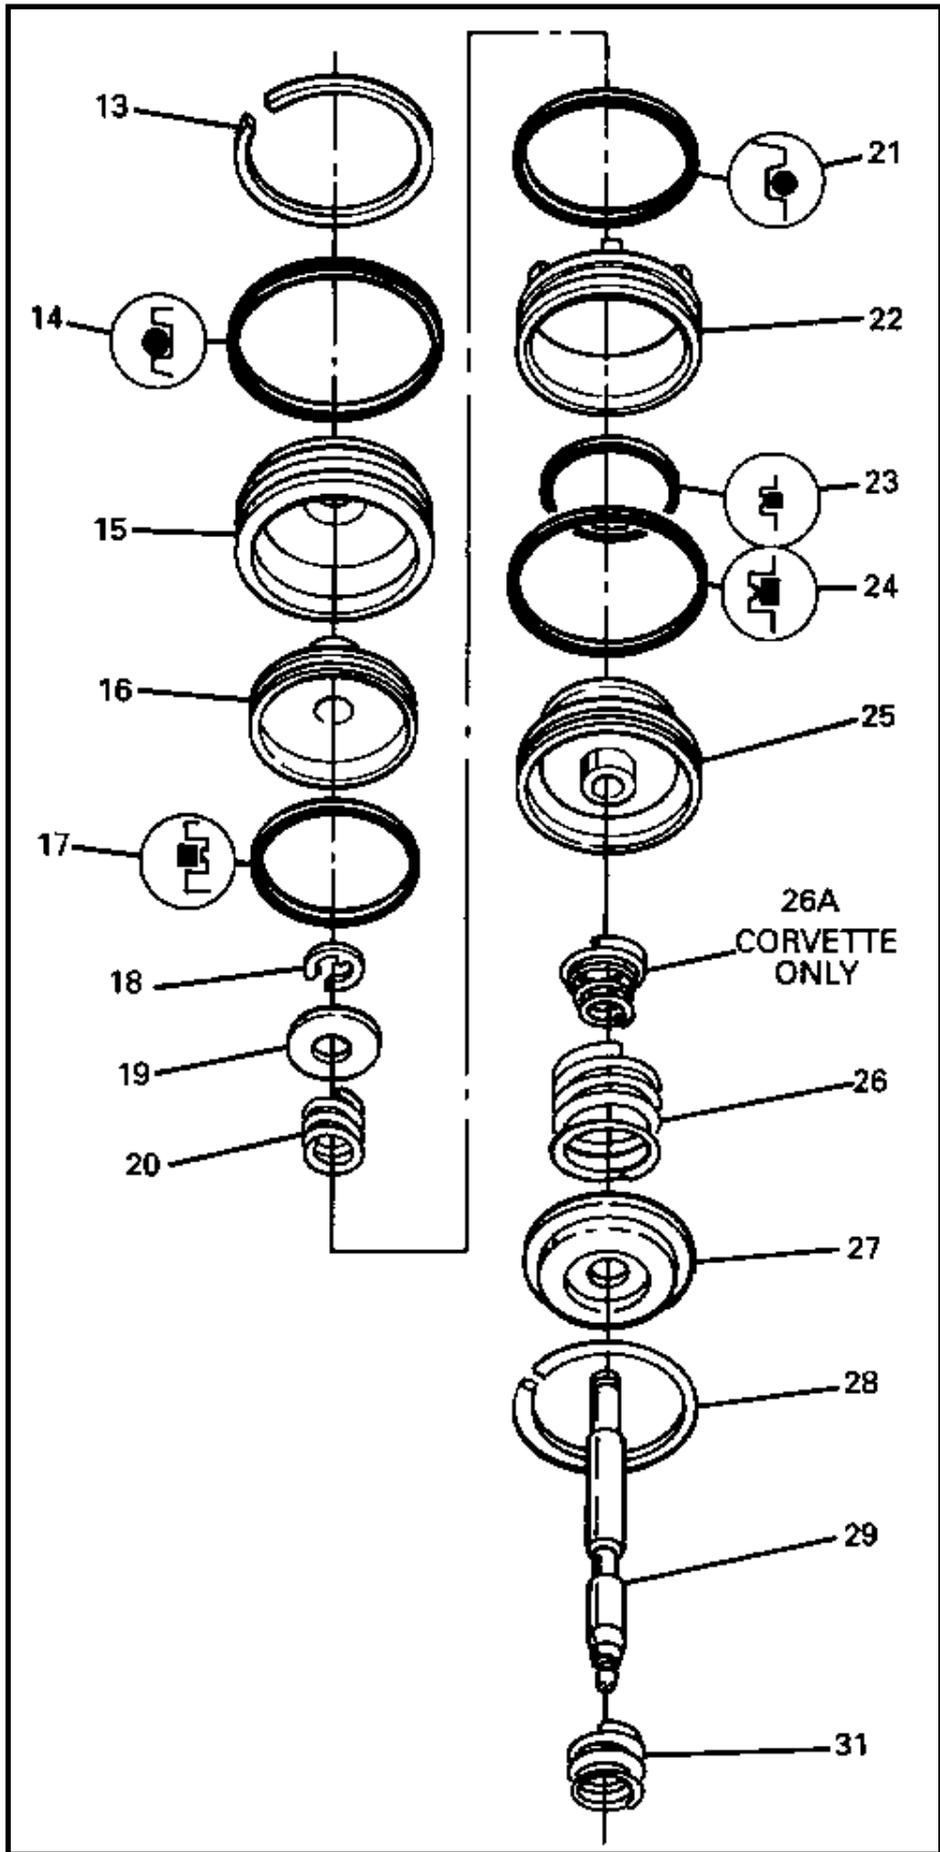
Refer to Figure 2

13 RING, SERVO COVER RETAINING 14 SEAL, "O'RING (2-4 SERVO

COVER) 15 COVER, 2-4 SERVO 16 PISTON, 4TH APPLY 17 RING, OIL SEAL (4TH APPLY PISTON - OUTER) 18 RING, RETAINER (APPLY PIN) 19 WASHER, SERVO APPLY PIN 20 SPRING, SERVO APPLY PIN 21 SEAL, "O" RING 22 HOUSING, SERVO PISTON (INNER) 23 RING, OIL SEAL (2ND APPLY PISTON - INNER) 24 RING, OIL SEAL (2ND APPLY PISTON - OUTER) 25 PISTON, 2ND APPLY 26 SPRING, SERVO CUSHION 26A SPRING, SERVO CUSHION ASSIST (CORVETTE ONLY) 27 RETAINER, SERVO CUSHION SPRING 28 RING, RETAINER (2ND APPLY PISTON) 29 PIN, 2ND APPLY PISTON 31 SPRING, SERVO RETURN

-----  
The new servo cushion assist spring and spacer plate can be used to service any OYDM, 1 YDM, or 1 YHM model of the HYDRA-MATIC 4L60 transmission built before May 20, 1991. Models built after this date already contain the new spring and spacer plate.

Install the new servo cushion assist spring inside the current servo cushion spring as shown in figure 2. Figure 2 shows the ONLY way the spring should be installed. Do not install the spring upside down. The new spring should not be used by itself.

Refer to the Automatic Transmission Unit Repair Section of the appropriate service manual for spacer plate removal and installation information. The 2-4 servo cushion assist spring is not shown in a service manual. Follow instructions for installing a 2-4 servo cushion spring, and add the servo cushion assist spring as shown in figure 2 of this bulletin.
