1990 - 1991 Corvette: Service Bulletin: 3-2 Coast Down Clunk

Subject: 3-2 COAST DOWN CLUNK (INSTALL SERVO SPRING)

Model and Year: 1990-91 CORVETTE WITH 4L60 AUTOMATIC
TRANSMISSION

Bulletin Number: 91-372-7A - (06/27/1991)

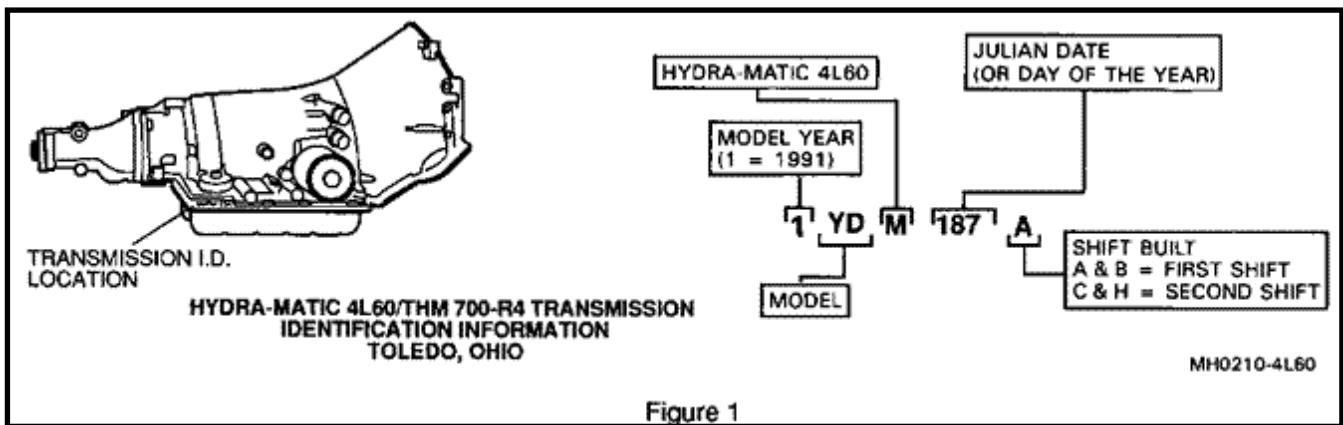
Figure 1

Date of Production Change: (Figure 1)

Beginning May 20, 1991 (Julian Date 140), all 1 YHM models of the HYDRA-MATIC 4L60 were built using the new servo cushion assist spring and spacer plate.
