1989 - 1996 Corvette: Service Bulletin: Information on Corvette ZF 6-Speed Manual Transmission Service Procedure

Model Year: 1989-96 CHEVROLET CORVETTE WITH ZF 6-SPEED MANUAL TRANSMISSION (ML9)

Source: Chevrolet Dealer Service Bulletin

Bulletin Number: 77-72-04

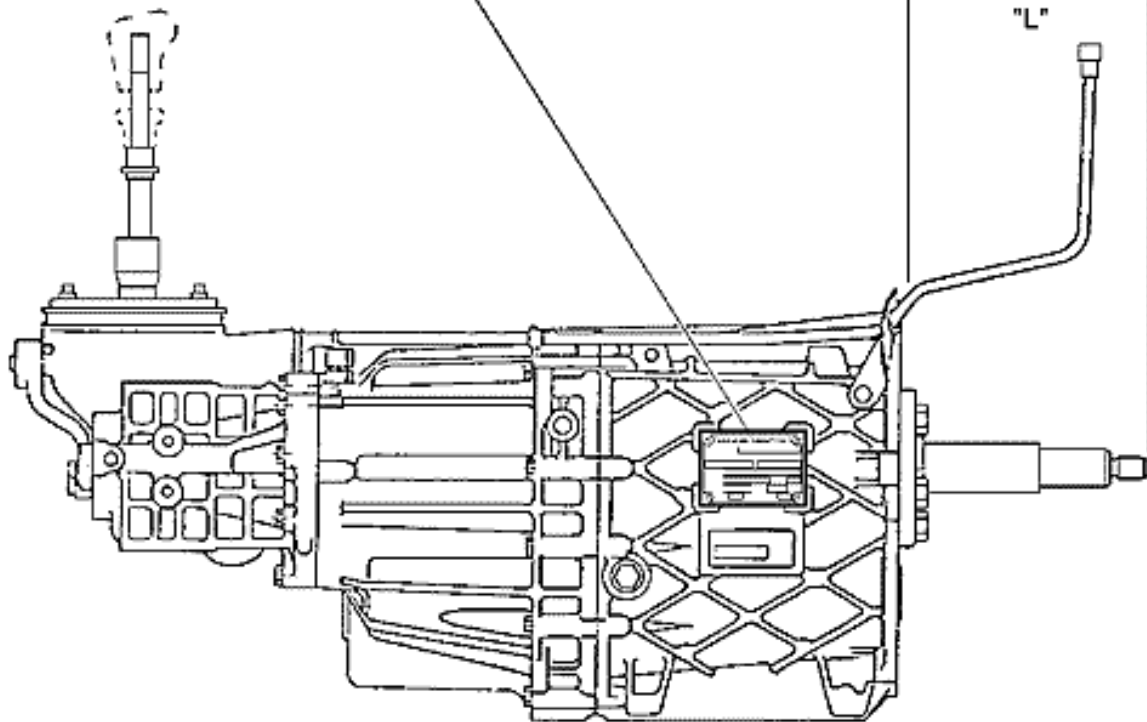
INPUT SHAFT LENGTH

ENGINE TYPE	"L" mm (in)
L98	159.5 (6.28)
LT5	190.5 (7.50)

SHOULD BE CHECKED AND RE-SHIMMED IF NECESSARY, PER PROCEDURE IN SHOP MANUAL. (SEE ILLUSTRATION) KENT MOORE SPECIAL TOOL #J38126 NEEDED FOR O- RING REPLACEMENT. IMPORTANT: BEARING RETAINER FOR L98/LT1 AND LT5 ENGINE IS NOT INTERCHANGEABLE.
