1989 - 1996 Corvette: Service Bulletin: Information on Corvette ZF 6-Speed Manual Transmission Service Procedure

Model Year: 1989-96 CHEVROLET CORVETTE WITH ZF 6-SPEED MANUAL TRANSMISSION (ML9)

Source: Chevrolet Dealer Service Bulletin

Bulletin Number: 77-72-04

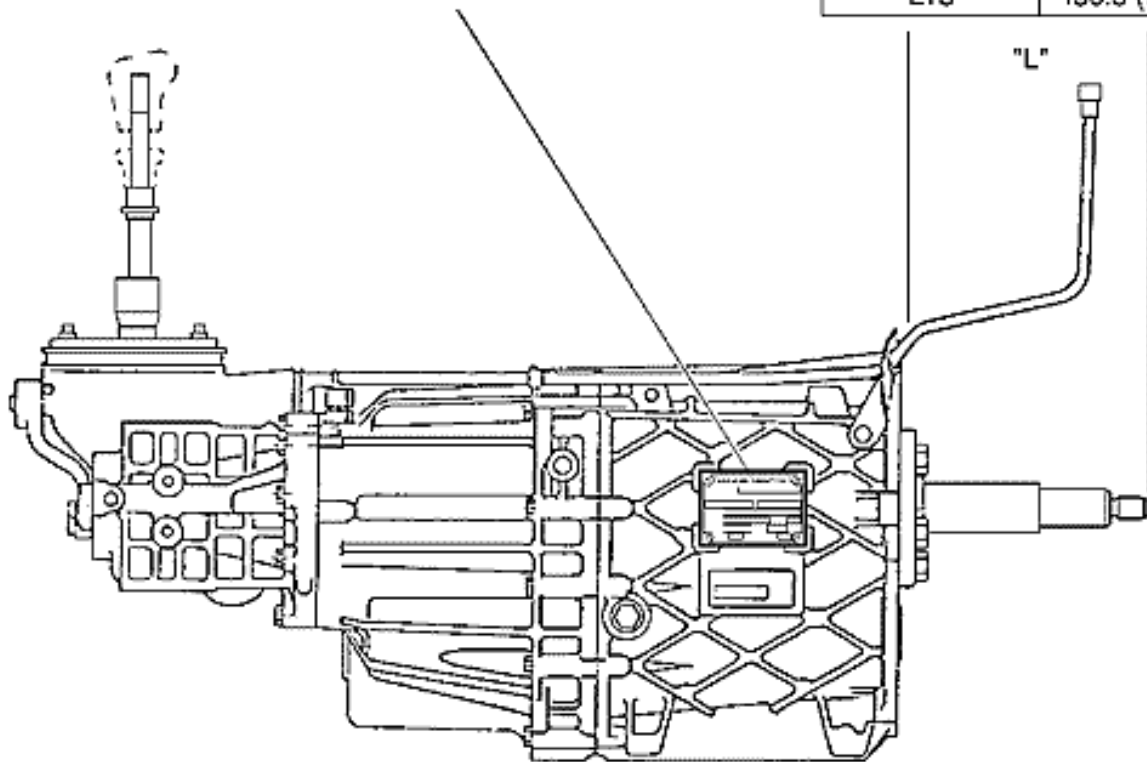
Figure 2

INPUT SHAFT LENGTH

ENGINE TYPE	"L" mm (in)
L98	159.5 (6.28)
LT5	190.5 (7.50)

TRANSMISSION LEAKS A) INPUT SHAFT LEAKS REPLACE INPUT SHAFT BEARING RETAINER ASSEMBLY, O-RING AND GASKET. FRONT INPUT BEARING ENDPLAY

SHOULD BE CHECKED AND RE-SHIMMED IF NECESSARY, PER PROCEDURE IN SHOP MANUAL. (SEE ILLUSTRATION) KENT MOORE SPECIAL TOOL #J38126 NEEDED FOR O- RING REPLACEMENT. IMPORTANT: BEARING RETAINER FOR L98/LT1 AND LT5 ENGINE IS NOT INTERCHANGEABLE.
