1989 - 1991 Corvette: Service Bulletin: No/Delayed Reverse When Cold

Subject: NO/DELAYED REVERSE WHEN COLD INSTALL REV.
INPUT CLUTCH SEAL

Bulletin Number: 91-493-7A - (03/11/1992)

1989-91 HYDRA-MATIC 4L60 (MD8)

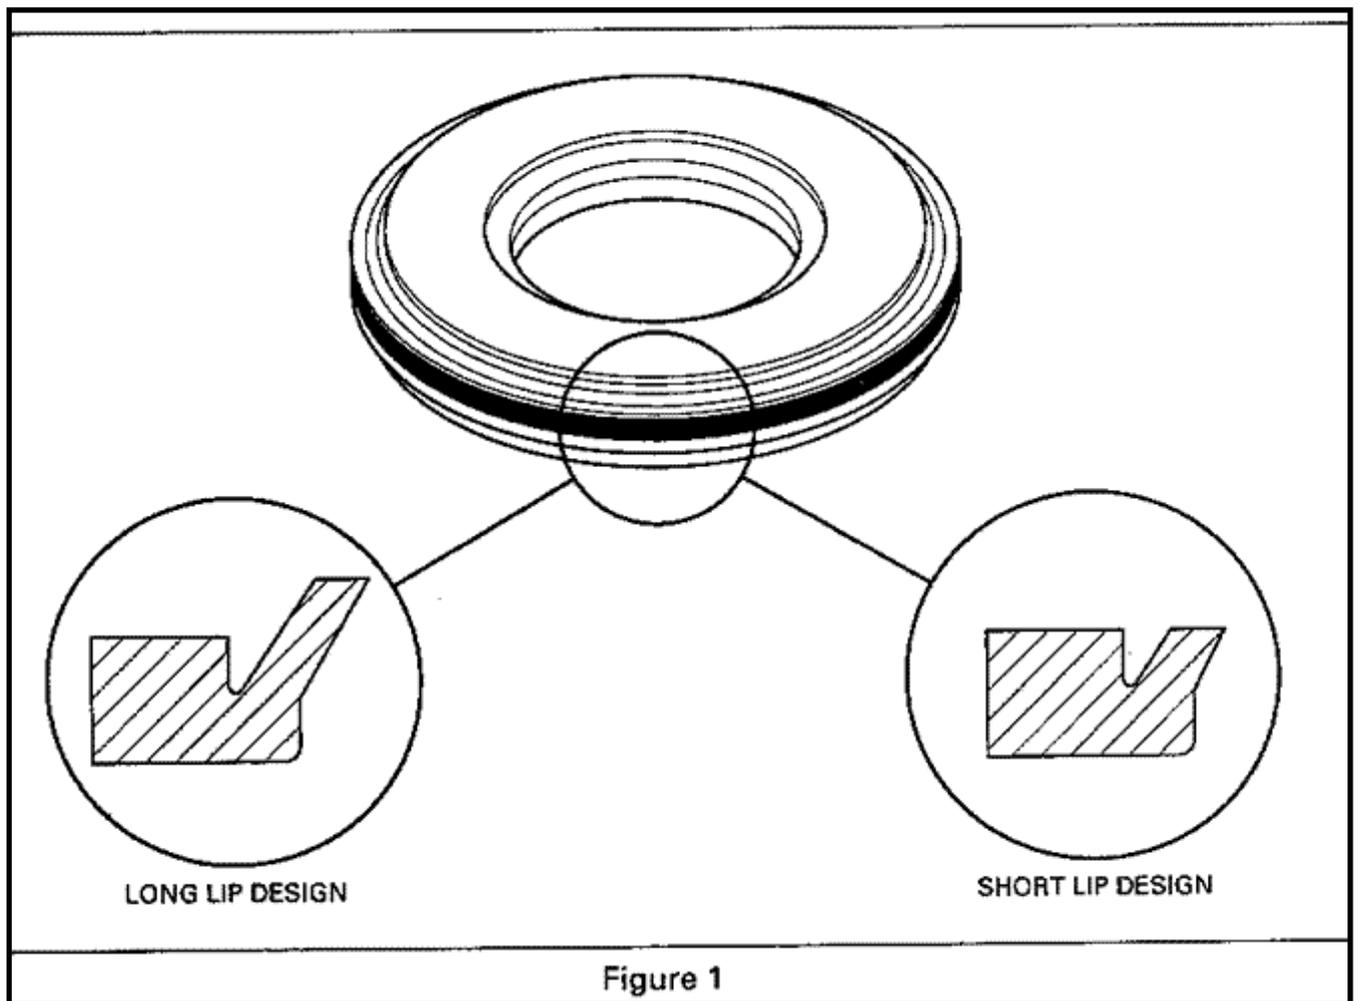
Some 1989-1991 HYDRA-MATIC 4L60 (THM 700-R4) transmissions may exhibit a 'no reverse' or 'delayed reverse' condition when outside temperatures are below zero degrees Fahrenheit.

If a transmission has a 'no reverse' or 'delayed reverse' condition, inspect the reverse input clutch piston outer seal. Determine if the seal is a 'short lip' or 'long lip' design by comparing it to Figure 1. If it is a short lip design, replace it with a long lip seal contained in the service packages listed under Service Parts Information.

If the reverse input clutch piston outer seal is a long lip design, or the newly installed long lip seal doesn't alleviate the delayed reverse condition, the reverse input clutch housing may be out of round. Inspect the housing and replace if necessary.
