# 1989 - 1991 Corvette: Service Bulletin: No/Delayed Reverse When Cold

**Subject:** NO/DELAYED REVERSE WHEN COLD INSTALL REV.  
INPUT CLUTCH SEAL

**Bulletin Number:** 91-493-7A - (03/11/1992)

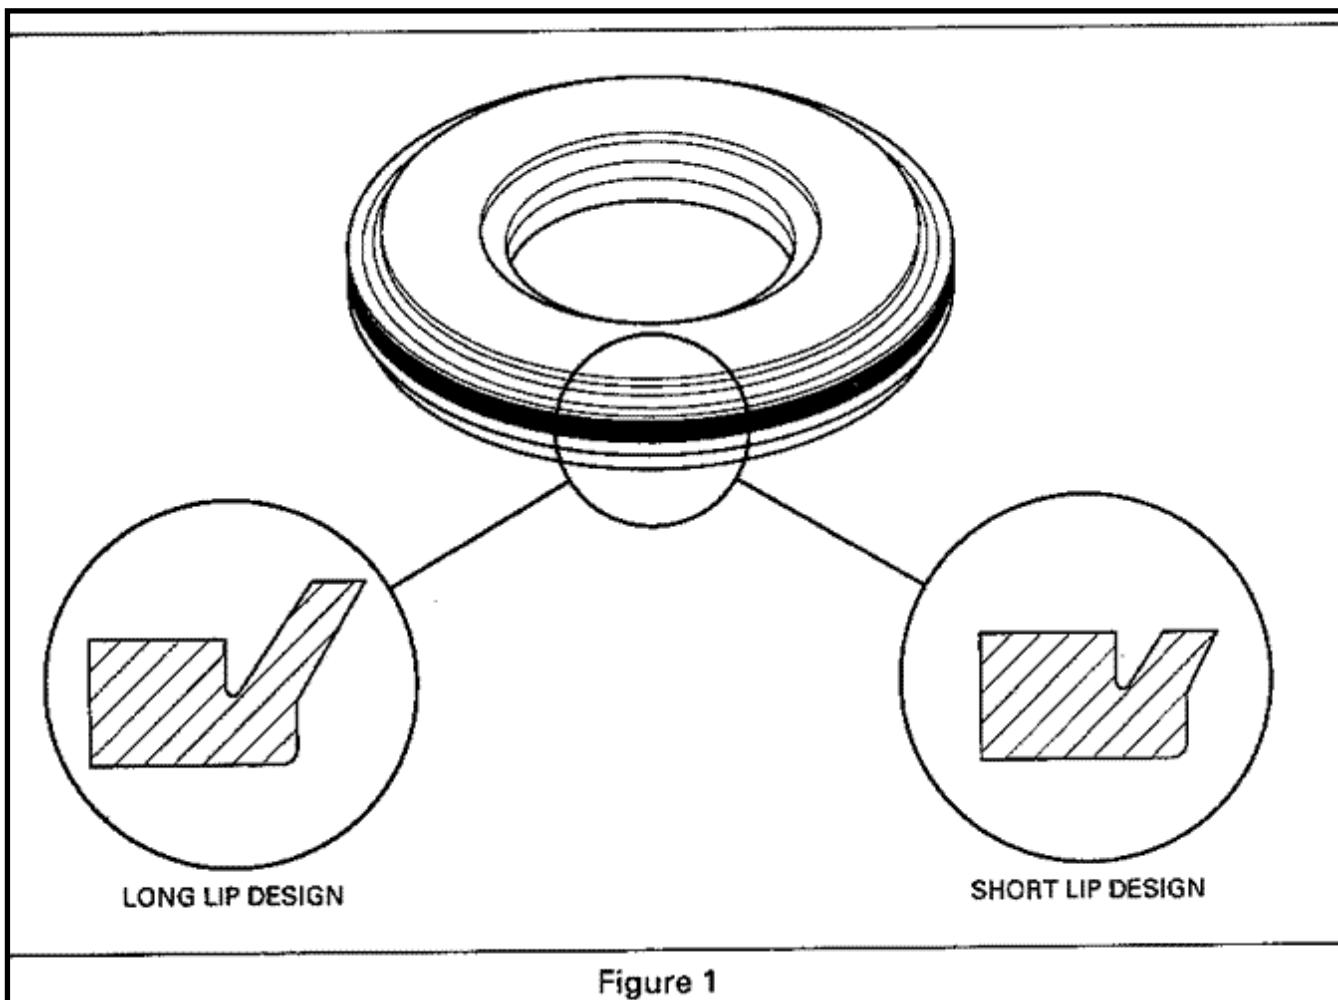
Figure 1

Some 1989-1991 HYDRA-MATIC 4L60 (THM 700-R4) transmissions may exhibit a 'no reverse' or 'delayed reverse' condition when outside temperatures are below zero degrees Fahrenheit.

If a transmission has a 'no reverse' or 'delayed reverse' condition, inspect the reverse input clutch piston outer seal. Determine if the seal is a 'short lip' or 'long lip' design by comparing it to Figure 1. If it is a short lip design, replace it with a long lip seal contained in the service packages listed under Service Parts Information.

If the reverse input clutch piston outer seal is a long lip design, or the newly installed long lip seal doesn't alleviate the delayed reverse condition, the reverse input clutch housing may be out of round. Inspect the housing and replace if necessary.
