# 1984 - 1985 Corvette: Service Bulletin: Improperly Installed Reverse Idler Shaft Roll Pin

**Subject:** IMPROPERLY INSTALLED REVERSE IDLER SHAFT ROLL PIN

**Model and Year:** 1984-1985 CORVETTE

**Bulletin Number:** 85-31 - (01/09/1985)

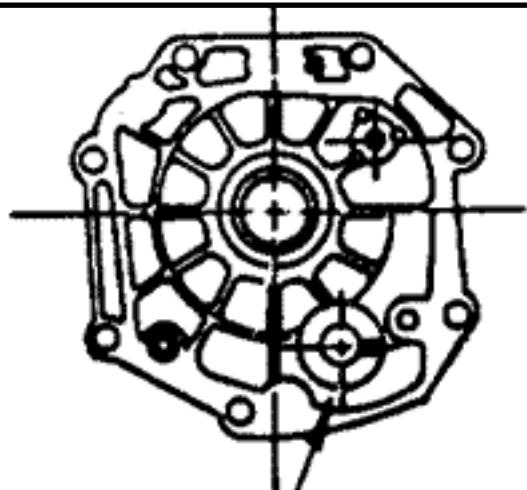
FIG. 1 REVER

Damage to the manual transmission may occur if the roll pin securing the reverse gear idler shaft to adapter plate (Figure 1) is not fully seated to prevent the shaft from spinning and/or backing out. To insure assembly operation results in the shaft securely locked in place, the roll pin has been lengthened from 0.50" to 0.75". When servicing transmissions with the shorter roll pin (0.50"), discard the roll pin and replace with longer roll pin (0.75") maximum.
