1984 - 1985 Corvette: Service Bulletin: Improperly Installed Reverse Idler Shaft Roll Pin

Subject: IMPROPERLY INSTALLED REVERSE IDLER SHAFT ROLL PIN

Model and Year: 1984-1985 CORVETTE

Bulletin Number: 85-31 - (01/09/1985)

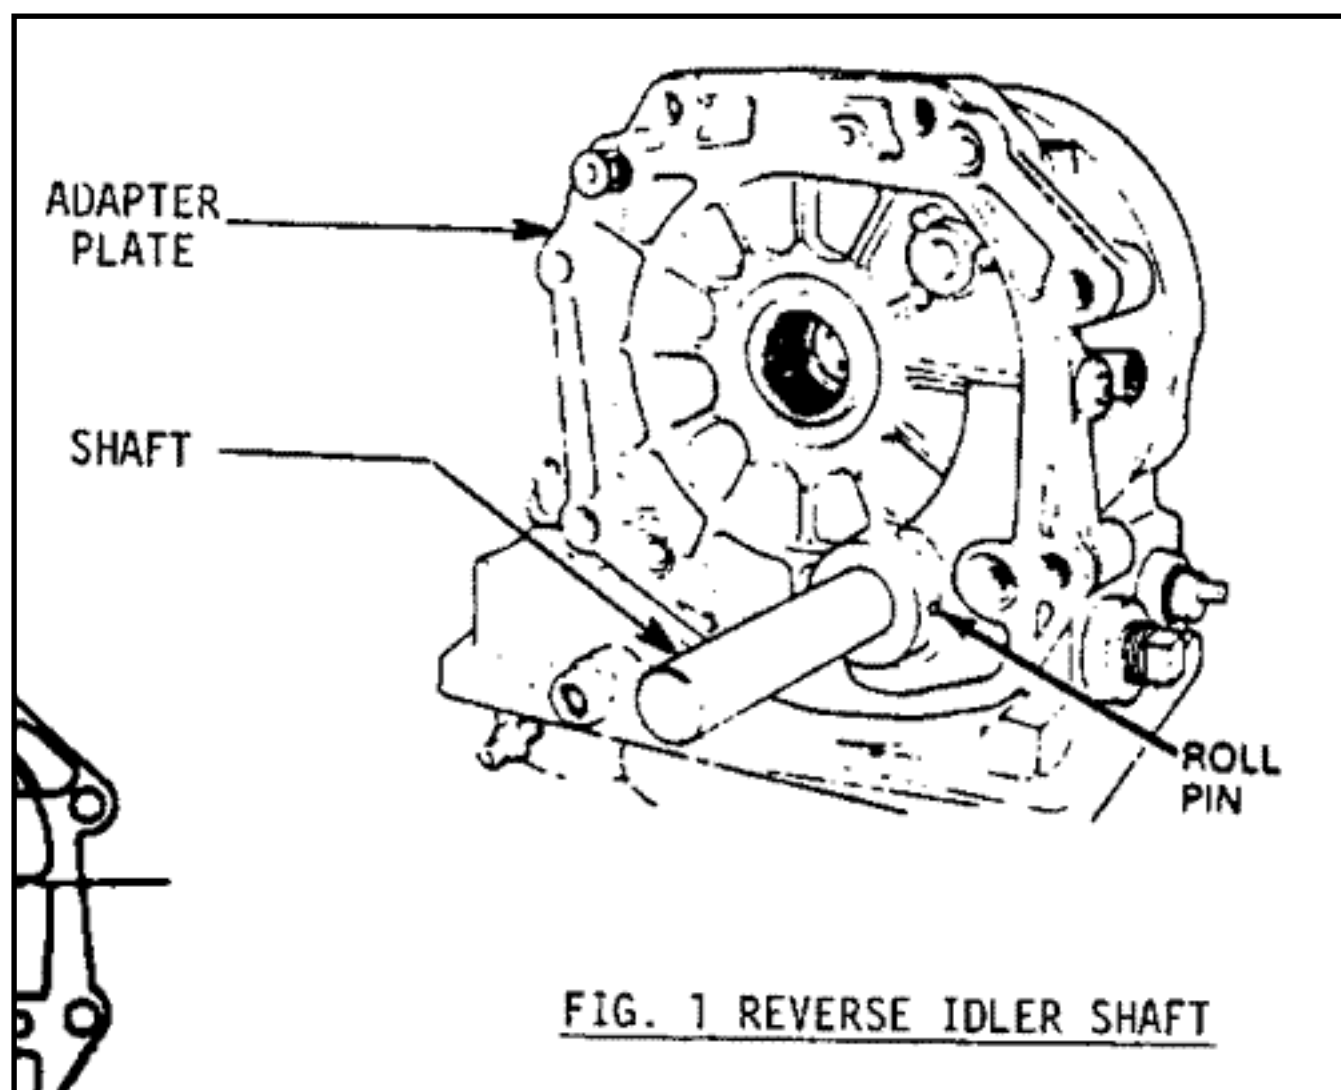
Damage to the manual transmission may occur if the roll pin securing the reverse gear idler shaft to adapter plate (Figure 1) is not fully seated to prevent the shaft from spinning and/or backing out. To insure assembly operation results in the shaft securely locked in place, the roll pin has been lengthened from 0.50" to 0.75". When servicing transmissions with the shorter roll pin (0.50"), discard the roll pin and replace with longer roll pin (0.75") maximum.

1. Insert small punch tool into plate boss hole and carefully drive roll pin into reverse idler shaft (Figure 3).

Driving roll pin too hard may cause to jam and result in shaft binding to adapter plate.

2. Pull reverse idler shaft from adapter plate and remove roll pin from shaft.
