1984 - 1985 Corvette: Service Bulletin: Improperly Installed Reverse Idler Shaft Roll Pin

Subject: IMPROPERLY INSTALLED REVERSE IDLER SHAFT ROLL
PIN

Model and Year: 1984-1985 CORVETTE

Bulletin Number: 85-31 - (01/09/1985)

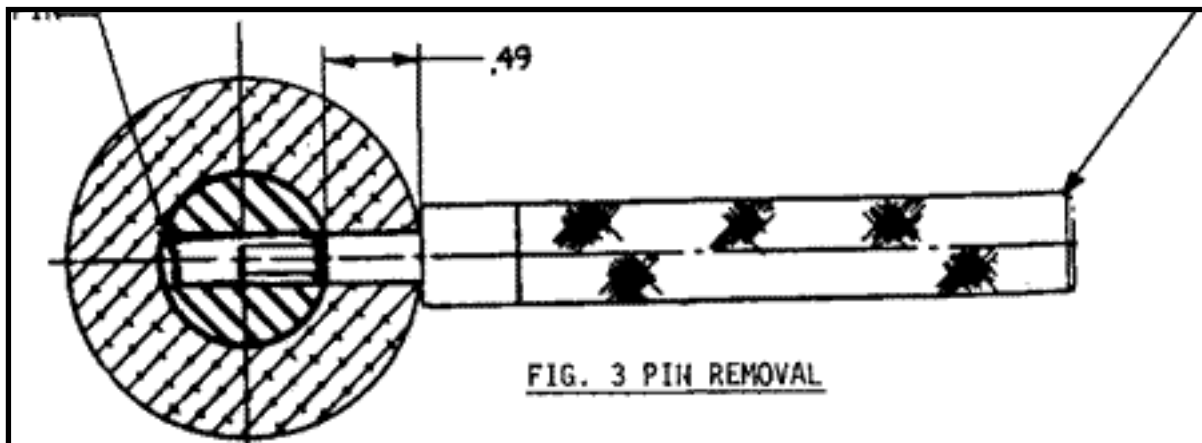
Driving roll pin too hard may cause to jam and result in shaft binding to adapter plate.

1. Insert small punch tool into plate boss hole and carefully drive roll pin into reverse idler shaft (Figure 3).
