1992 - 1993 Corvette: Recall: Power Steering Gear Inlet Hose

Subject: PRODUCT SAFETY CAMPAIGN 93CO2 - POWER STEERING GEAR INLET HOSE

Model and Year: 1992-93 CHEVROLET LT1 CORVETTE

Bulletin Number: 93C02

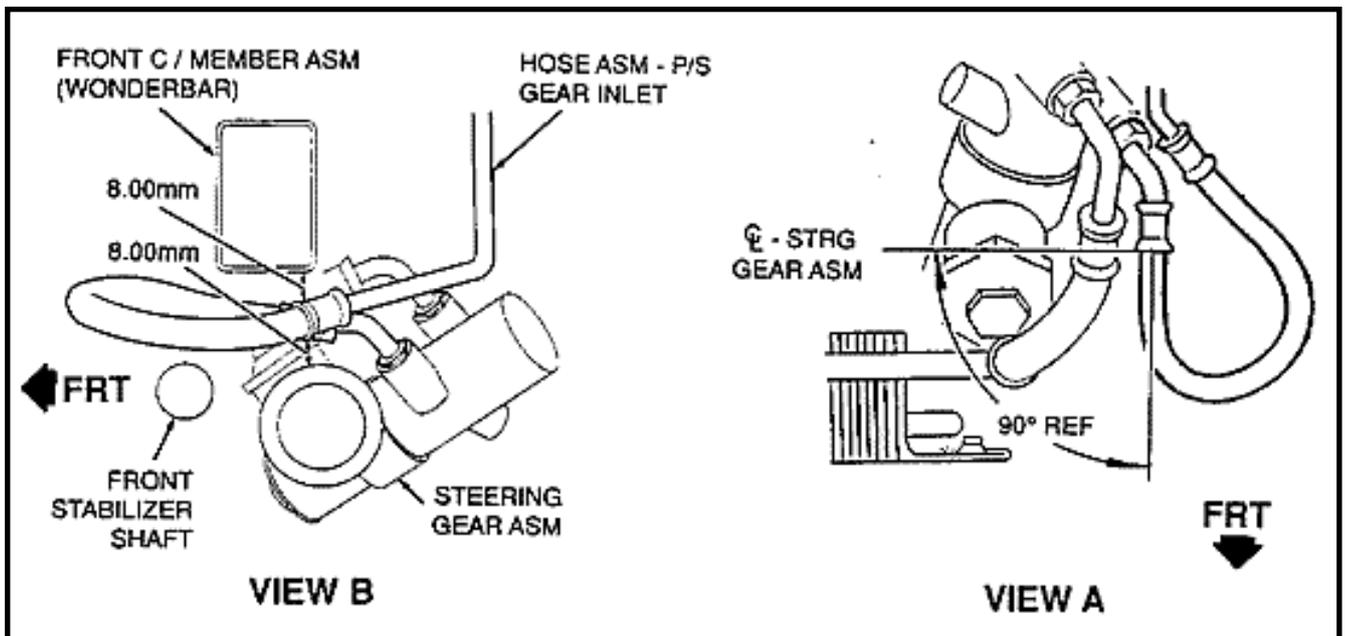
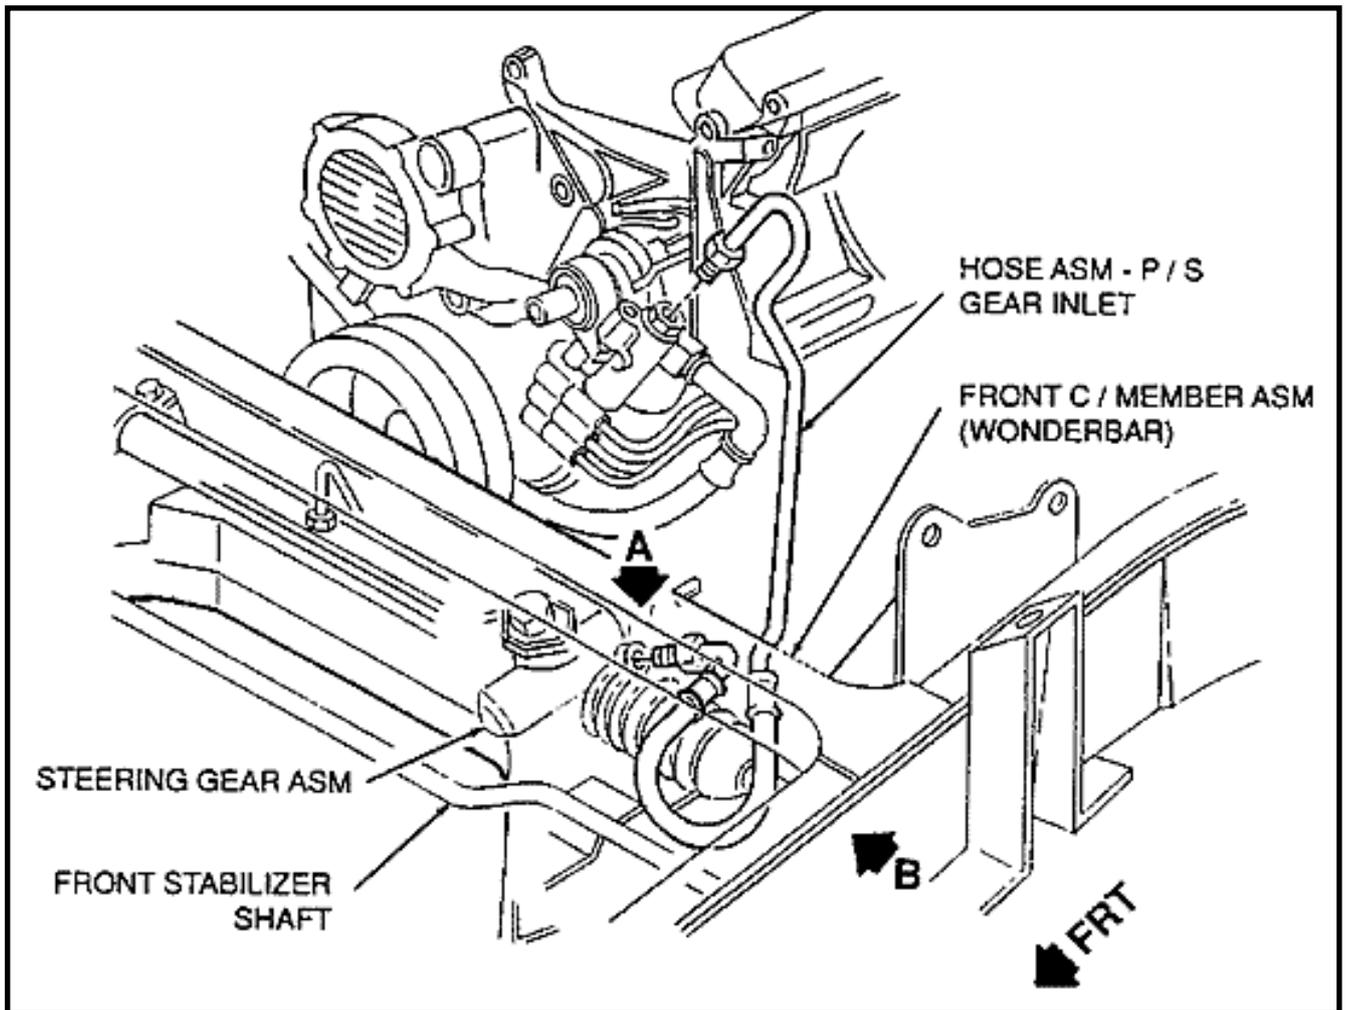
Notice: Be certain to leave adequate clearance between front cross-member and hose/pipe assembly. View B on page 4 illustrates proper clearance.

1. Install new power steering gear inlet hose following procedures on page 3B-6 of either

the 1992 Corvette Service Manual (ST-364-92-1) or the 1993 Corvette Service Manual (ST-364-93PSID).
