1992 - 1993 Corvette: Recall: Power Steering Gear Inlet Hose

Subject: PRODUCT SAFETY CAMPAIGN 93CO2 - POWER STEERING GEAR INLET HOSE

Model and Year: 1992-93 CHEVROLET LT1 CORVETTE

Bulletin Number: 93C02

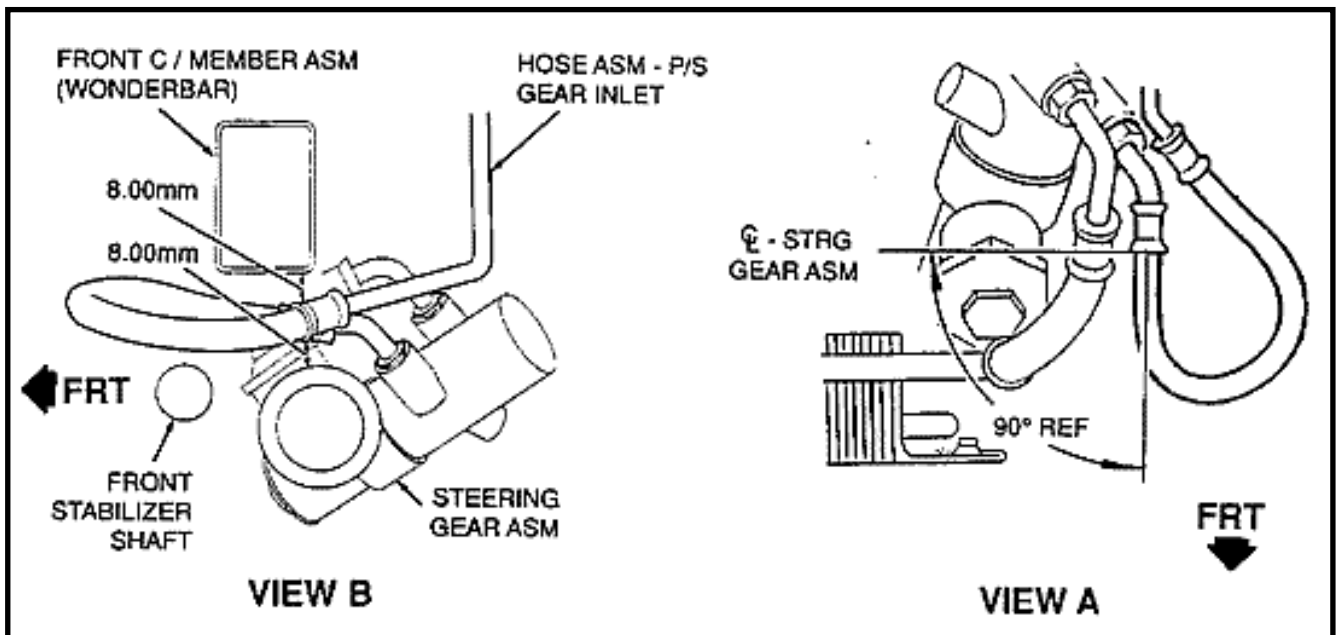
General Motors has determined that a defect which relates to motor vehicle safety exists in certain late 1992 and early 1993 Chevrolet Corvette model vehicles equipped with LT1 engines. These vehicles were assembled with a power steering gear inlet hose which may fracture. Since the fluid within this hose is under pressure, fracture of the hose could cause power steering fluid to spray out of the hose and, if an ignition source is present, an

engine compartment fire could occur.

Figures on page 4 may assist in performing this repair procedure.

1. Install new power steering gear inlet hose following procedures on page 3B-6 of either

the 1992 Corvette Service Manual (ST-364-92-1) or the 1993 Corvette Service Manual (ST-364-93PSID).

Notice: Be certain to leave adequate clearance between front cross-member and hose/pipe assembly. View B on page 4 illustrates proper clearance.
