1992 - 1993 Corvette: Recall: Power Steering Gear Inlet Hose

Subject: PRODUCT SAFETY CAMPAIGN 93C02 - POWER STEERING GEAR INLET HOSE

Model and Year: 1992-93 CHEVROLET LT1 CORVETTE

Bulletin Number: 93C02

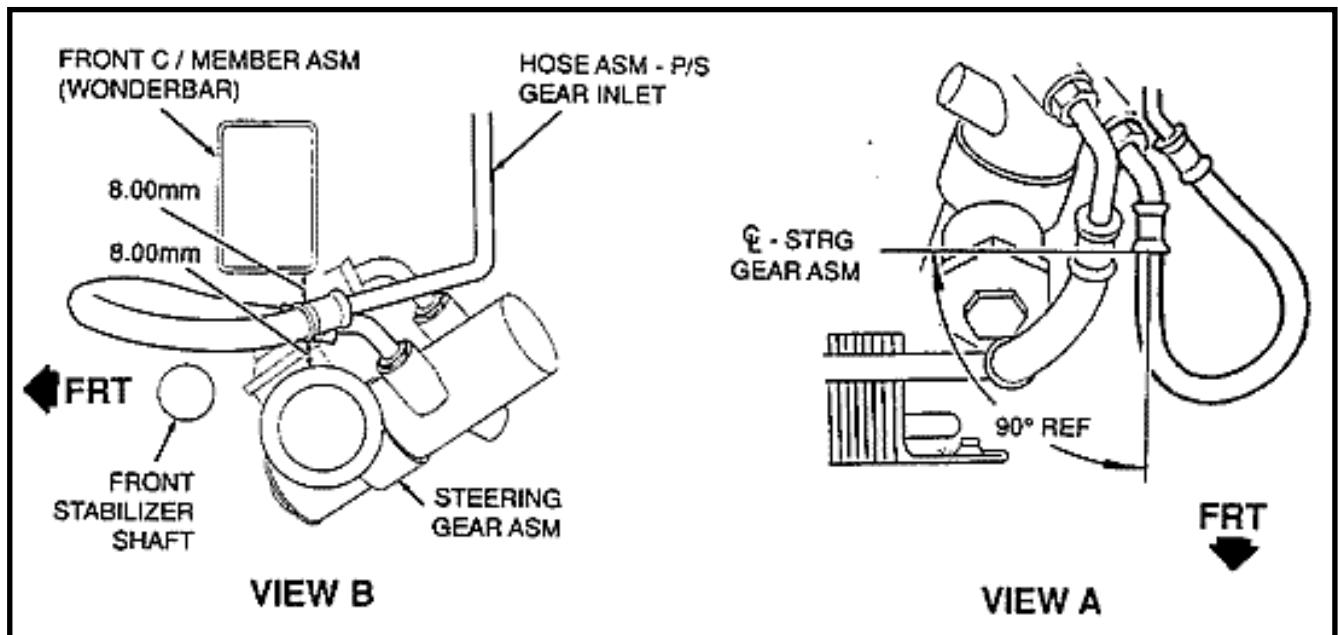
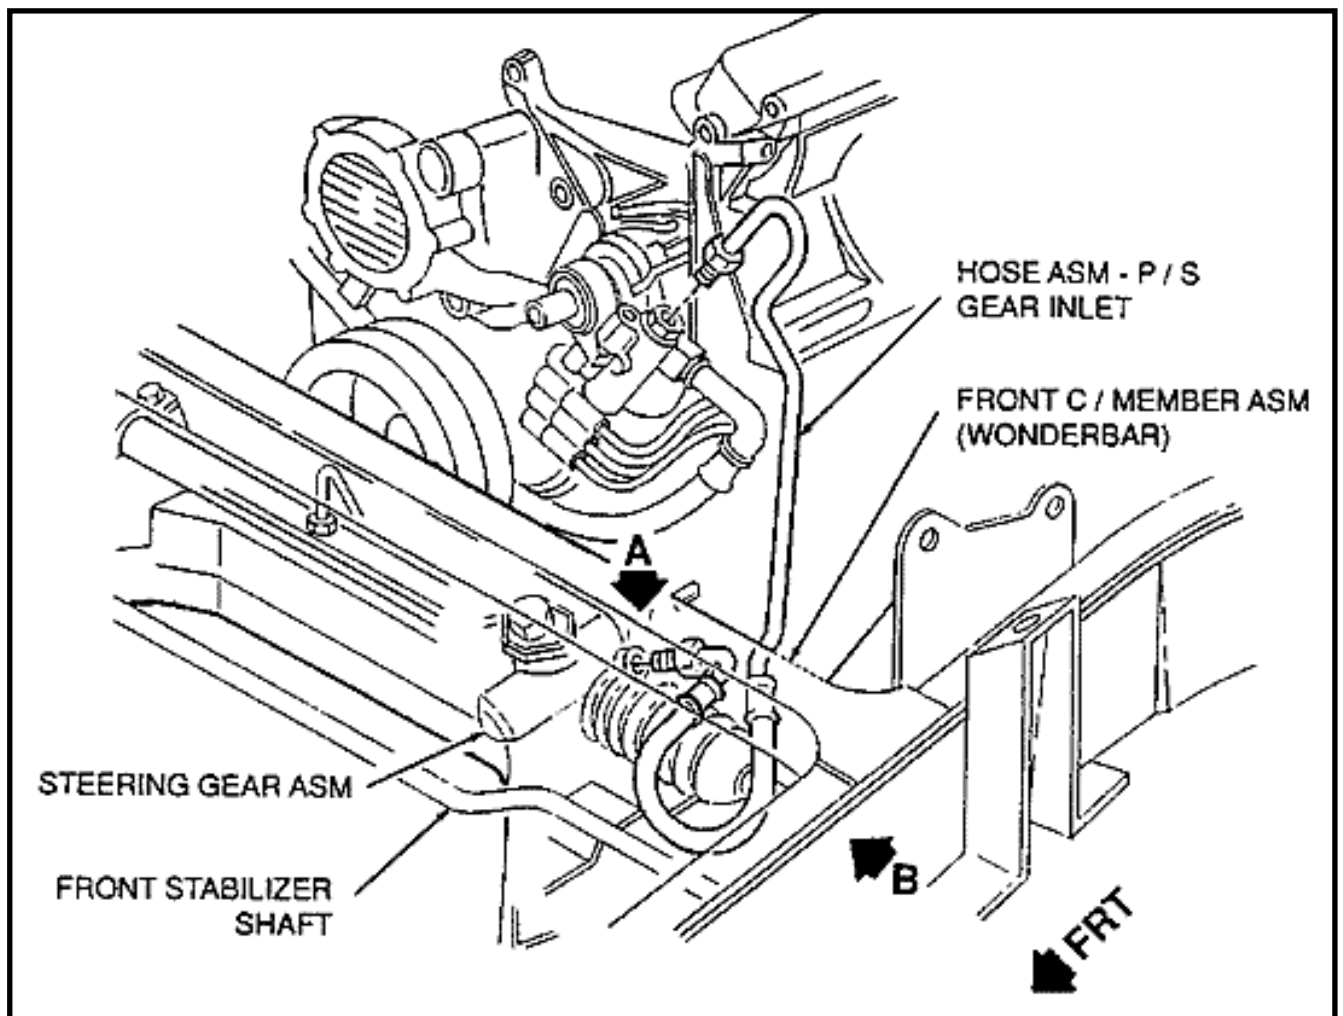
Figures on page 4 may assist in performing this repair procedure.

1. Install new power steering gear inlet hose following procedures on page 3B-6 of either

the 1992 Corvette Service Manual (ST-364-92-1) or the 1993 Corvette Service Manual (ST-364-93PSID).

Notice: Be certain to leave adequate clearance between front cross-member and hose/pipe assembly. View B on page 4 illustrates proper clearance.
