# 1992 - 1993 Corvette: Recall: Power Steering Gear Inlet Hose

**Subject:** PRODUCT SAFETY CAMPAIGN 93CO2 - POWER STEERING GEAR INLET HOSE

**Model and Year:** 1992-93 CHEVROLET LT1 CORVETTE

**Bulletin Number:** 93C02

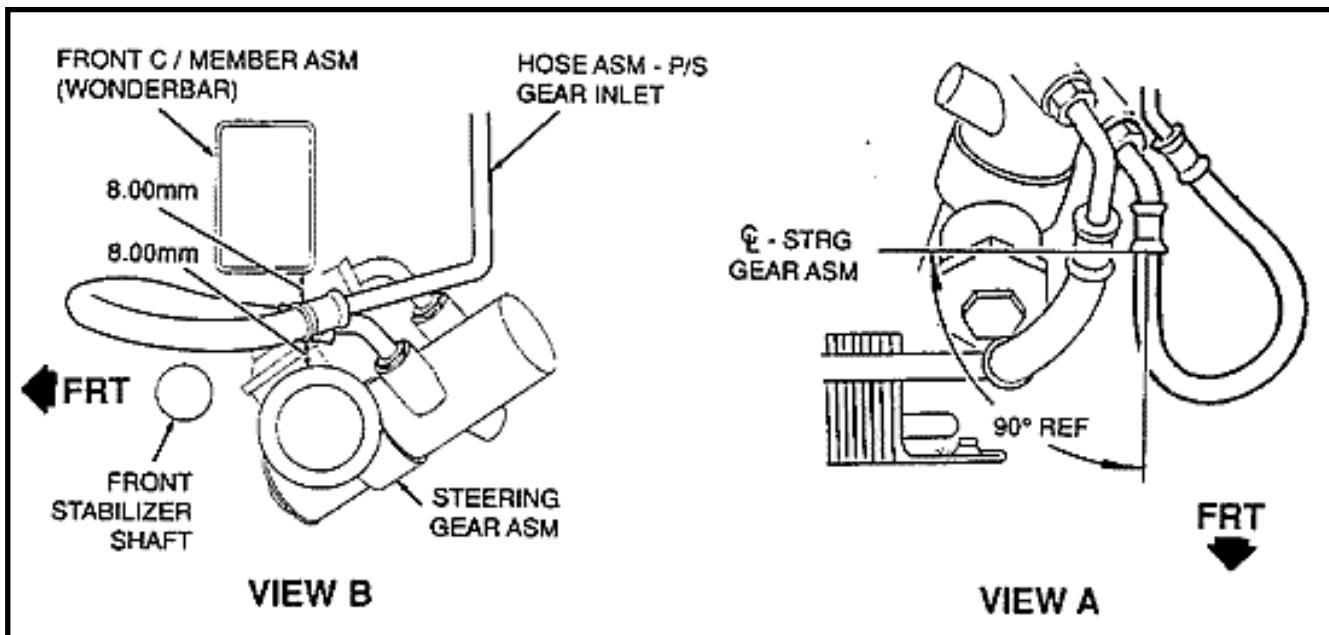
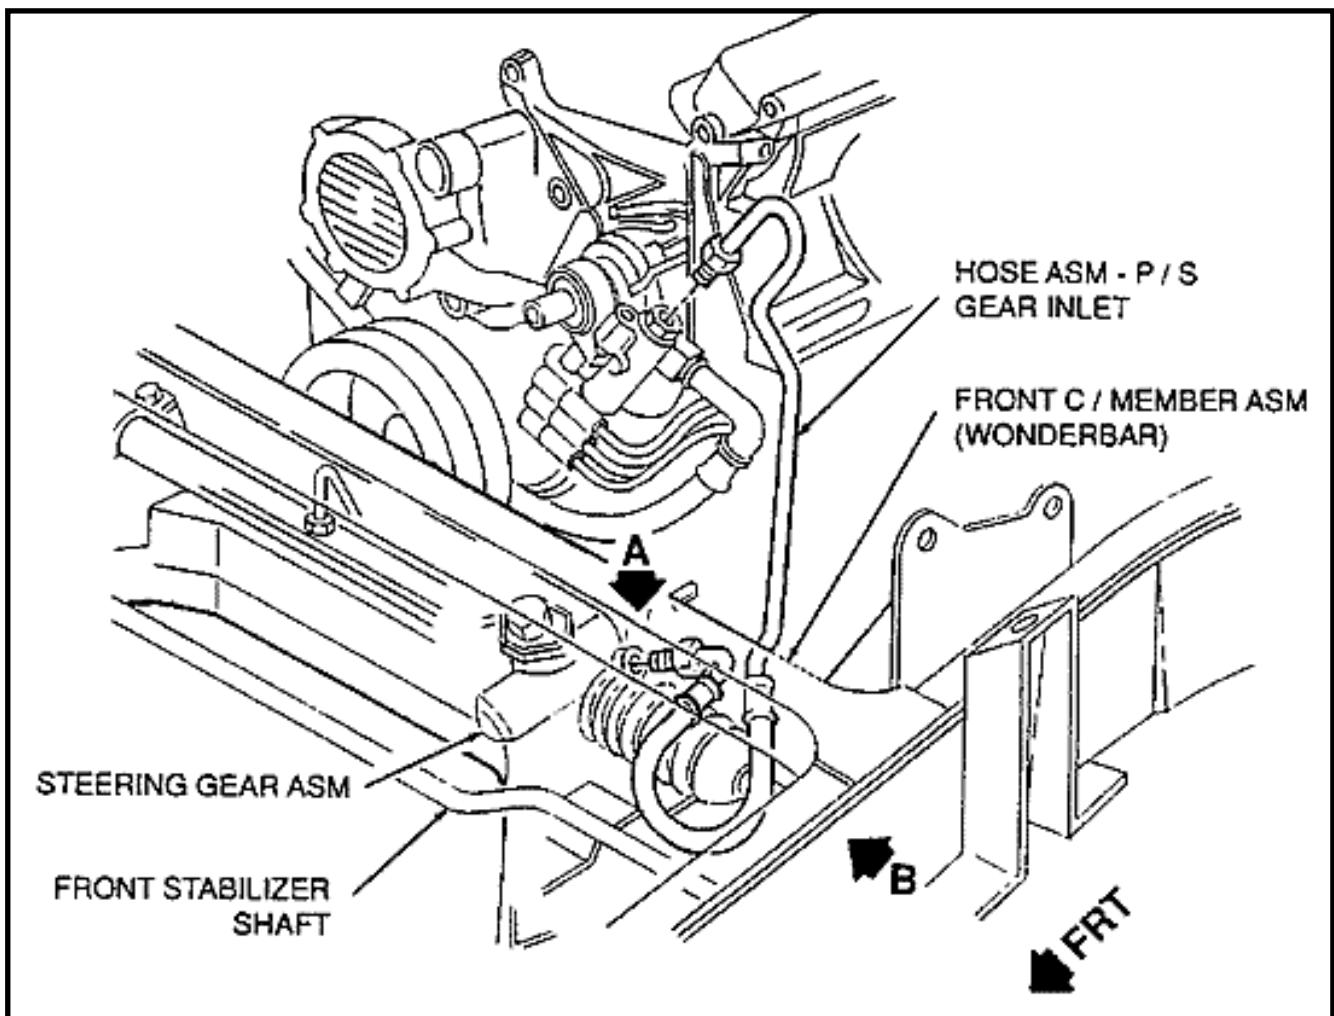
Figures on page 4 may assist in performing this repair procedure.

General Motors has determined that a defect which relates to motor vehicle safety exists in certain late 1992 and early 1993 Chevrolet Corvette model vehicles equipped with LT1 engines. These vehicles were assembled with a power steering gear inlet hose which may fracture. Since the fluid within this hose is under pressure, fracture of the hose could cause power steering fluid to spray out of the hose and, if an ignition source is present, an

engine compartment fire could occur.

1. Install new power steering gear inlet hose following procedures on page 3B-6 of either

the 1992 Corvette Service Manual (ST-364-92-1) or the 1993 Corvette Service Manual (ST-364-93PSID).

**Notice: Be certain to leave adequate clearance between front cross-member and hose/pipe assembly. View B on page 4 illustrates proper clearance.**
