1990 Corvette: Service Bulletin: Clicking Noise When Steering Wheel is Rotated

Subject: 'CLICKING' NOISE WHEN STEERING WHEEL IS ROTATED

Model and Year: 1990 CORVETTE

Bulletin Number: 90-327-3B - (08/03/1990)

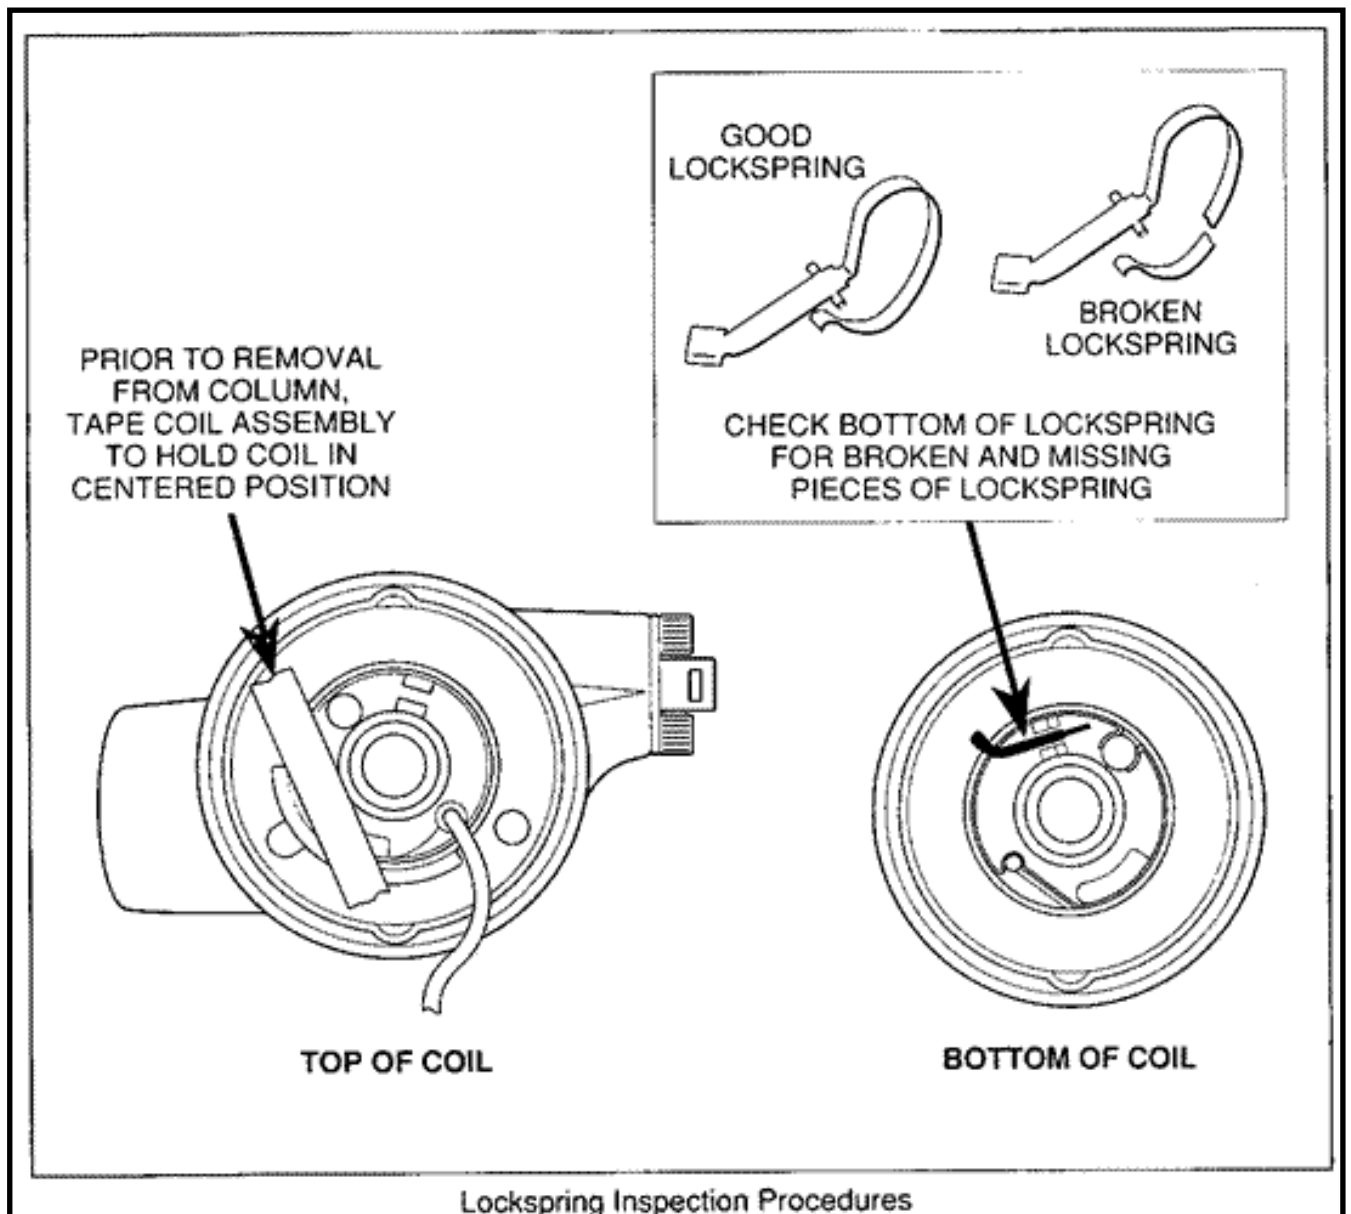
A "clicking" noise may be heard when the steering wheel is turned.

The Supplemental Inflatable Restraint (SIR) coil lockspring, which holds the coil in a centered position during service, may be missing or broken. The brass colored lockspring may not be strong enough to withstand compression during assembly. The SIR system continues to function normally.

1. Black lockspring - latest design, not subject to breakage.
2. Brass colored lockspring - early design, subject to breakage.
3. No lockspring - Some steering columns may have been built without locksprings from VIN's #1 14400 to #1 15822 (Man. Trans.) and #1 16055 (Auto. Trans.).

1. Disconnect negative battery cable.
2. Disable SIR system following Service Manual instructions.
3. Place wheels in the straight ahead position before removing coil.
4. Refer to 1990 Corvette Service Manual for complete instructions on removing the coil assembly from the steering column. Before removing the coil assembly from the column, tape the coil assembly to hold it in the centered position, as shown in the illustration.

5. Remove the coil from the column, turn the coil over, and inspect the lockspring for broken or missing pieces as shown in the illustration.

- a. If the lockspring is black, it is not subject to breakage. Leave the lockspring in place.

b. If the spring is brass colored, and is not broken, leave it in place.

c. If the spring is brass colored, and is broken, remove all the pieces of the spring and discard. It is not necessary to replace the lockspring with a new one.

d. if the spring is missing, it is not necessary to replace it.
