1990 Corvette: Service Bulletin: Clicking Noise When Steering Wheel is Rotated

Subject: 'CLICKING' NOISE WHEN STEERING WHEEL IS ROTATED

Model and Year: 1990 CORVETTE

Bulletin Number: 90-327-3B - (08/03/1990)

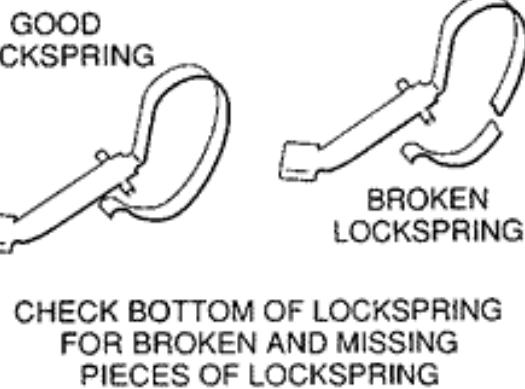
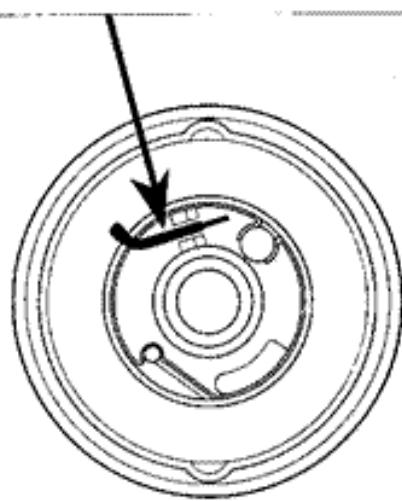
BOTTOM OF COIL

The Supplemental Inflatable Restraint (SIR) coil lockspring, which holds the coil in a centered position during service, may be missing or broken. The brass colored lockspring may not be strong enough to withstand compression during assembly. The SIR system continues to function normally.

1. Black lockspring - latest design, not subject to breakage.
2. Brass colored lockspring - early design, subject to breakage.
3. No lockspring - Some steering columns may have been built without locksprings from VIN's #1 14400 to #1 15822 (Man. Trans.) and #1 16055 (Auto. Trans.).

5. Remove the coil from the column, turn the coil over, and inspect the lockspring for broken or missing pieces as shown in the illustration.
 - a. If the lockspring is black, it is not subject to breakage. Leave the lockspring in place.
 - b. If the spring is brass colored, and is not broken, leave it in place.
 - c. If the spring is brass colored, and is broken, remove all the pieces of the spring and discard. It is not necessary to replace the lockspring with a new one.

NOTICE: All pieces of the broken lockspring must be removed, or serious damage to the steering column may result.
