1990 Corvette: Service Bulletin: Clicking Noise When Steering Wheel is Rotated

Model and Year: 1990 CORVETTE

Source: Chevrolet Service Bulletin

Bulletin Number: 90-327-3B - (08/03/1990)

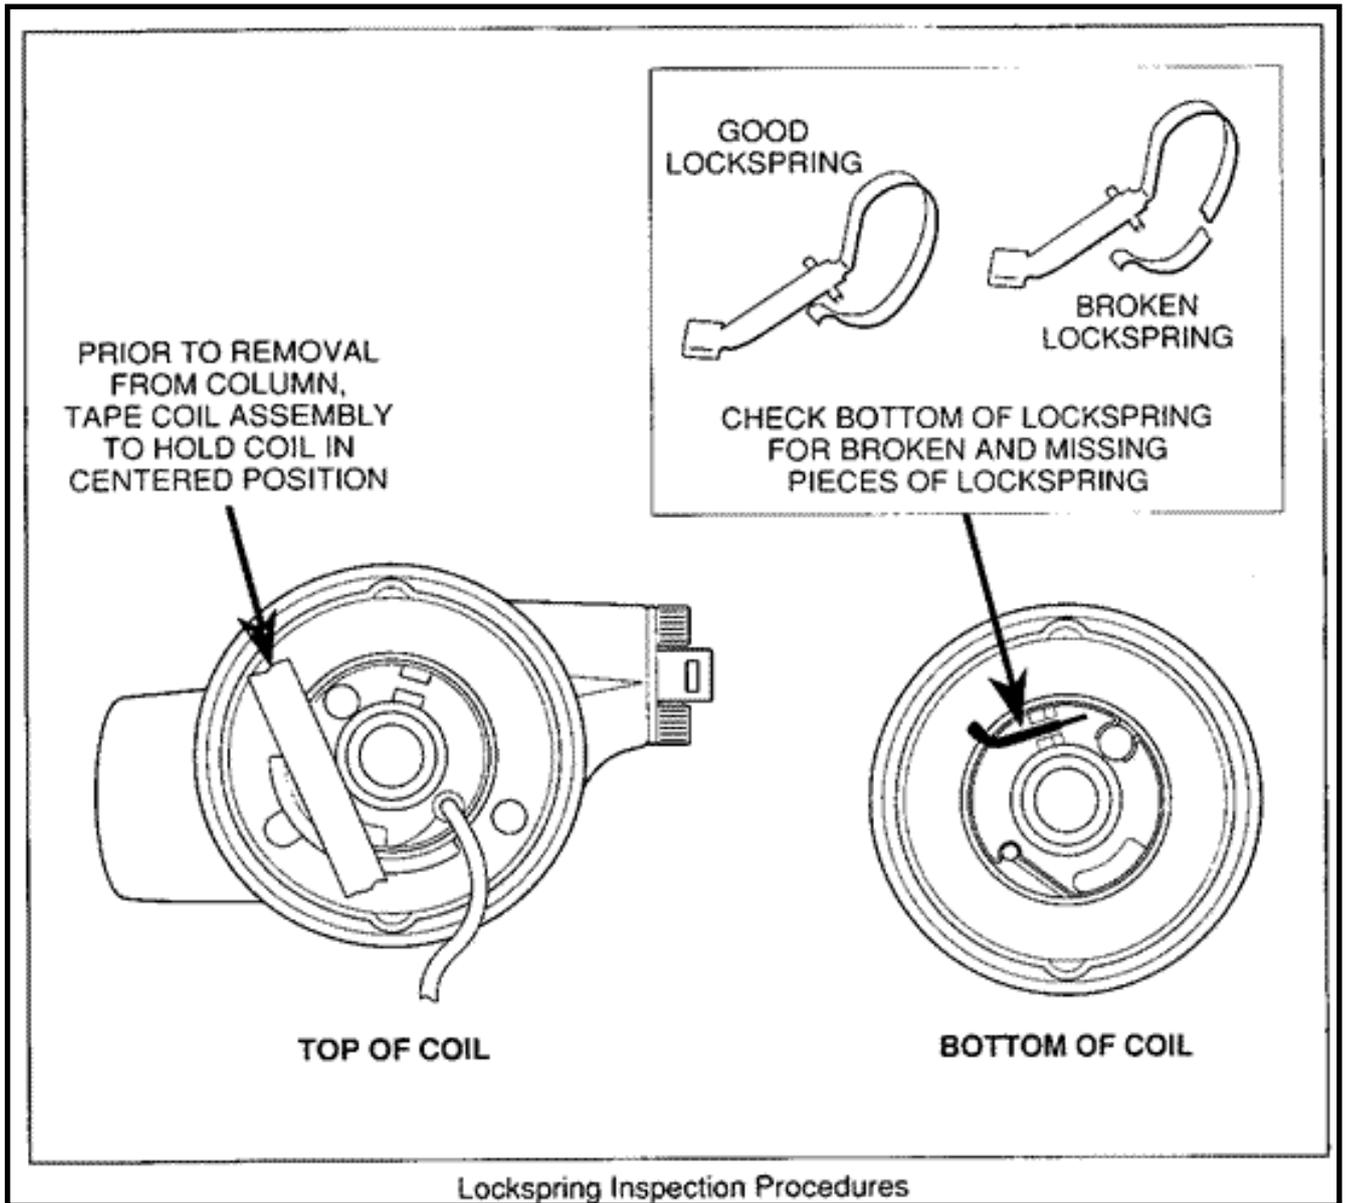
A "clicking" noise may be heard when the steering wheel is turned.

The Supplemental Inflatable Restraint (SIR) coil lockspring, which holds the coil in a centered position during service, may be missing or broken. The brass colored lockspring may not be strong enough to withstand compression during assembly. The SIR system continues to function normally.

1. Black lockspring - latest design, not subject to breakage.
2. Brass colored lockspring - early design, subject to breakage.
3. No lockspring - Some steering columns may have been built without locksprings from VIN's #1 14400 to #1 15822 (Man. Trans.) and #1 16055 (Auto. Trans.).

4. Refer to 1990 Corvette Service Manual for complete instructions on removing the coil assembly from the steering column. Before removing the coil assembly from the column, tape the coil assembly to hold it in the centered position, as shown in the illustration.

5. Remove the coil from the column, turn the coil over, and inspect the lockspring for broken or missing pieces as shown in the illustration.

a. If the lockspring is black, it is not subject to breakage. Leave the lockspring in place.

b. If the spring is brass colored, and is not broken, leave it in place.

c. If the spring is brass colored, and is broken, remove all the pieces of the spring and discard. It is not necessary to replace the lockspring with a new one.

NOTICE: All pieces of the broken lockspring must be removed, or serious damage to the steering column may result.
