1990 Corvette: Service Bulletin: Clicking Noise When Steering Wheel is Rotated

Subject: 'CLICKING' NOISE WHEN STEERING WHEEL IS ROTATED

Model and Year: 1990 CORVETTE

Bulletin Number: 90-327-3B - (08/03/1990)

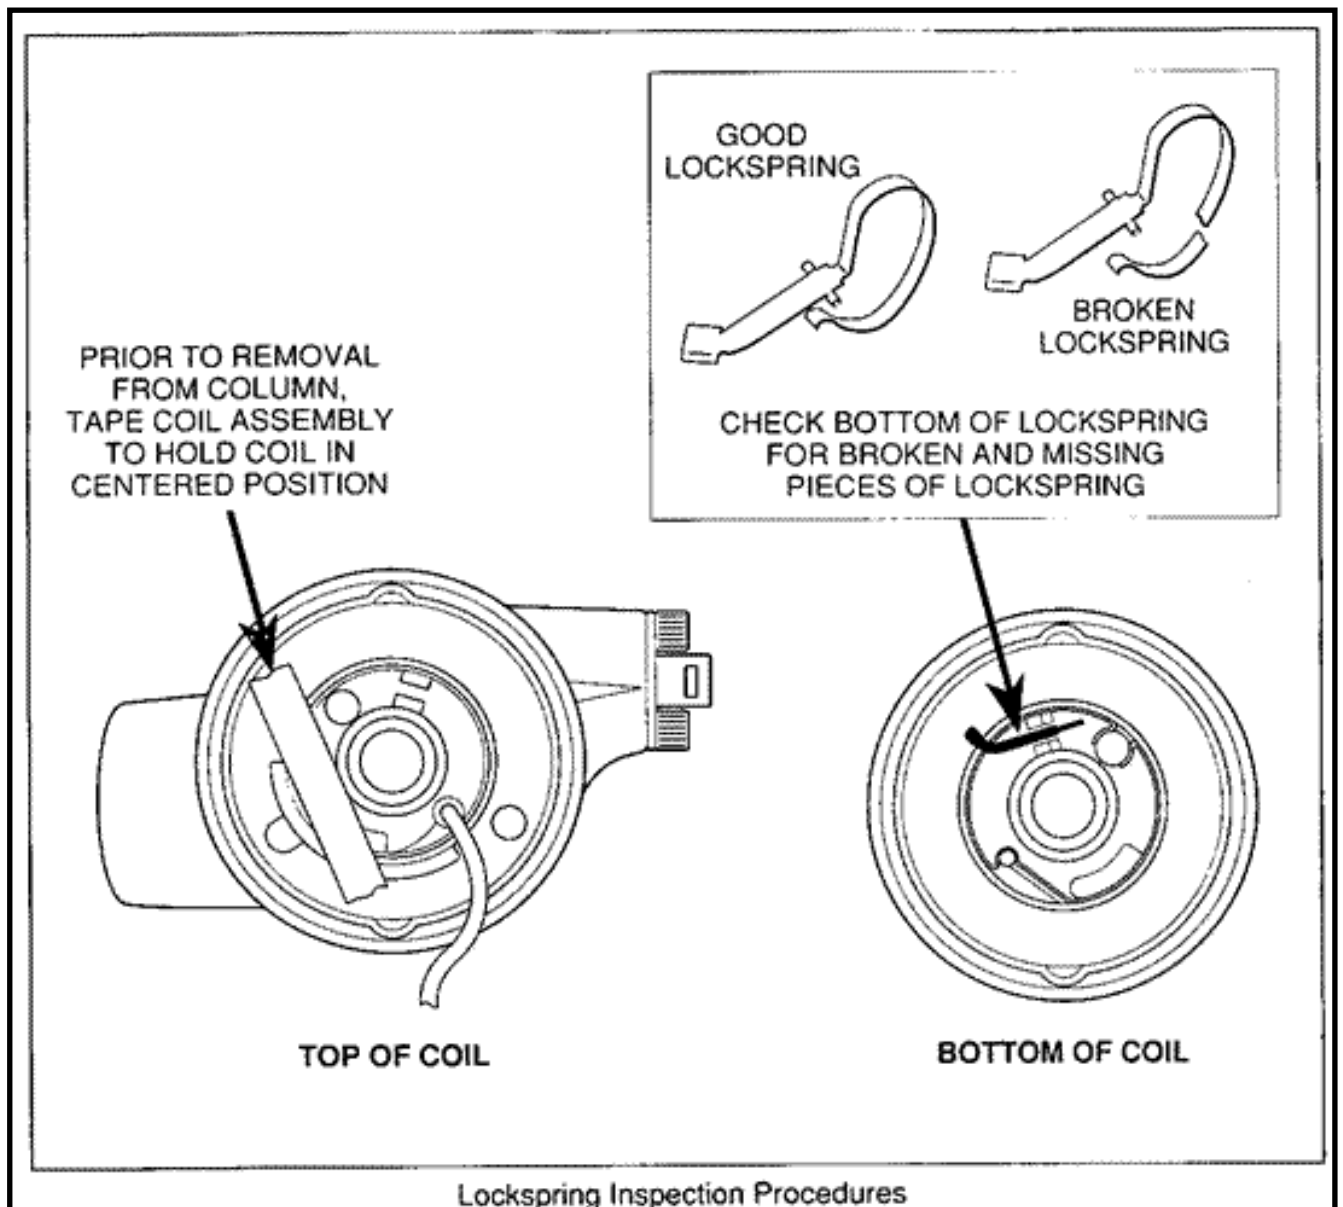
A "clicking" noise may be heard when the steering wheel is turned.

The Supplemental Inflatable Restraint (SIR) coil lockspring, which holds the coil in a centered position during service, may be missing or broken. The brass colored lockspring may not be strong enough to withstand compression during assembly. The SIR system continues to function normally.

1. Black lockspring - latest design, not subject to breakage.
2. Brass colored lockspring - early design, subject to breakage.
3. No lockspring - Some steering columns may have been built without locksprings from VIN's #1 14400 to #1 15822 (Man. Trans.) and #1 16055 (Auto. Trans.).

2. Disable SIR system following Service Manual instructions.
3. Place wheels in the straight ahead position before removing coil.
4. Refer to 1990 Corvette Service Manual for complete instructions on removing the coil assembly from the steering column. Before removing the coil assembly from the column, tape the coil assembly to hold it in the centered position, as shown in the illustration.

5. Remove the coil from the column, turn the coil over, and inspect the lockspring for broken or missing pieces as shown in the illustration.
 - a. If the lockspring is black, it is not subject to breakage. Leave the lockspring in place.
 - b. If the spring is brass colored, and is not broken, leave it in place.
 - c. If the spring is brass colored, and is broken, remove all the pieces of the spring and discard. It is not necessary to replace the lockspring with a new one.

NOTICE: All pieces of the broken lockspring must be removed, or serious damage to the steering column may result.

- d. if the spring is missing, it is not necessary to replace it.
6. Replace the coil assembly in the steering column.
7. Enable SIR system.
8. Reconnect the negative battery cable.
