1988 - 1990 Corvette: Service Bulletin: Power Steering Shudder / Groan

Subject: POWER STEERING SHUDDER/GROAN INSTALL P/S COOLER & HOSE

Model and Year: 1988-90 CORVETTE WITH 5.7L ENGINE

Bulletin Number: 90-376-3B - (10/25/1990)

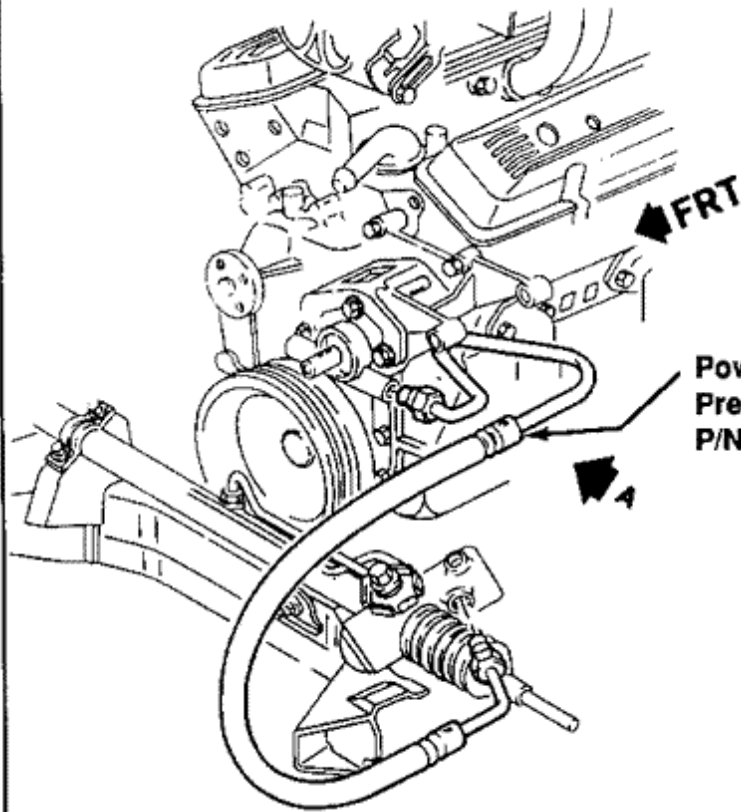
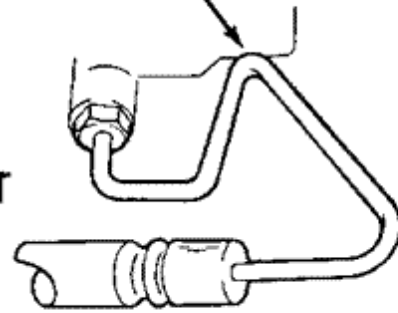
Step B Illustration

Power Steering
Pressure/Inlet Hose Asm.
P/N 262027177

Pipe at Pump End of
Hose Asm. is to be
Against Lower Corner
of Pump

Replace existing pressure/inlet hose (pump to steering gear) with new assembly with internal tuner cable.

Torque Specifications
Fittings (Pressure/Inlet Hose) – 28 N·m (21 lbs. ft.)
