# 1988 - 1990 Corvette: Service Bulletin: Power Steering Shudder / Groan

**Subject:** POWER STEERING SHUDDER/GROAN INSTALL P/S COOLER & HOSE

**Model and Year:** 1988-90 CORVETTE WITH 5.7L ENGINE

**Bulletin Number:** 90-376-3B - (10/25/1990)

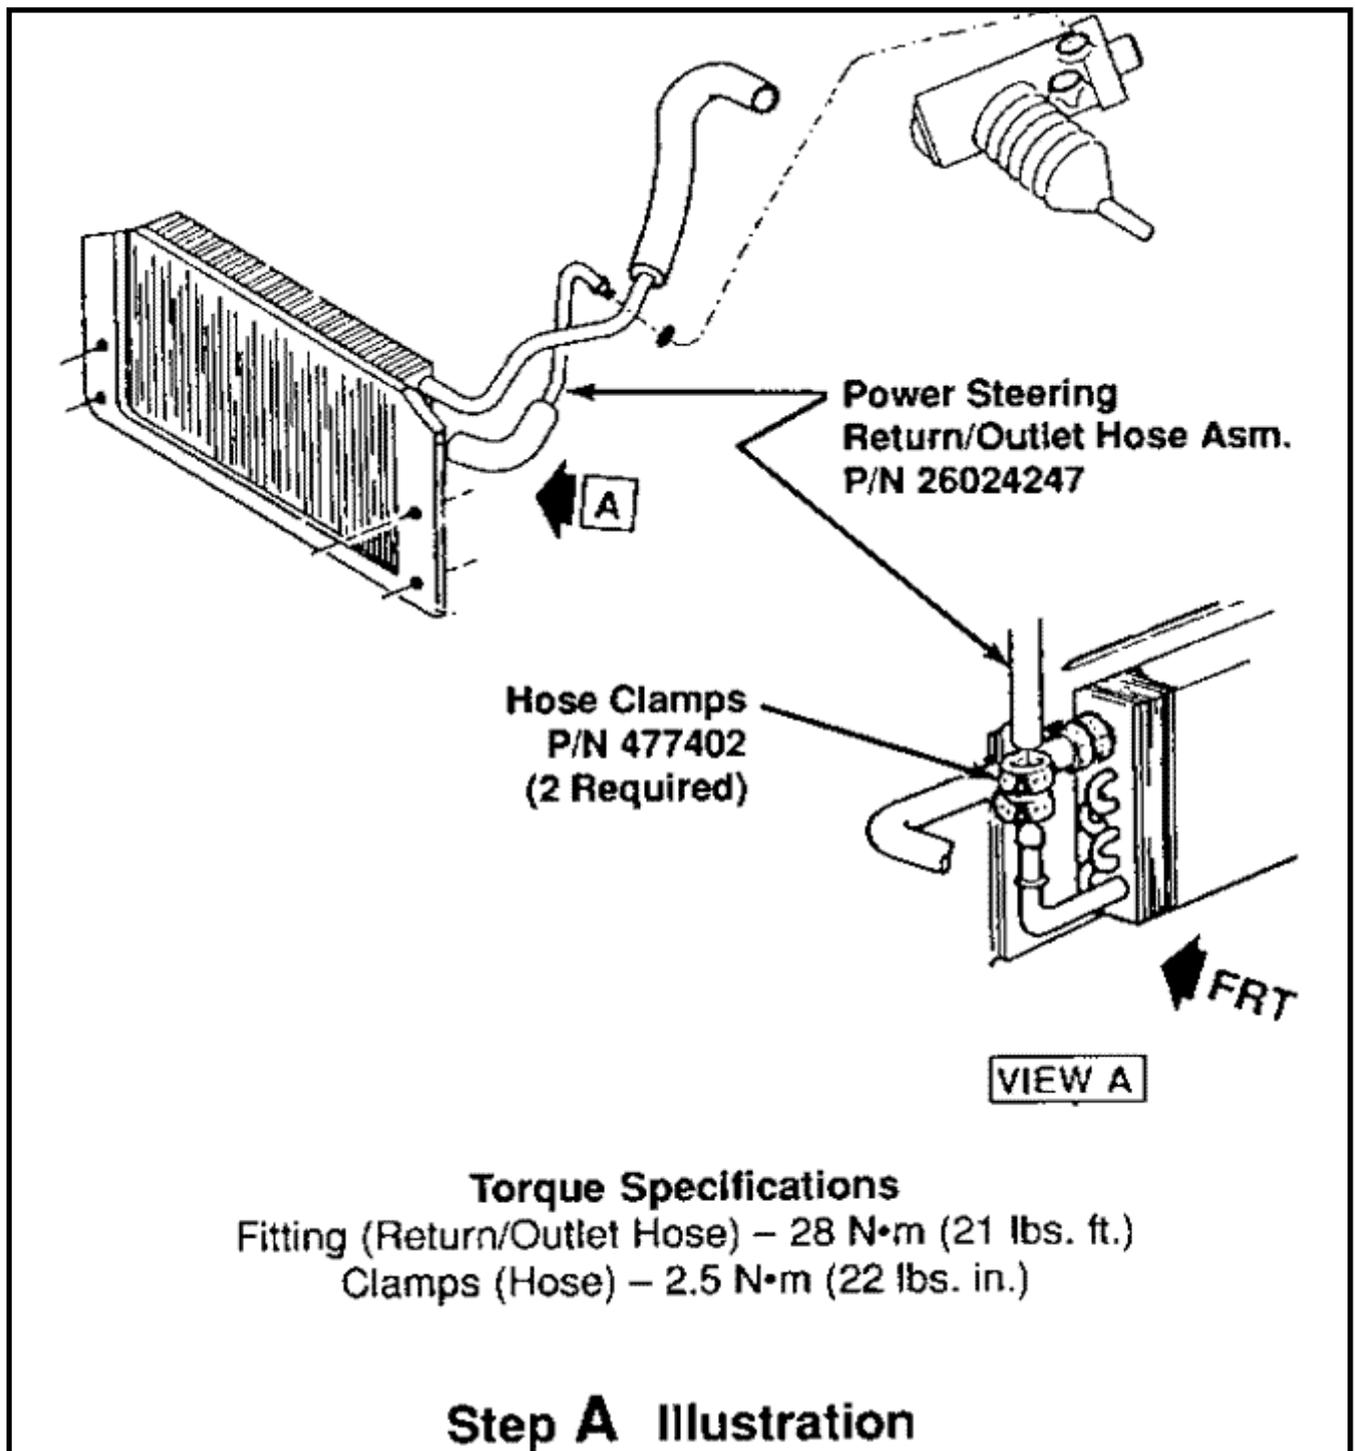
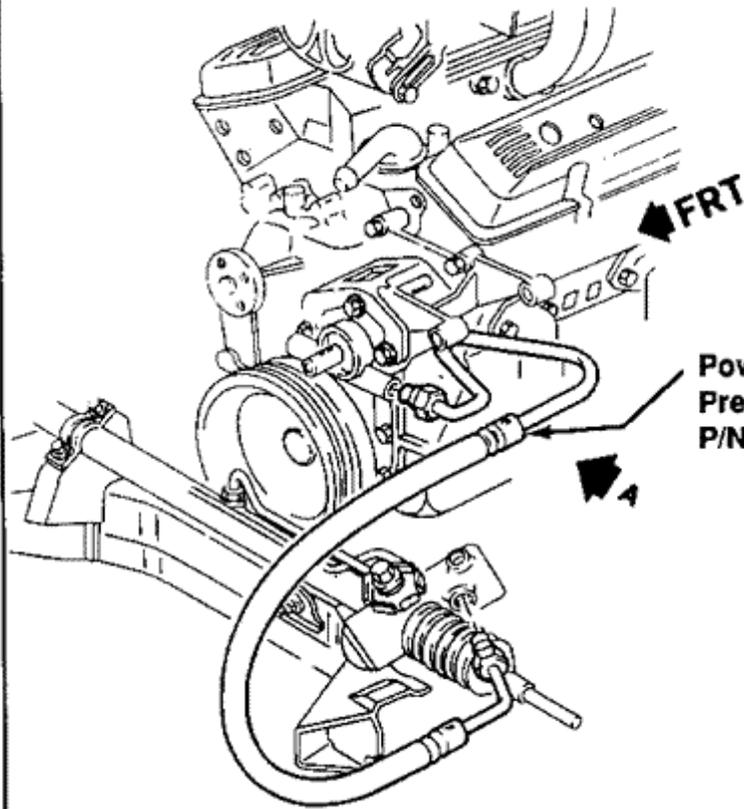
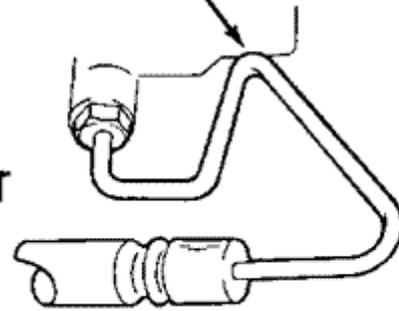
**Step B Illustration**

Power Steering  
Pressure/Inlet Hose Asm.  
P/N 262027177

Pipe at Pump End of  
Hose Asm. is to be  
Against Lower Corner  
of Pump

View A

Replace existing pressure/inlet hose (pump to steering gear) with new assembly with internal tuner cable.

**Torque Specifications**  
Fittings (Pressure/Inlet Hose) – 28 N·m (21 lbs. ft.)
