# 1984 Corvette: Service Bulletin: Rack / Pinion Power Steering Valve Ring Service

**Subject:** RACK/PINION POWER STEERING VALVE RING SERVICE  
**Model and Year:** 1981-84 CHEVETTE, 1982-84 CAVALIER, CELEBRITY, CITATION AND 1984 CORVETTE  
**Source:** Chevrolet Service Bulletin  
**Bulletin Number:** 84-74 - (06/02/1984)

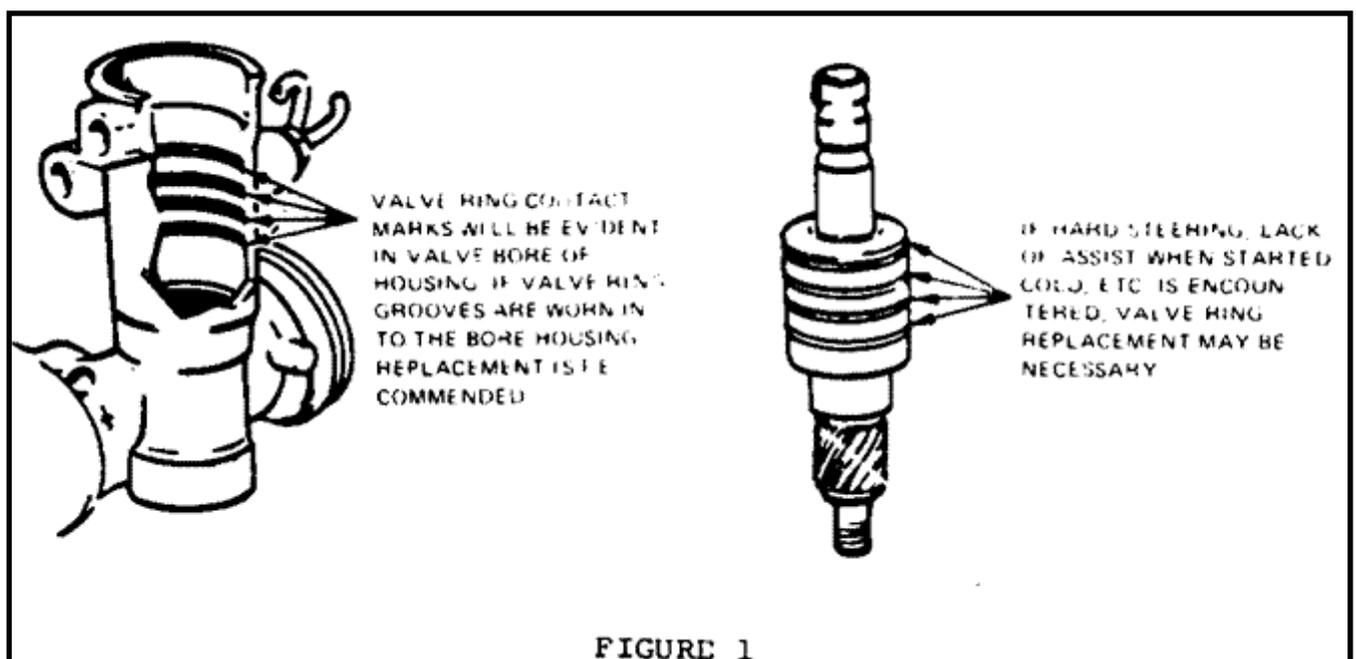
The design intent is that valve rings will remain stationary in the bore of a power rack and pinion assembly. If hard steering, lack of assist when started cold, etc., is encountered with normal pump pressure, inspect the rack and pinion housing valve bore (see illustration).

Ring contact marks in the valve bore is normal. If ring groove wear exists, replacement of the housing is necessary to assure that replacement rings will not eventually wear further into the housing and result in a recurrence of a lack of power assist symptom.

If only one (1) or two (2) of the four (4) ring contact marks in the housing have resulted in ring groove wear, the corresponding ring land of the valve is most likely causing excessive ring drag. Replacement of the valve as well as the housing would then be required.

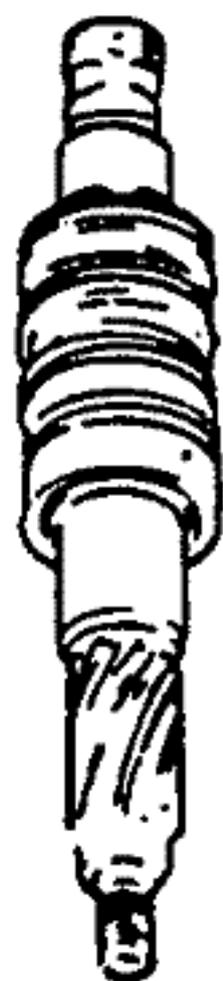
FIGURE 2

The valve and pinion assembly must be pressed out of the housing per Chassis Service Manual procedure. Excessive force or hammer use will likely damage the valve or valve pinion pin. After valve removal, inspect the valve pinion pin for being loose, bent, or protruding beyond the valve machined surface (see illustration). If any of these conditions exist, valve body replacement is required.

Pinion pin must not be bent, loose, or protrude beyond machined surface of valve.

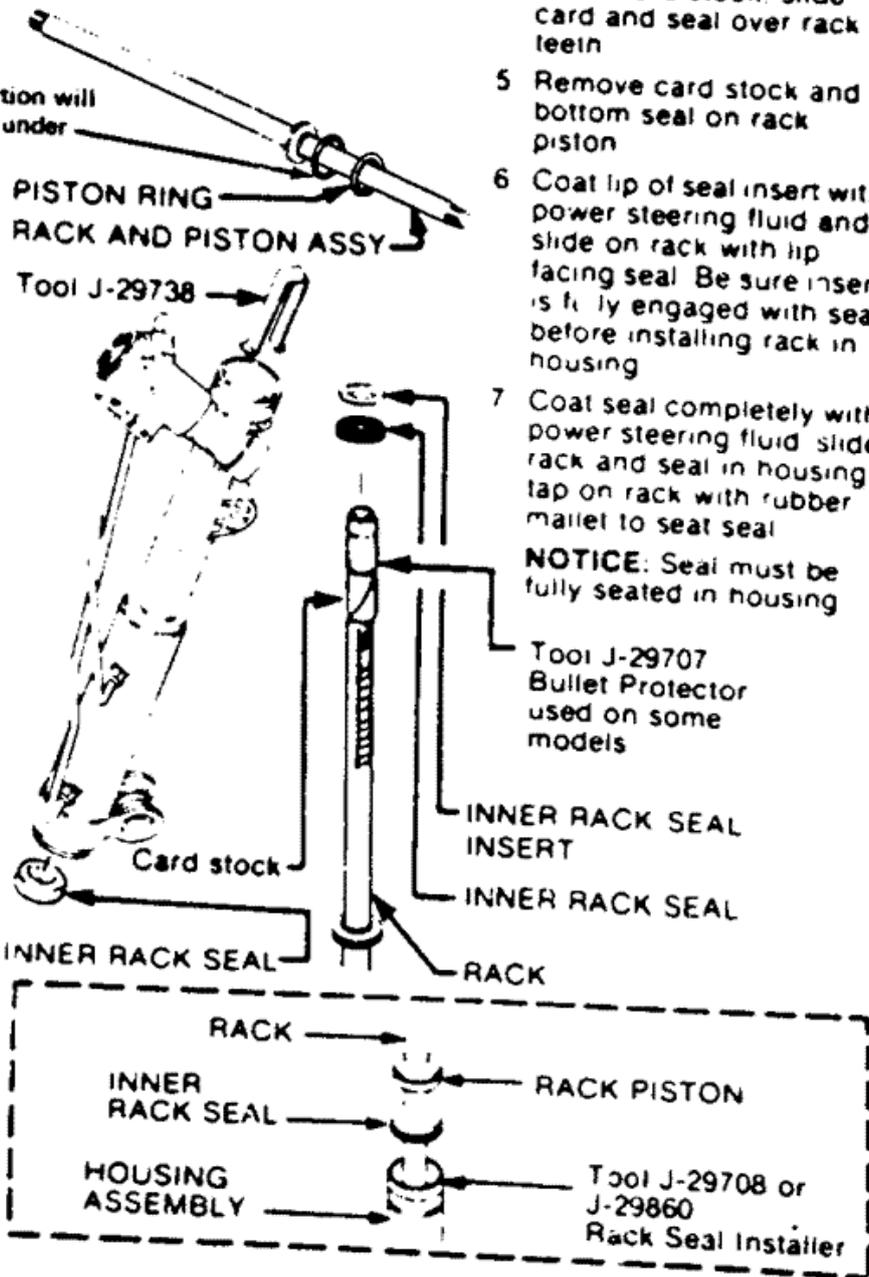
FIGURE 3

A lack of power assist symptom may also be caused by leakage past the rack piston ring in the housing tube bore. Inspect the rack piston ring for damage or distortion. The piston ring to ring land side clearance should not exceed .008". Also inspect the housing tube bore for any nicks, scoring or other imperfection in the rack piston travel area.

Mid 1984 production will have an "O" ring under piston ring.

- 1 Remove rack from housing
- 2 Remove piston ring and dispose
- 3 Fit tool J-29738 into housing. Using rod approx 12" long, gently tap on rod until seal is removed
- 4 Dispose of old seal

- 1 Install new piston ring on rack
- 2 Care should be taken not to cut ring at installation
- 3 Wrap card stock around end of rack and rack teeth
- 4 Coat seal lip with power steering fluid, slide seal with seal lip facing piston on to card stock, slide card and seal over rack teeth
- 5 Remove card stock and bottom seal on rack piston
- 6 Coat lip of seal insert with power steering fluid and slide on rack with lip facing seal. Be sure insert is fully engaged with seal before installing rack in housing
- 7 Coat seal completely with power steering fluid, slide rack and seal in housing, tap on rack with rubber mallet to seat seal
