1984 Corvette: Service Bulletin: Rack / Pinion Power Steering Valve Ring Service

Subject: RACK/PINION POWER STEERING VALVE RING SERVICE
Model and Year: 1981-84 CHEVETTE, 1982-84 CAVALIER, CELEBRITY, CITATION AND 1984 CORVETTE
Source: Chevrolet Service Bulletin
Bulletin Number: 84-74 - (06/02/1984)

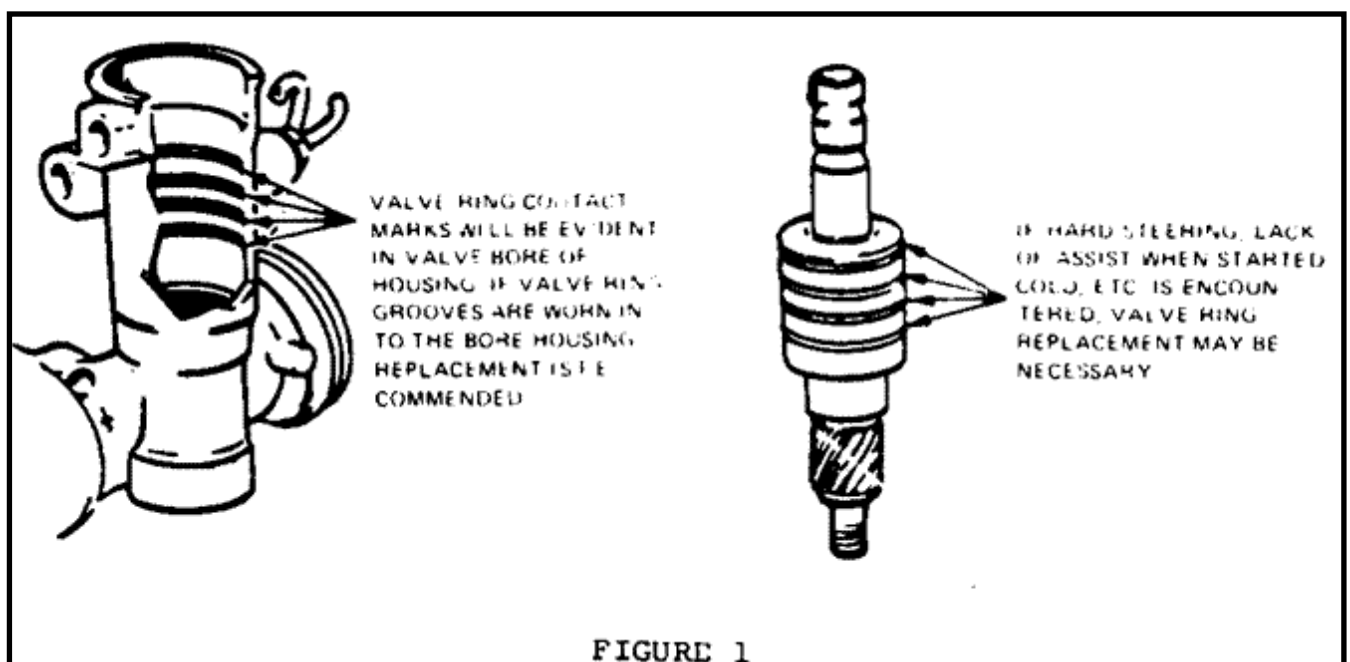
The design intent is that valve rings will remain stationary in the bore of a power rack and pinion assembly. If hard steering, lack of assist when started cold, etc., is encountered with normal pump pressure, inspect the rack and pinion housing valve bore (see illustration).

Ring contact marks in the valve bore is normal. If ring groove wear exists, replacement of the housing is necessary to assure that replacement rings will not eventually wear further into the housing and result in a recurrence of a lack of power assist symptom.

If only one (1) or two (2) of the four (4) ring contact marks in the housing have resulted in ring groove wear, the corresponding ring land of the valve is most likely causing excessive ring drag. Replacement of the valve as well as the housing would then be required.

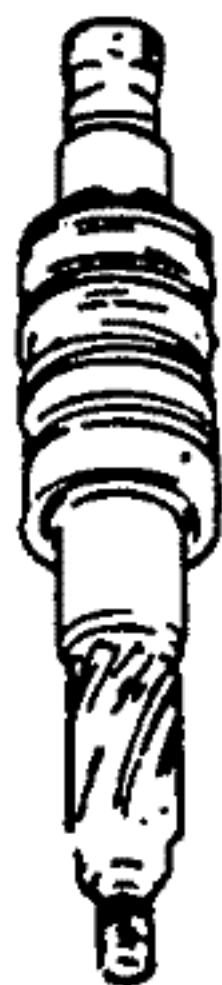
FIGURE 2

The valve and pinion assembly must be pressed out of the housing per Chassis Service Manual procedure. Excessive force or hammer use will likely damage the valve or valve pinion pin. After valve removal, inspect the valve pinion pin for being loose, bent, or protruding beyond the valve machined surface (see illustration). If any of these conditions exist, valve body replacement is required.

Pinion pin must not be bent, loose, or protrude beyond machined surface of valve.
