1984 Corvette: Service Bulletin: Rack / Pinion Power Steering Valve Ring Service

Subject: RACK/PINION POWER STEERING VALVE RING SERVICE
Model and Year: 1981-84 CHEVETTE, 1982-84 CAVALIER, CELEBRITY, CITATION AND 1984 CORVETTE
Source: Chevrolet Service Bulletin
Bulletin Number: 84-74 - (06/02/1984)

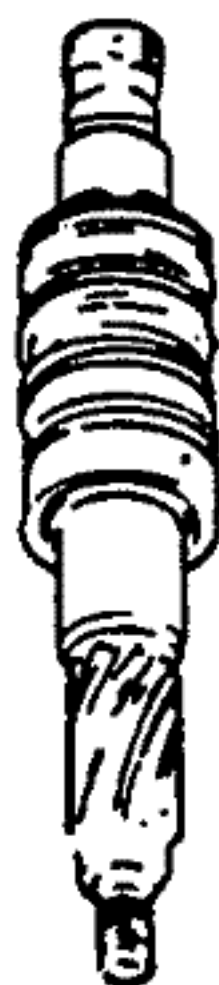
FIGURE 2

The valve and pinion assembly must be pressed out of the housing per Chassis Service Manual procedure. Excessive force or hammer use will likely damage the valve or valve pinion pin. After valve removal, inspect the valve pinion pin for being loose, bent, or protruding beyond the valve machined surface (see illustration). If any of these conditions exist, valve body replacement is required.

Pinion pin must
not be bent, loose,
or protrude beyond
machined surface of
valve.

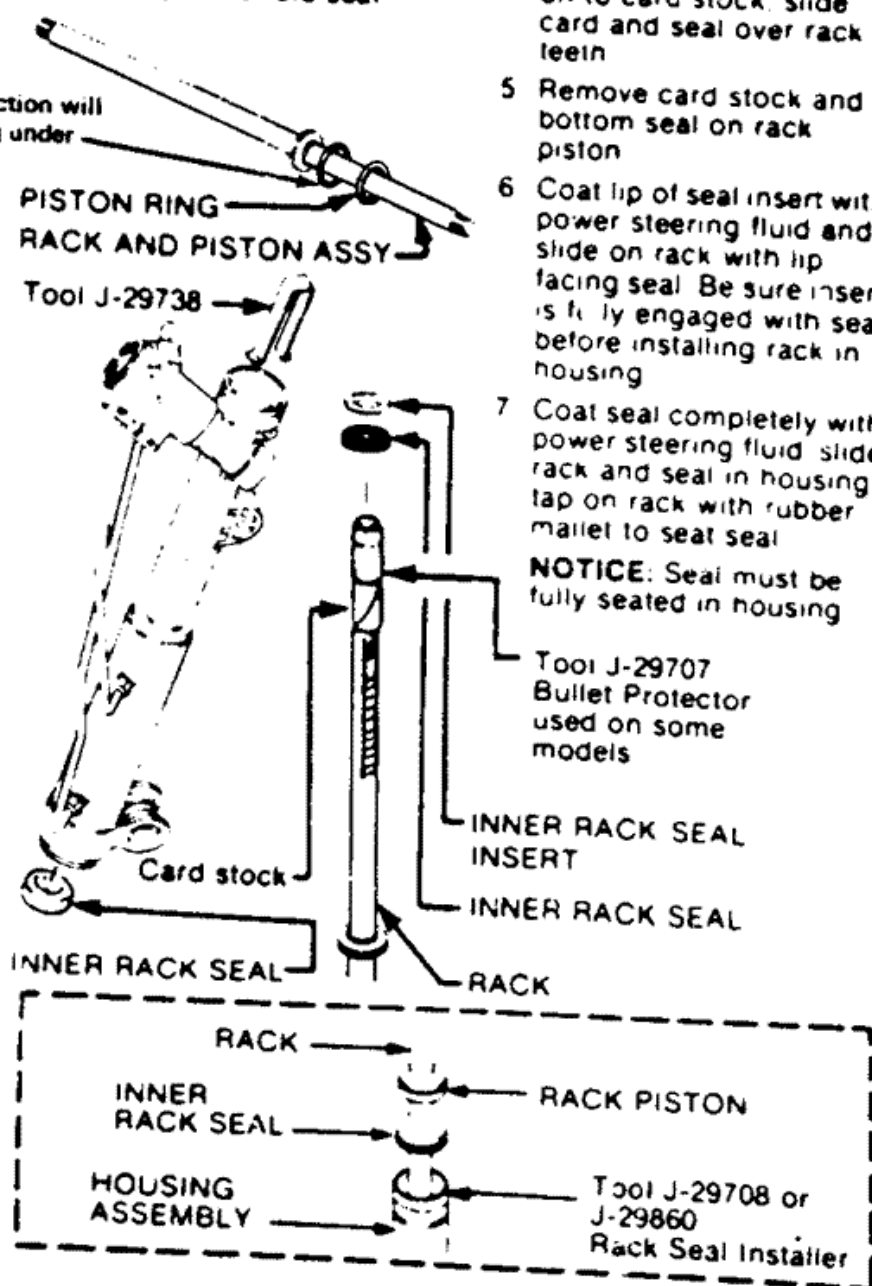
FIGURE 3

A lack of power assist symptom may also be caused by leakage past the rack piston ring in the housing tube bore. Inspect the rack piston ring for damage or distortion. The piston ring to ring land side clearance should not exceed .008". Also inspect the housing tube bore for any nicks, scoring or other imperfection in the rack piston travel area.

REMOVE AND INSTALL INNER RACK SEAL, RACK AND PISTON RING

- 1 Remove rack from housing
- 2 Remove piston ring and dispose
- 3 Fit tool J-29738 into housing. Using rod approx 12" long, gently tap on rod until seal is removed
- 4 Dispose of old seal

- 1 Install new piston ring on rack
- 2 Care should be taken not to cut ring at installation
- 3 Wrap card stock around end of rack and rack teeth
- 4 Coat seal lip with power steering fluid, slide seal with seal lip facing piston on to card stock, slide card and seal over rack teeth
- 5 Remove card stock and bottom seal on rack piston
- 6 Coat lip of seal insert with power steering fluid and slide on rack with lip facing seal. Be sure insert is fully engaged with seal before installing rack in housing
- 7 Coat seal completely with power steering fluid, slide rack and seal in housing, tap on rack with rubber mallet to seat seal

NOTICE: Seal must be fully seated in housing
