1984 Corvette: Service Bulletin: Rack / Pinion Power Steering Valve Ring Service

Subject: RACK/PINION POWER STEERING VALVE RING SERVICE

Model and Year: 1981-84 CHEVETTE, 1982-84 CAVALIER, CELEBRITY, CITATION AND 1984 CORVETTE

Bulletin Number: 84-74 - (06/02/1984)

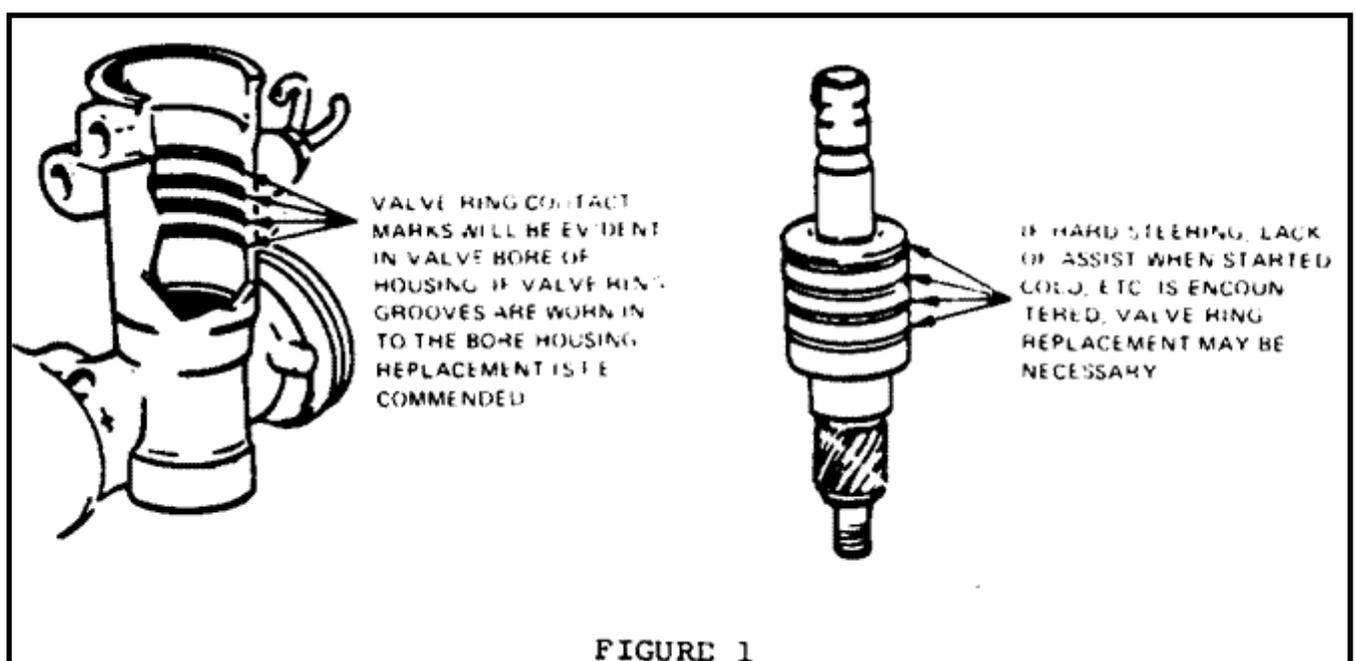
The design intent is that valve rings will remain stationary in the bore of a power rack and pinion assembly. If hard steering, lack of assist when started cold, etc., is encountered with normal pump pressure, inspect the rack and pinion housing valve bore (see illustration).

Ring contact marks in the valve bore is normal. If ring groove wear exists, replacement of the housing is necessary to assure that replacement rings will not eventually wear further into the housing and result in a recurrence of a lack of power assist symptom.

If only one (1) or two (2) of the four (4) ring contact marks in the housing have resulted in ring groove wear, the corresponding ring land of the valve is most likely causing excessive ring drag. Replacement of the valve as well as the housing would then be required.

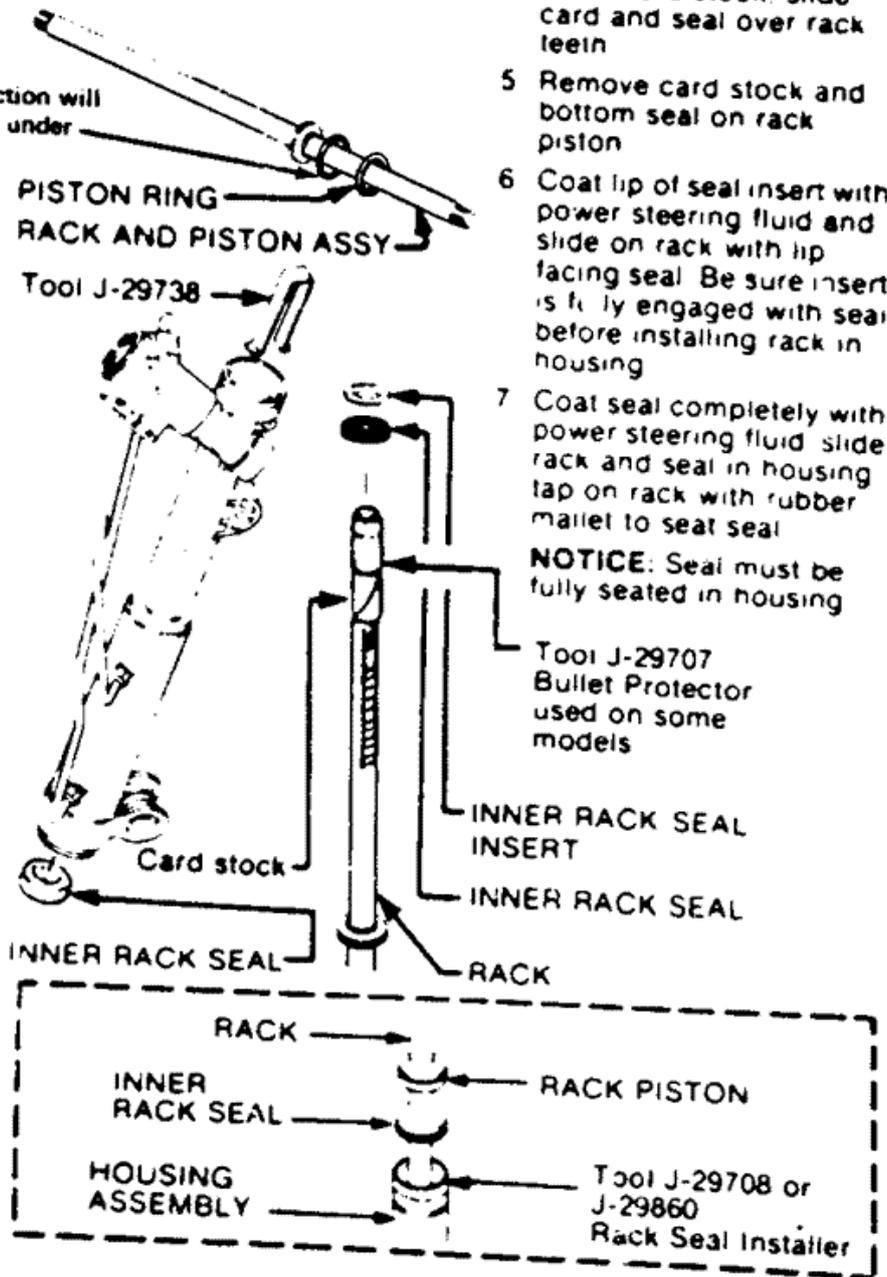
FIGURE 3

A lack of power assist symptom may also be caused by leakage past the rack piston ring in the housing tube bore. Inspect the rack piston ring for damage or distortion. The piston ring to ring land side clearance should not exceed .008". Also inspect the housing tube bore for any nicks, scoring or other imperfection in the rack piston travel area.

Mid 1984 production will have an "O" ring under piston ring.

REMOVE AND INSTALL INNER RACK SEAL, RACK AND PISTON RING

- 1 Remove rack from housing
- 2 Remove piston ring and dispose
- 3 Fit tool J-29738 into housing. Using rod approx 12" long, gently tap on rod until seal is removed
- 4 Dispose of old seal

- 1 Install new piston ring on rack
- 2 Care should be taken not to cut ring at installation
- 3 Wrap card stock around end of rack and rack teeth
- 4 Coat seal lip with power steering fluid, slide seal with seal lip facing piston on to card stock, slide card and seal over rack teeth
- 5 Remove card stock and bottom seal on rack piston
- 6 Coat lip of seal insert with power steering fluid and slide on rack with lip facing seal. Be sure insert is fully engaged with seal before installing rack in housing
- 7 Coat seal completely with power steering fluid, slide rack and seal in housing, tap on rack with rubber mallet to seat seal
