1984 Corvette: Service Bulletin: Rack / Pinion Power Steering Valve Ring Service

Subject: RACK/PINION POWER STEERING VALVE RING SERVICE

Model and Year: 1981-84 CHEVETTE, 1982-84 CAVALIER, CELEBRITY, CITATION AND 1984 CORVETTE

Bulletin Number: 84-74 - (06/02/1984)

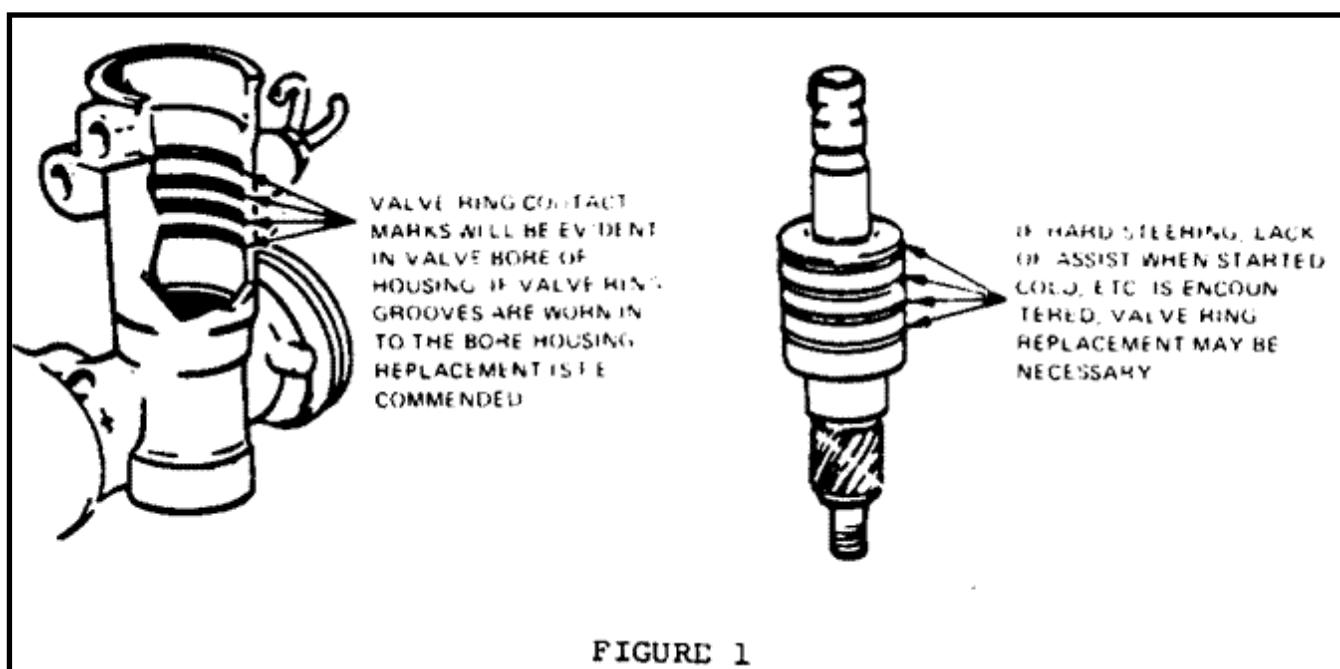
The design intent is that valve rings will remain stationary in the bore of a power rack and pinion assembly. If hard steering, lack of assist when started cold, etc., is encountered with normal pump pressure, inspect the rack and pinion housing valve bore (see illustration).

Ring contact marks in the valve bore is normal. If ring groove wear exists, replacement of the housing is necessary to assure that replacement rings will not eventually wear further into the housing and result in a recurrence of a lack of power assist symptom.

If only one (1) or two (2) of the four (4) ring contact marks in the housing have resulted in ring groove wear, the corresponding ring land of the valve is most likely causing excessive ring drag. Replacement of the valve as well as the housing would then be required.

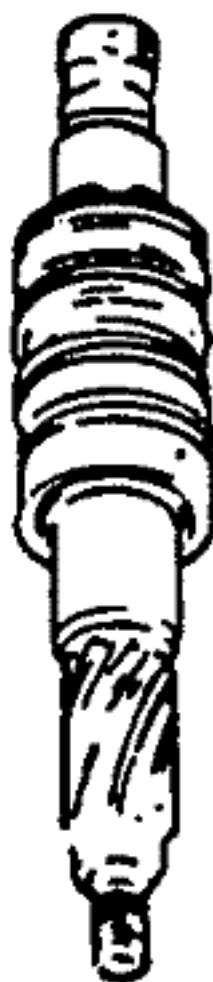
FIGURE 2

The valve and pinion assembly must be pressed out of the housing per Chassis Service Manual procedure. Excessive force or hammer use will likely damage the valve or valve pinion pin. After valve removal, inspect the valve pinion pin for being loose, bent, or protruding beyond the valve machined surface (see illustration). If any of these conditions exist, valve body replacement is required.

**Pinion pin must
not be bent, loose,
or protrude beyond
machined surface of
valve.**

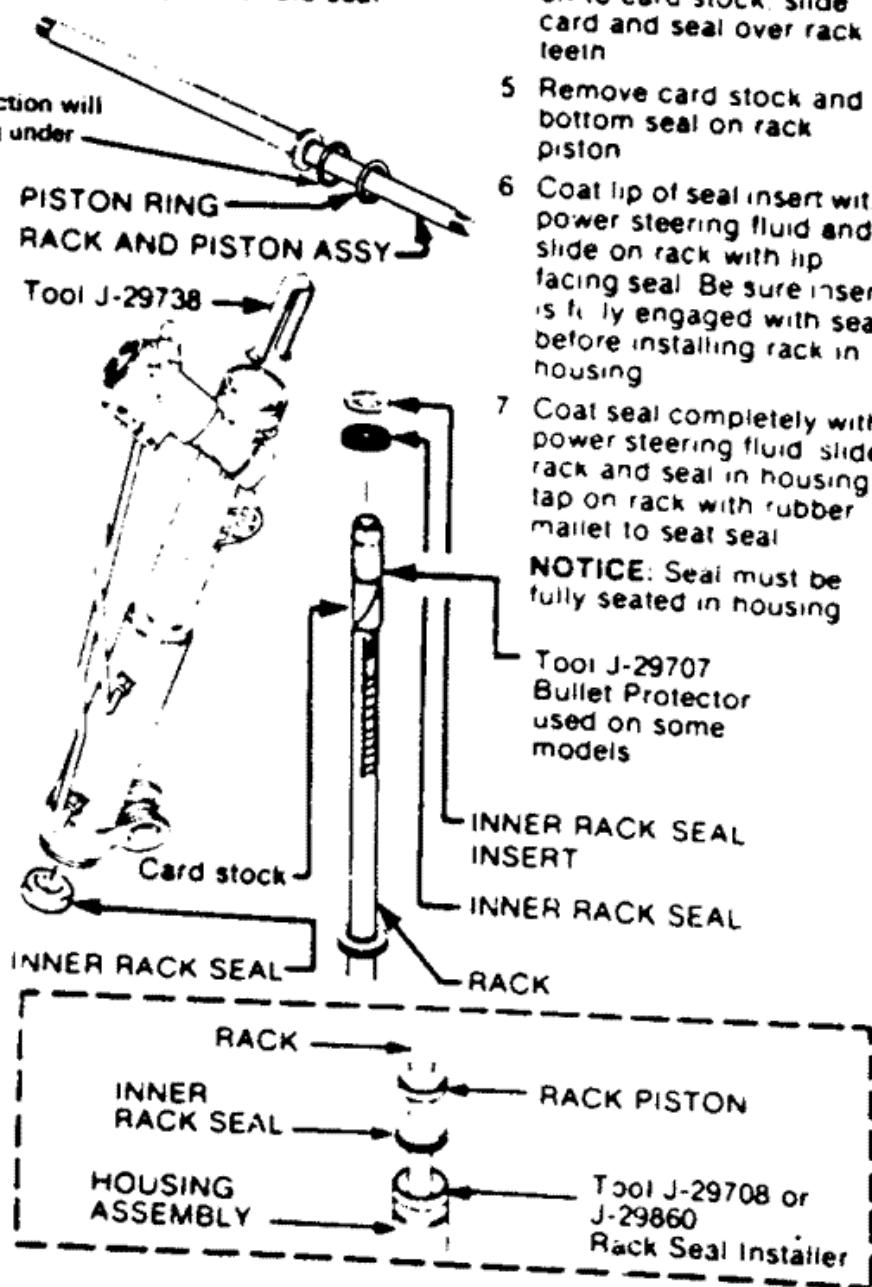
FIGURE 3

A lack of power assist symptom may also be caused by leakage past the rack piston ring in the housing tube bore. Inspect the rack piston ring for damage or distortion. The piston ring to ring land side clearance should not exceed .008". Also inspect the housing tube bore for any nicks, scoring or other imperfection in the rack piston travel area.

- 1 Remove rack from housing
- 2 Remove piston ring and dispose
- 3 Fit tool J-29738 into housing. Using rod approx 12" long, gently tap on rod until seal is removed
- 4 Dispose of old seal

- 1 Install new piston ring on rack
- 2 Care should be taken not to cut ring at installation
- 3 Wrap card stock around end of rack and rack teeth
- 4 Coat seal lip with power steering fluid. Slide seal with seal lip facing piston on to card stock. Slide card and seal over rack teeth
- 5 Remove card stock and bottom seal on rack piston
- 6 Coat lip of seal insert with power steering fluid and slide on rack with lip facing seal. Be sure insert is fully engaged with seal before installing rack in housing
- 7 Coat seal completely with power steering fluid. Slide rack and seal in housing. Tap on rack with rubber mallet to seat seal

NOTICE: Seal must be fully seated in housing
